SITE INFORMATION

*ADDRESS: <u>30174 458th Ave.</u>

*CITY: Wakonda

STRUCTURE DETAILS				
SHPO ID:		-		
*PROPERTY NAME:				
OTHER NAME:				
CURRENT FUNCTION:	Vacant	FOUNDA	TION:	Poured concrete
				Steel roofing over
CURRENT SUBFUNCTION:		ROOF MATE	RIAL:	cedar shingles
HISTORIC FUNCTION:	Livestock barn	ROOF SH	IAPE:	Gambrel
HISTORIC SUBFUNCTION:	Hay and grain storage	STRUCTURAL SYS	TEM:	Balloon framing
		ST	TYLE:	Gambrel roof barn
OCCUPIED:	Yes	1	TYPE:	Livestock barn
	Yes with			2x6, sheathing &
ACCESSIBLE:	permission	WA	ALLS:	cedar siding
STORIES:	2	SIGNIFICANT PERSON:	Dav	vid Horlocker
*DATE OF CONSTRUCTION:	1915 to 1925 CU	LTURAL AFFILIATION:		?
		-

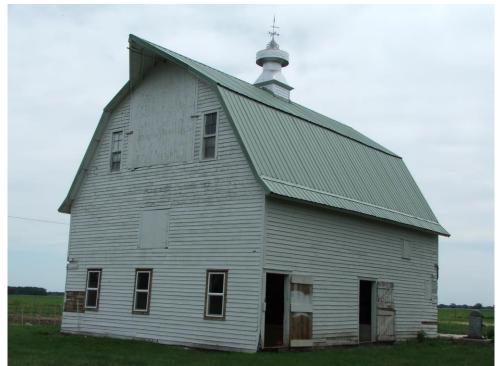
1

ROLL NUMBER: PHOTO NUMBER: CAMERA DIRECTION: Looking NW, SE corner

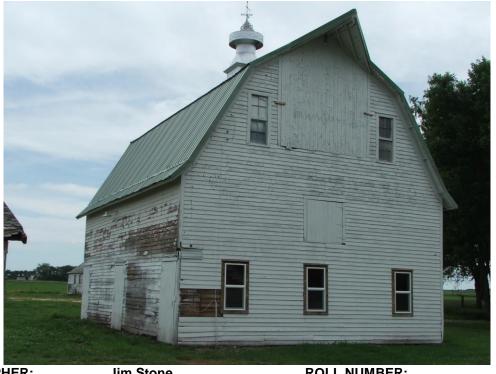
PHOTOGRAPHER:	Jim Stone	ROLL NUMBER:	
DATE OF PHOTO:	June 5, 2012	PHOTO NUMBER:	2
		CAMERA DIRECTION:	Looking NE, SW corner

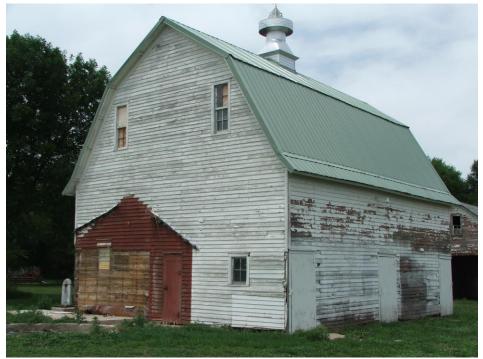
DATE OF PHOTO:
 June 5, 2012
 PHOTO NUMBER:
 3

CAMERA DIRECTION:
 Looking SE. NW corner

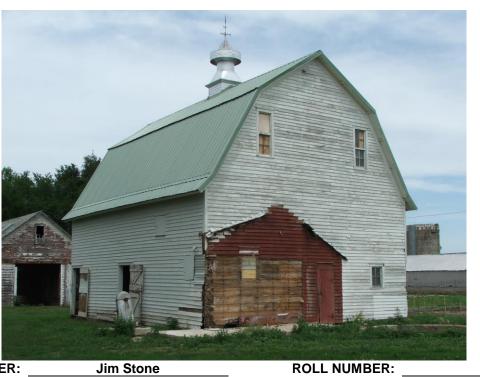
DATE OF PHOTO:
 June 5, 2012
 PHOTO NUMBER:
 4

CAMERA DIRECTION:
 Looking SW, NE corner

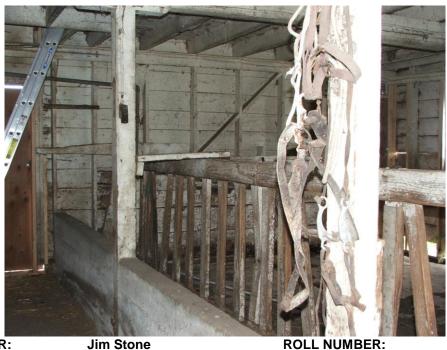
PHOTO NUMBER: 5 First floor, looking East, original milk cow CAMERA DIRECTION: stanchions

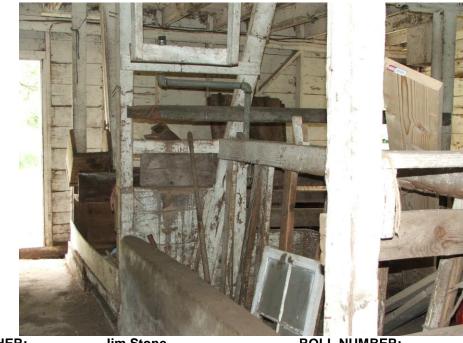
6 First floor, looking east, milk cow stanchions

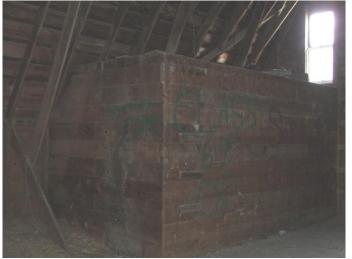
7 Hayloft, granary in NW corner

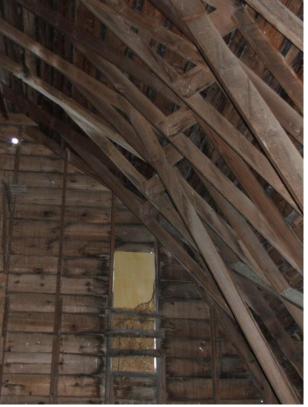
8 Hayloft, looking SW, hip rafter bracing

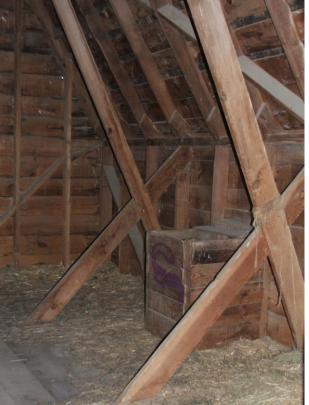
PHOTOGRAPHER:	Jim Stone	ROLL NUMBER:	
DATE OF PHOTO:	June 5, 2012	PHOTO NUMBER:	9
			Havloft looking SW

nayion, looking Sw, CAMERA DIRECTION: lower rafter bracing
