**SOUTH DAKOTA STATE HISTORIC PRESERVATION OFFICE
HISTORIC SITES SURVEY STRUCTURE FORM**

*SURVEY DATE: June 5, 2012 *ADDRESS: 30174 458th Ave.
*SURVEYOR: Jim Stone *COUNTY: Clay
*CITY: Wakonda

CURRENT FUNCTION: Vacant FOUNDATION: Poured concrete
 CURRENT SUBFUNCTION: _____ ROOF MATERIAL: Steel roofing over cedar shingles
 HISTORIC FUNCTION: Livestock barn ROOF SHAPE: Gambrel
 HISTORIC SUBFUNCTION: Hay and grain storage STRUCTURAL SYSTEM: Balloon framing
 OCCUPIED: Yes STYLE: Gambrel roof barn
 Yes with TYPE: Livestock barn
 ACCESSIBLE: permission WALLS: 2x6, sheathing & cedar siding

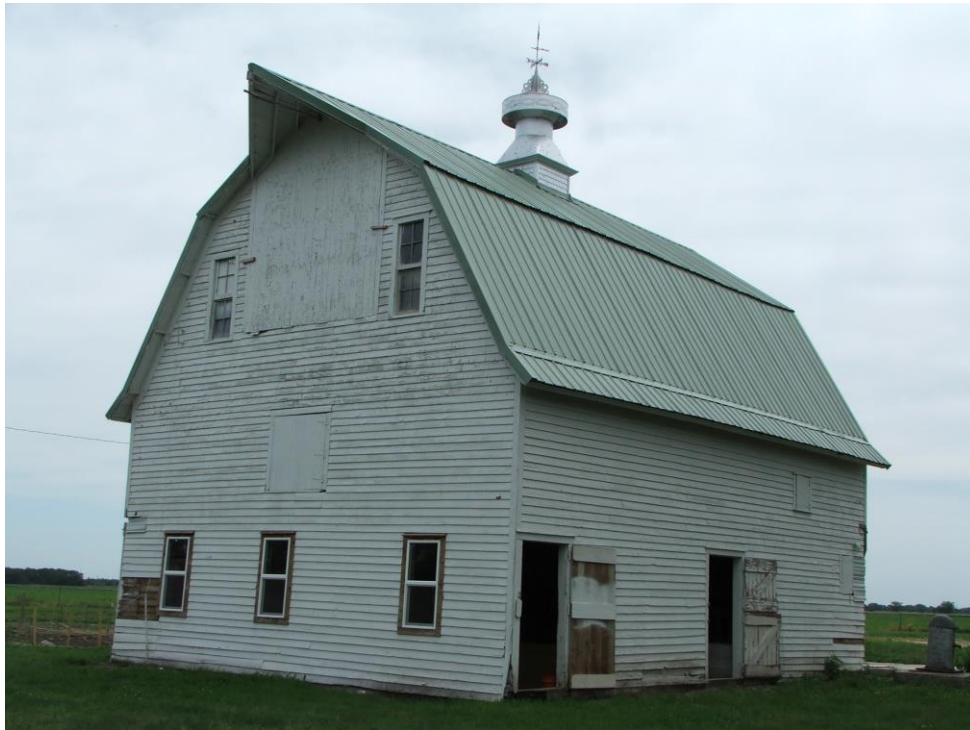
*PHYSICAL NOTES: Barn is in very good condition. Needs some siding and sheathing on the SE Corner. Some windows need to be replaced. Metal cupola.

ROLL NUMBER: _____
PHOTO NUMBER: 1
CAMERA DIRECTION: Looking NW, SE corner

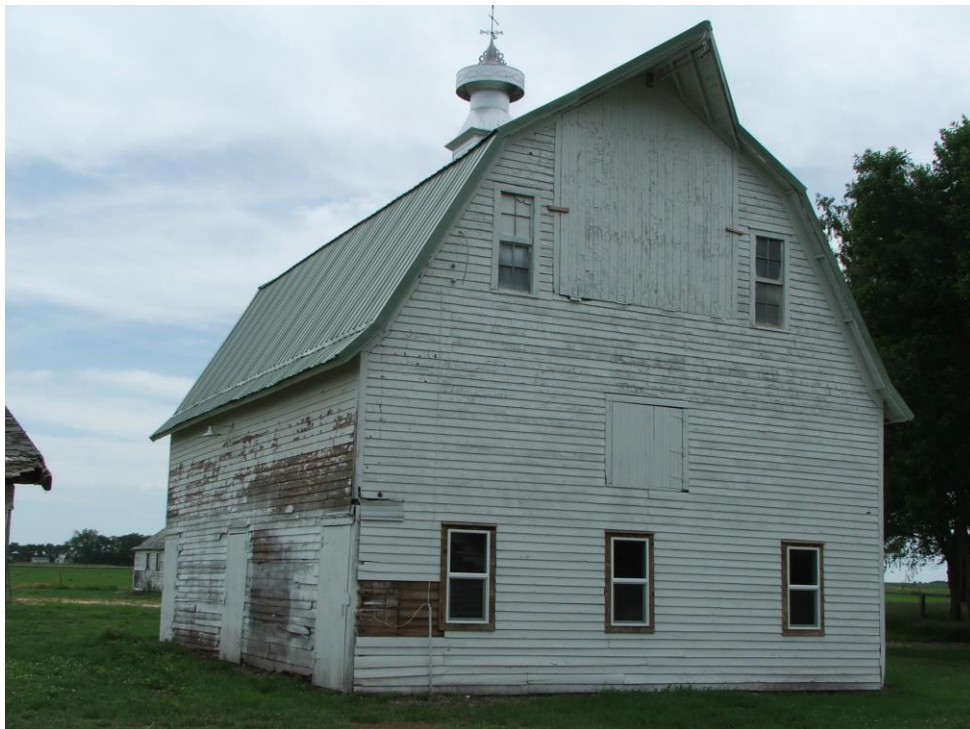
ROLL NUMBER: _____
PHOTO NUMBER: 2
CAMERA DIRECTION: Looking NE, SW corner

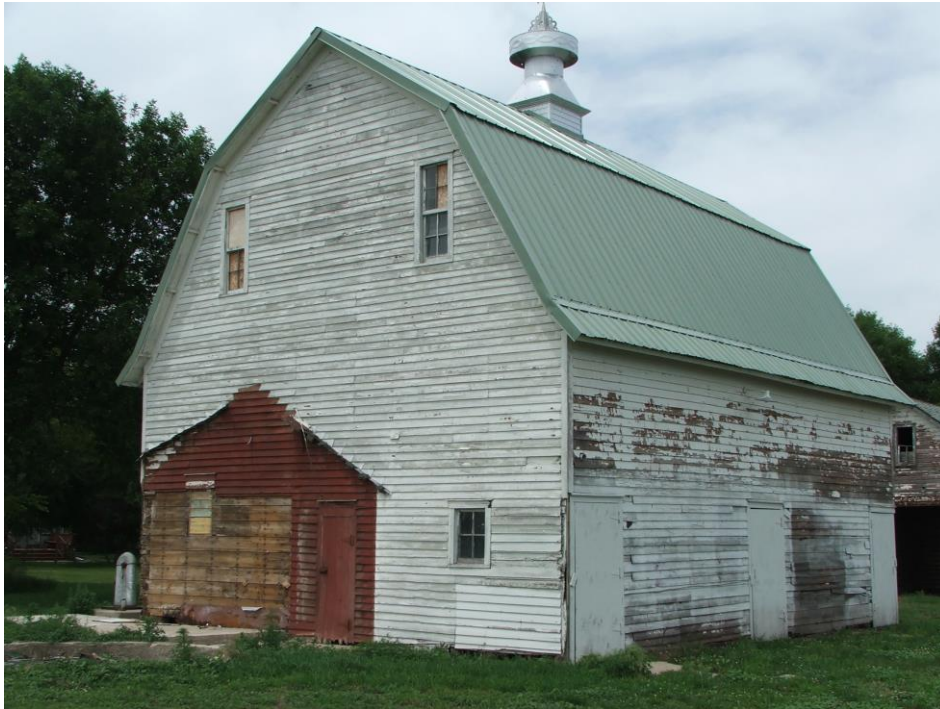
ROLL NUMBER: _____
PHOTO NUMBER: 3
CAMERA DIRECTION: Looking SE. NW corner

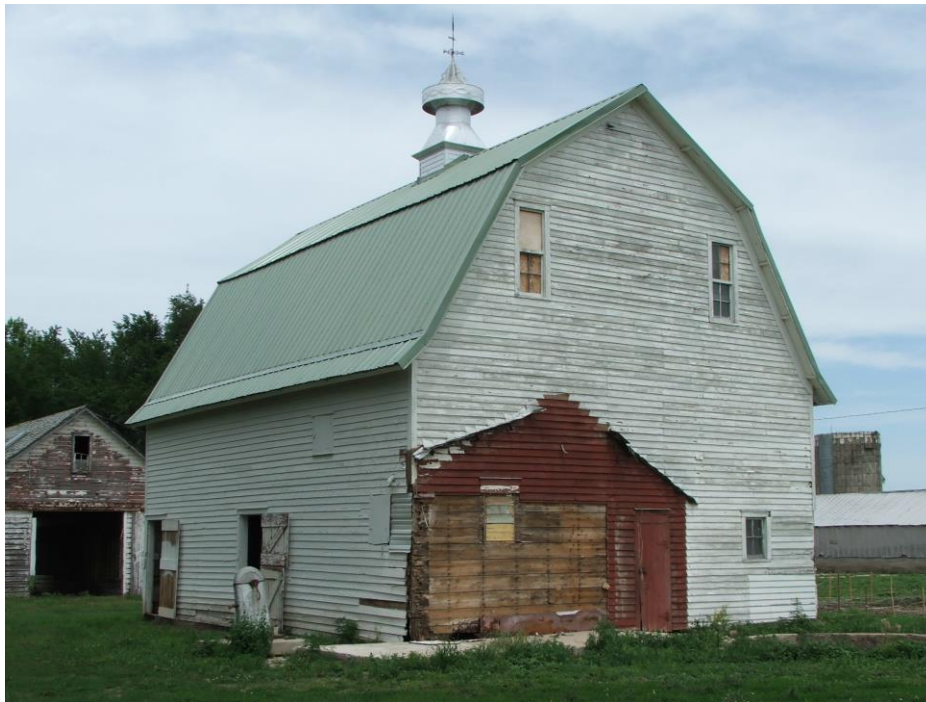
ROLL NUMBER: _____
PHOTO NUMBER: 4
CAMERA DIRECTION: Looking SW, NE corner

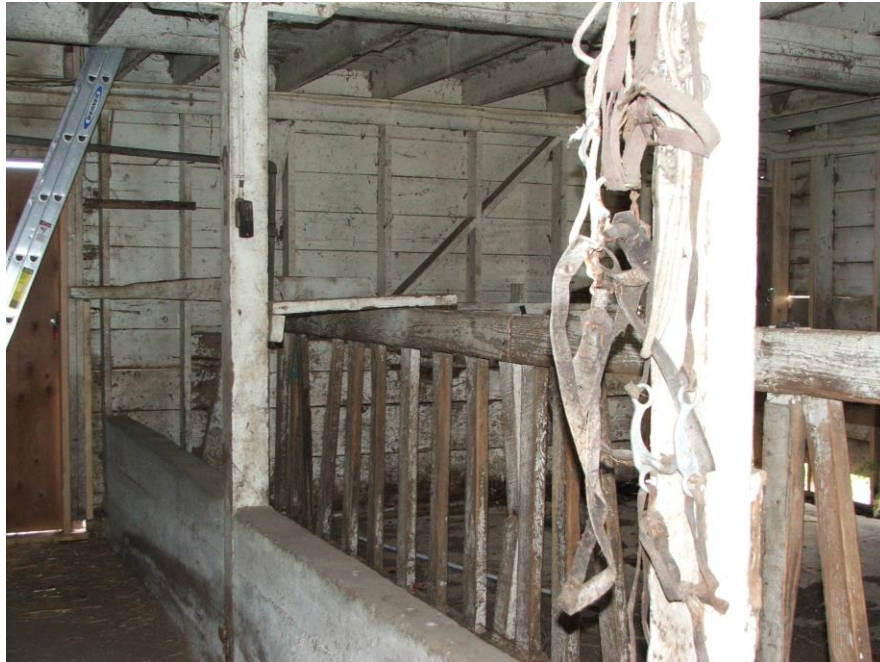
ROLL NUMBER: _____
PHOTO NUMBER: 5

CAMERA DIRECTION: First floor, looking East,
original milk cow
stanchions

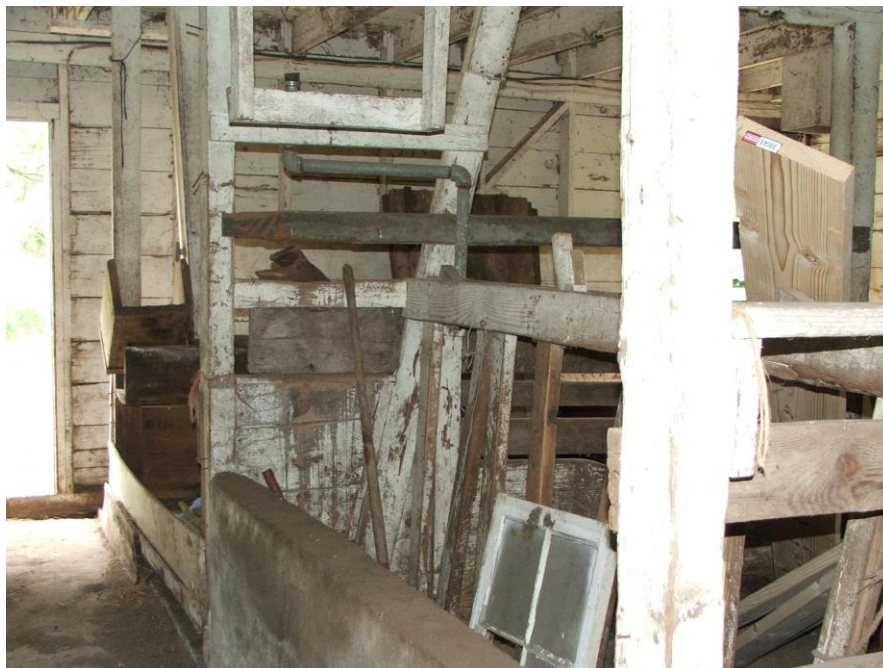
ROLL NUMBER: _____
PHOTO NUMBER: 6

CAMERA DIRECTION: First floor, looking east,
milk cow stanchions

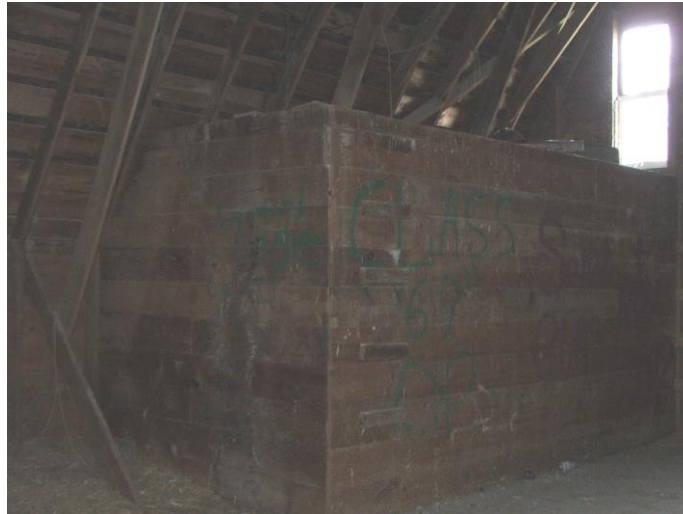
ROLL NUMBER: _____
PHOTO NUMBER: 7
CAMERA DIRECTION: Hayloft, granary in NW corner

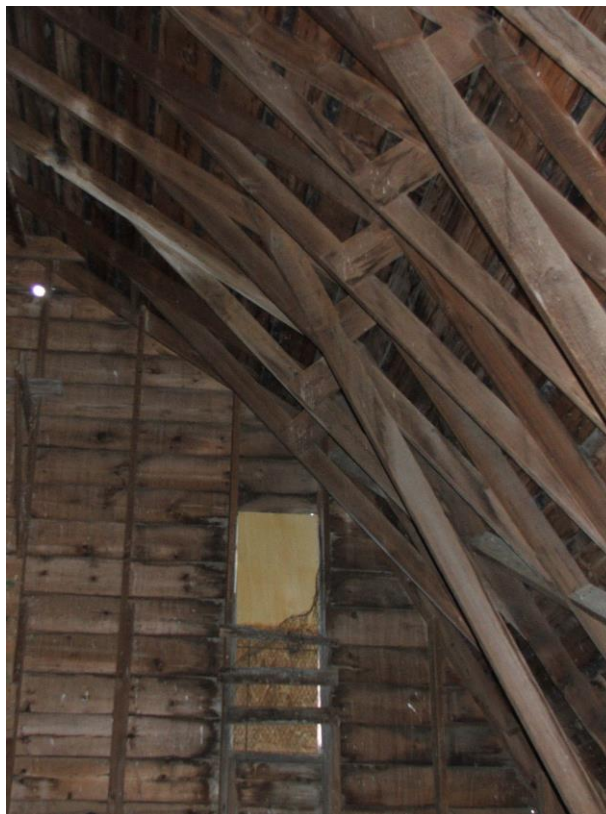
ROLL NUMBER: _____
PHOTO NUMBER: 8
CAMERA DIRECTION: Hayloft, looking SW, hip rafter bracing

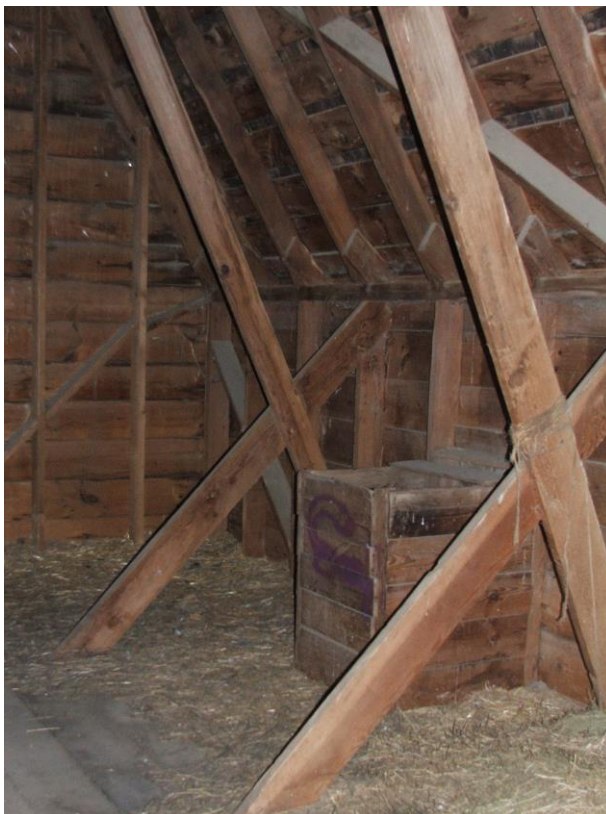
ROLL NUMBER: _____
PHOTO NUMBER: 9
CAMERA DIRECTION: Hayloft, looking SW,
lower rafter bracing
