**SOUTH DAKOTA STATE HISTORIC PRESERVATION OFFICE
HISTORIC SITES SURVEY STRUCTURE FORM**

*SURVEY DATE: February 12, 2013 *ADDRESS: 30442 Frog Creek Road
*SURVEYOR: Jim Stone *COUNTY: Clay
*CITY: Wakonda

CURRENT FUNCTION: <u>Vacant</u>	FOUNDATION: <u>Poured concrete</u>
CURRENT SUBFUNCTION: <u>Vacant</u>	ROOF MATERIAL: <u>Cedar shingles</u>
HISTORIC FUNCTION: <u>Livestock barn</u>	ROOF SHAPE: <u>Gable</u>
HISTORIC SUBFUNCTION: <u>Hay storage</u>	STRUCTURAL SYSTEM: <u>Balloon framing</u>
	STYLE: <u>Gable roof barn</u>
OCCUPIED: <u>Yes</u>	TYPE: <u>Livestock barn</u>
	<u>2x4 studs, 1x6 #106</u>
ACCESSIBLE: <u>Yes with permission</u>	WALLS: <u>drop siding</u>
STORIES: <u>2</u>	SIGNIFICANT PERSON: <u>David J. Mart</u>
*DATE OF CONSTRUCTION: _____	CULTURAL AFFILIATION: <u>?</u>

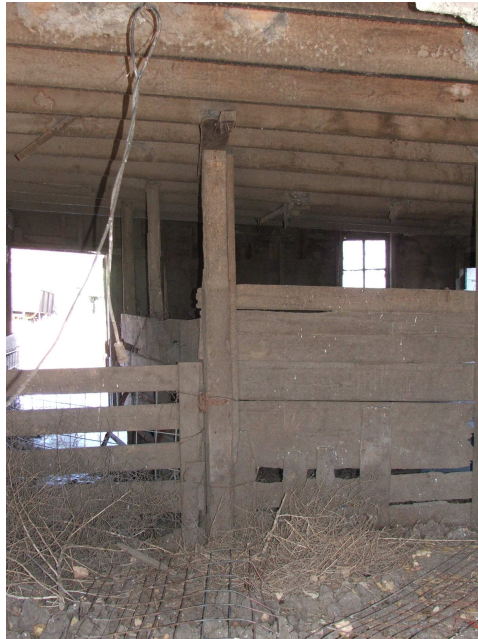
ROLL NUMBER: _____
PHOTO NUMBER: 5

CAMERA DIRECTION: First floor, center area of barn, looking North, partition in center, may be side of a horse stall

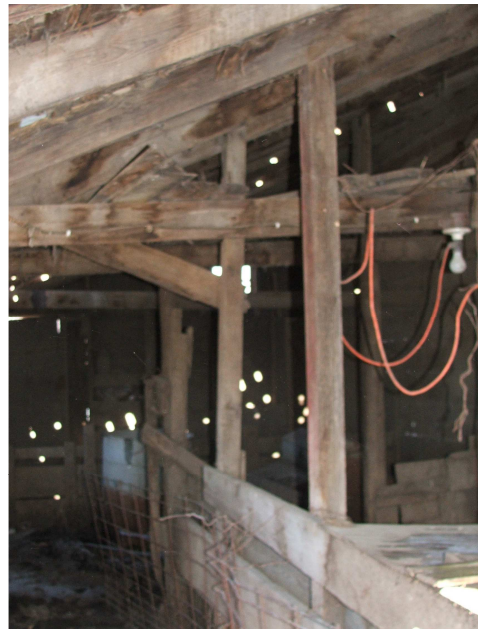
ROLL NUMBER: _____
PHOTO NUMBER: 6

CAMERA DIRECTION: First floor, West lean-to, looking North, pens installed later for swine

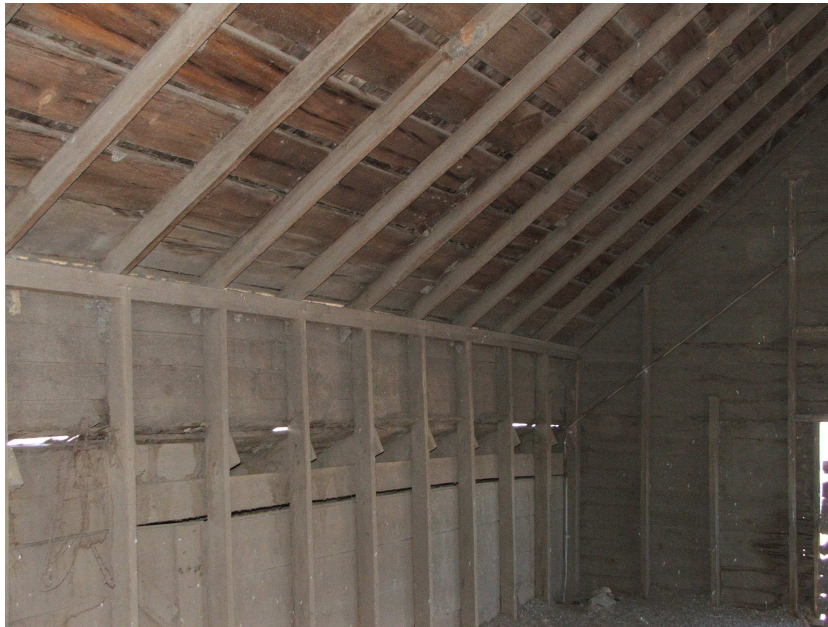
ROLL NUMBER: _____
PHOTO NUMBER: 7

Hayloft, looking NW, 2x4 stud wall, 2x4 rafters, note 2x6 rafters for West lean-to

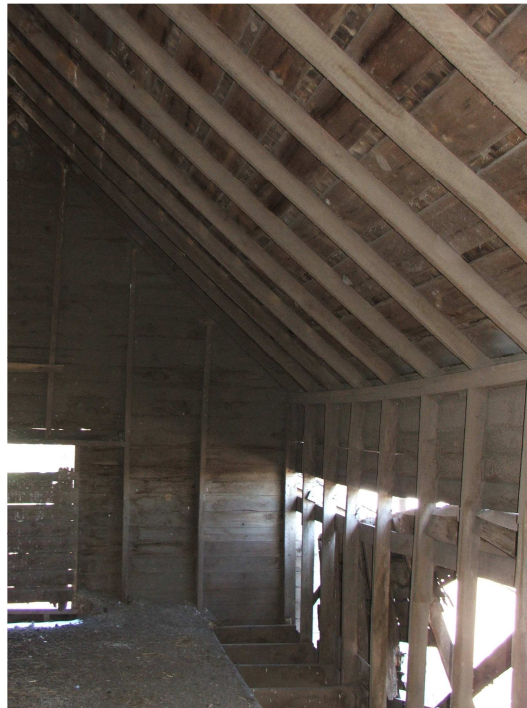
ROLL NUMBER: _____
PHOTO NUMBER: 8

OTHER NOTES: All Exterior walls are 2x4 stud walls with 1x6 #106 drop siding. Floor joists are 2x8's. Rafters are 2x4's on the center part and 2x6 rafters on the lean-to's. Both lean-to's appear to have been built at the same time as the center part of the barn. The roof on the East lean-to is rotting out and falling down. Windows are 9" x 12" four light.

Hayloft, looking NE, 2x4 wall, 2x4 rafters and collapsed East lean-to.
