```SITE INFORMATION

*SURVEY DATE: January 24, 2014

*ADDRESS: 1232 Dawson Road

STRUCTURE DETAILS				
SHPO ID: *PROPERTY NAME:				
OTHER NAME:				
CURRENT FUNCTION:	Vacant	FOUNDA	TION:	Brick
CURRENT SUBFUNCTION:	Vacant	ROOF MATE	RIAL:	Asphalt shingles over cedar shingles
HISTORIC FUNCTION:	Livestock barn	ROOF SH	HAPE:	Gable roof
HISTORIC SUBFUNCTION:	Hay and grain storage	geSTRUCTURAL SYS	STRUCTURAL SYSTEM:	
		S	TYLE:	Gable roof barn
OCCUPIED:	No		TYPE:	Livestock barn
ACCESSIBLE:	Yes with permission	WALLS:		2x6 & 2x4 studs, 1x6 # 106 drop siding
STORIES:	2	SIGNIFICANT PERSON:	Jo	oseph C. Dawson
*DATE OF CONSTRUCTION:	1890 to 1910	CULTURAL AFFILIATION:		?

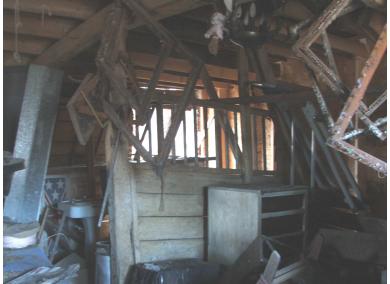
5

First floor, looking NE at 6x6 posts, 6x6 beams, 2x8 floor joists and double horse stalls.

CAMERA DIRECTION: double horse stalls.

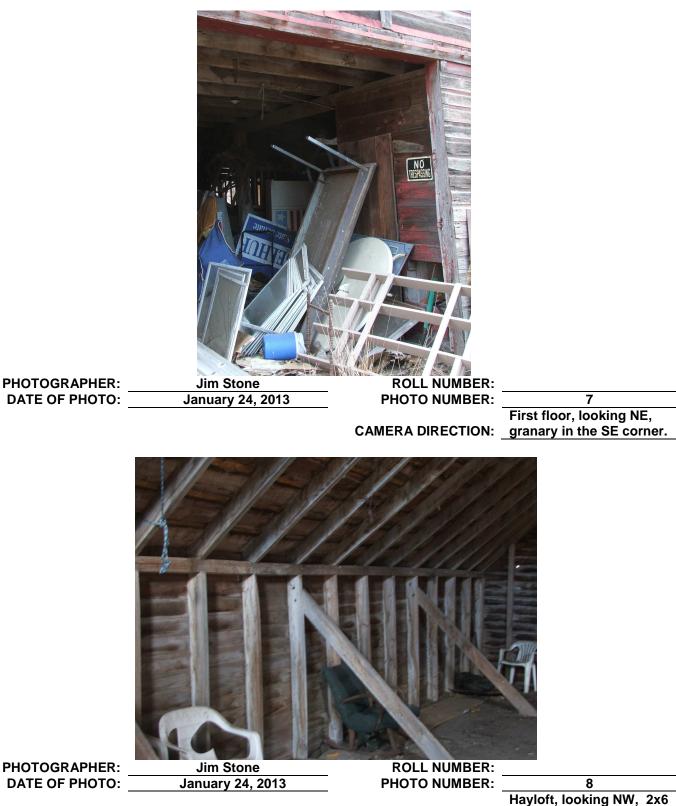
CAMERA DIRECTION: down to floor, 8' O. C.

bracing from top of wall
