**SOUTH DAKOTA STATE HISTORIC PRESERVATION OFFICE
HISTORIC SITES SURVEY STRUCTURE FORM**

*SURVEY DATE: November 25, 2013 *ADDRESS: 46976 314th Street
*SURVEYOR: Jim Stone *COUNTY: Clay
*CITY: Burbank

CURRENT FUNCTION: Calving barn FOUNDATION: Poured concrete
 CURRENT SUBFUNCTION: Cattle shelter ROOF MATERIAL: Steel roofing over cedar shingles
 HISTORIC FUNCTION: Livestock barn ROOF SHAPE: Gable roof
 HISTORIC SUBFUNCTION: Hay & grain storage STRUCTURAL SYSTEM: Balloon framing
 OCCUPIED: No STYLE: Gable roof barn
 TYPE: Livestock barn
2x6 studs, 1x6 #106 drop siding, 1/2"x6" cedar lap siding and steel roofing

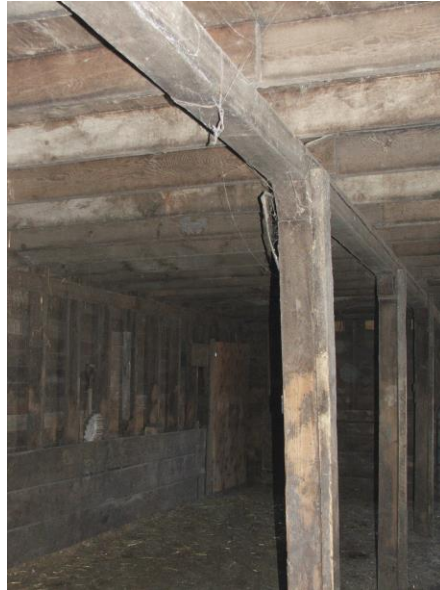
ROLL NUMBER: _____
PHOTO NUMBER: 5

**First floor, looking NW,
6x6 posts, 6x6 beam and
2x10 floor joists
supporting the hayloft
floor.**

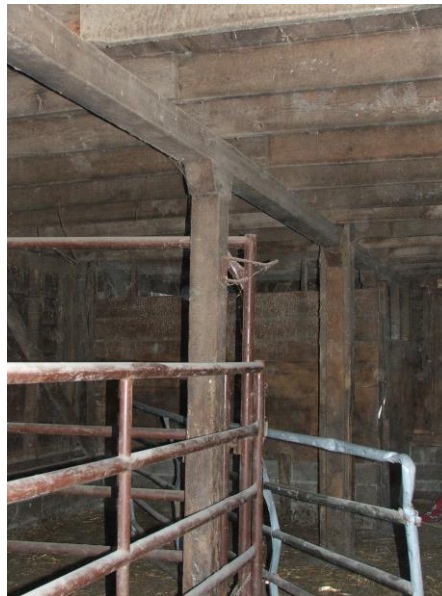
ROLL NUMBER: _____
PHOTO NUMBER: 6

**First floor, looking SE,
6x6 posts, 6x6 beam,
2x10 floor joists,
granaries in SE corner.**

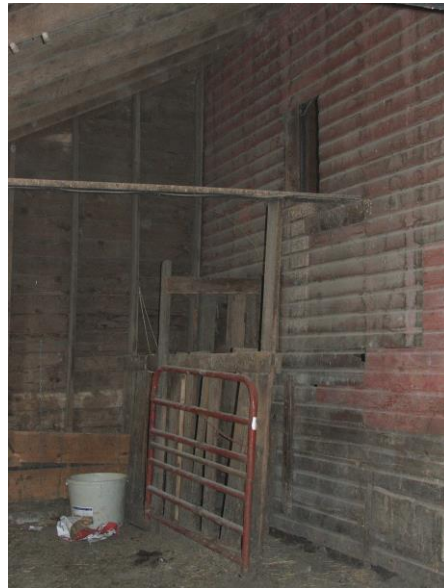
ROLL NUMBER: _____
PHOTO NUMBER: 7

West lean-to looking NE, original 1x6 drop siding on West wall of original barn, part of the milk cow stanchions still in place at the North end.

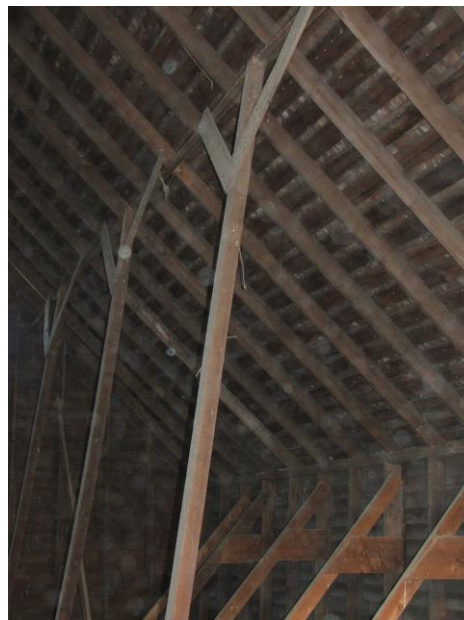
ROLL NUMBER: _____
PHOTO NUMBER: 8

Hayloft, looking NE, 4x4 posts with a 2x6 beam supporting center of the rafters.

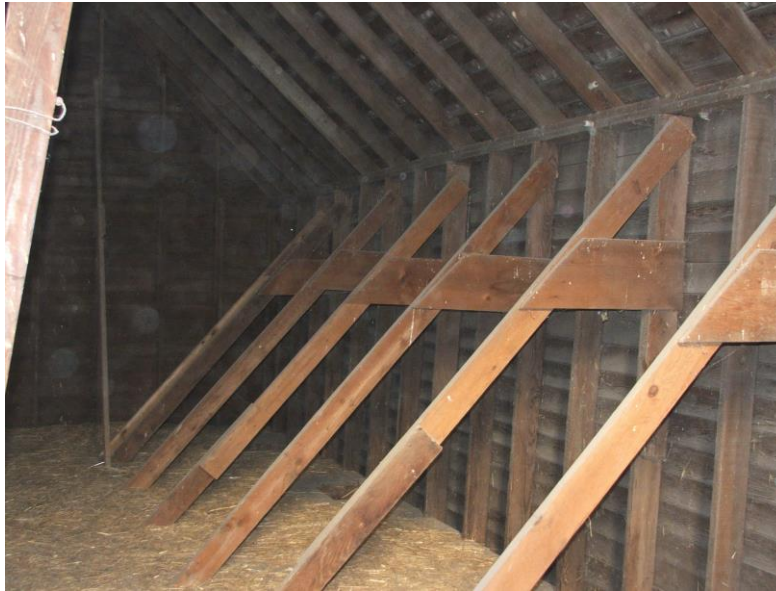
ROLL NUMBER: _____
PHOTO NUMBER: 9

**Hayloft, looking NE, 2x6
bracing replaced after
straightening the barn,
now are 4' O.C., were 8'
O. C.**

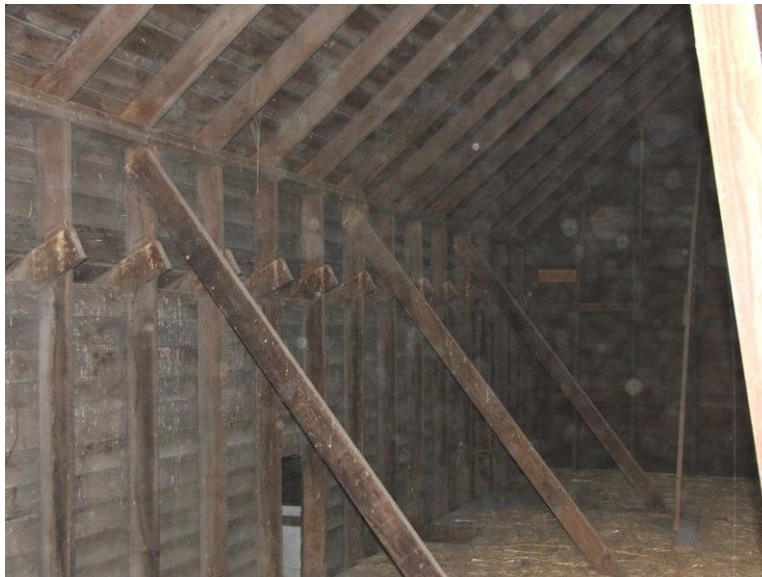
ROLL NUMBER: _____
PHOTO NUMBER: 10

**Hayloft looking NW,
original 2x6 bracing on
the West wall, 8' O. C.**
