**SOUTH DAKOTA STATE HISTORIC PRESERVATION OFFICE
HISTORIC SITES SURVEY STRUCTURE FORM**

*SURVEY DATE: July 30, 2013 *ADDRESS: 30608 458th Ave.
*SURVEYOR: Jim Stone *COUNTY: Clay
*CITY: Wakonda

CURRENT FUNCTION: Calving barn FOUNDATION: Poured concrete
 CURRENT SUBFUNCTION: Vacant ROOF MATERIAL: Steel roofing over cedar shingles
 HISTORIC FUNCTION: Livestock barn ROOF SHAPE: Gambrel roof
 HISTORIC SUBFUNCTION: Hay storage STRUCTURAL SYSTEM: Balloon framing
 OCCUPIED: No STYLE: Gambrel roof barn
 TYPE: Livestock barn
 ACCESSIBLE: Yes with permission WALLS: 2x6 studs, diagonal sheathing and 1/2"x6" cedar lap siding.

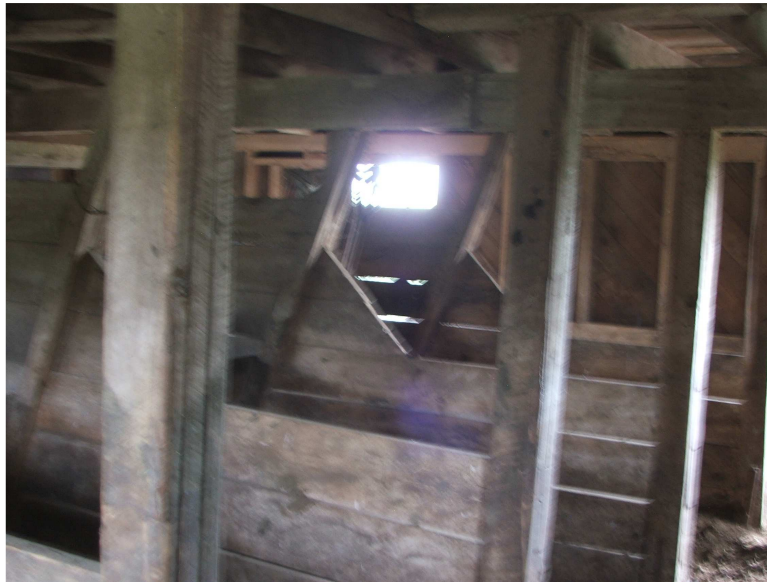
ROLL NUMBER: _____
PHOTO NUMBER: 5

**First floor, looking SE,
6x6 posts, (3) 1x10's for
beams, 2x8 floor joists,
and horse stalls on west
end.**

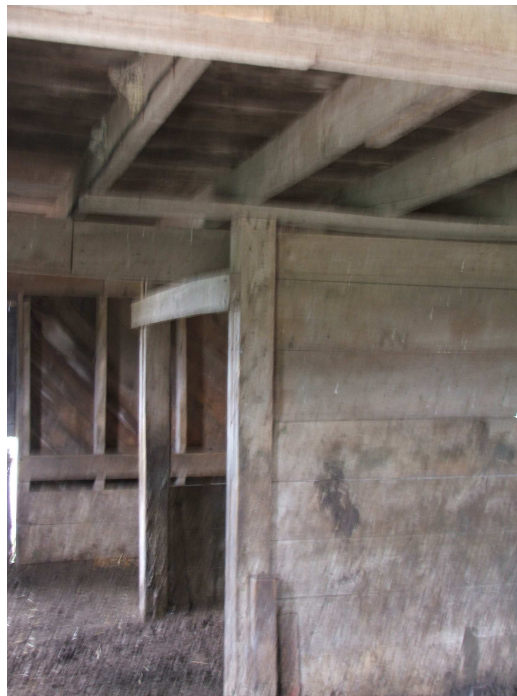
ROLL NUMBER: _____
PHOTO NUMBER: 6

**First floor, looking SW,
where horse stalls were
on the East end.**

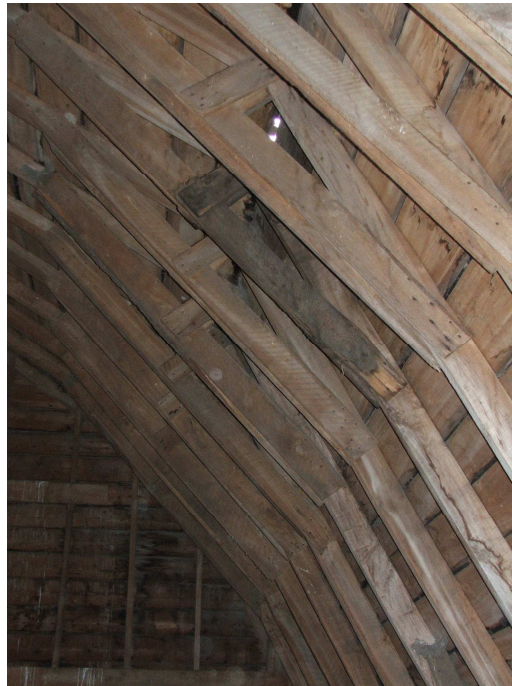
ROLL NUMBER: _____
PHOTO NUMBER: 7

**Hayloft, looking SW, 2x6
rafters with 2x6 brace at
roof hip.**

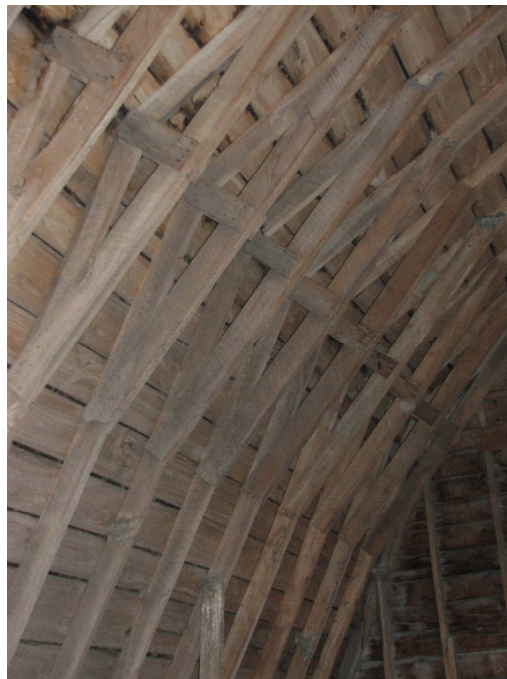
ROLL NUMBER: _____
PHOTO NUMBER: 8

**Hayloft looking SE, 2x6
rafters with 2x6 brace at
the roof hip.**
