SITE INFORMATION

*SURVEY DATE:	, 2012	*ADDRESS: 31339 463rd Ave.										
*SURVEYOR:		*COUNTY:	Clay									
	*CITY:	Vermillion										
LOCATION DESCRIPTIO	N: Vermillio	n, from the inters	ection of Sout	th Dako	ta H	ighw	ay 5	0 bi-	pass	and		
South Dakota Highway 19, North 3 miles to 314 th Street, turn right (East) ½ mile to 463 rd Ave., turn left												
(North) about ¾ mile on the left (West) side. LEGAL DESCRIPTION: Andersen Tract 2, NE ¼, 26 – 93 – 52 Spirit Mound Twp.												
LEGAL DESCRIPTION:	Andersen T	ract 2, NE 1/4, 26	– 93 – 52 Spi	rit Mou	nd T	wp.						
*QUARTER 1: NE	≣ 1/4	OW	NER NAME:	l iea V		C						
			R ADDRESS:									
	·			Sioux City								
	52		•	lowa								
				51106

STRUCTURE DETAILS

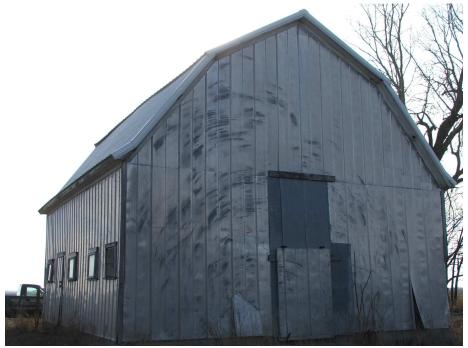
PHOTOGRAPHER: Jim Stone ROLL NUMBER: DATE OF PHOTO: December 5, 2012 PHOTO NUMBER: 2

CAMERA DIRECTION: Looking NW, SE corner

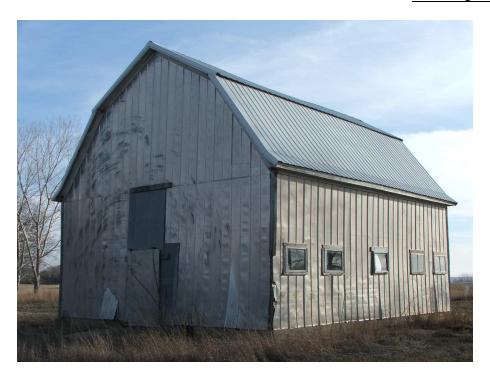
PHOTOGRAPHER: Jim Stone ROLL NUMBER: DATE OF PHOTO: December 5, 2012 PHOTO NUMBER: 3

CAMERA DIRECTION: Looking SW, NE corner

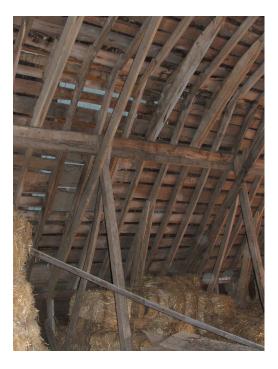
Hayloft, looking SW, 4x4 posts and 2x6 bracing. Note posts support rafters about 3' below

CAMERA DIRECTION: hip
