SOUTH DAKOTA STATE HISTORIC PRESERVATION OFFICE
HISTORIC SITES SURVEY STRUCTURE FORM

SHPO ID: _____			
*PROPERTY NAME: _____			
OTHER NAME: _____			
CURRENT FUNCTION: <u>Swine barn</u>	FOUNDATION: <u>Poured concrete</u>		
CURRENT SUBFUNCTION: <u>Straw storage</u>	ROOF MATERIAL: <u>Steel roofing over cedar shingles</u>		
HISTORIC FUNCTION: <u>Swine barn</u>	ROOF SHAPE: <u>Gothic round</u>		
HISTORIC SUBFUNCTION: <u>Hay and grain storage</u>	STRUCTURAL SYSTEM: <u>Balloon framing</u>		
	STYLE: <u>Gothic round roof barn</u>		
OCCUPIED: <u>Yes</u>	TYPE: <u>Swine barn</u>		
	<u>Yes with</u>		
ACCESSIBLE: <u>permission</u>	WALLS: <u>2x6 stud, horizontal steel roofing siding</u>		
STORIES: <u>2</u>	SIGNIFICANT PERSON: <u>Ed Mossifin</u>		
*DATE OF CONSTRUCTION: <u>1920's</u>	CULTURAL AFFILIATION: <u>Norwegian</u>

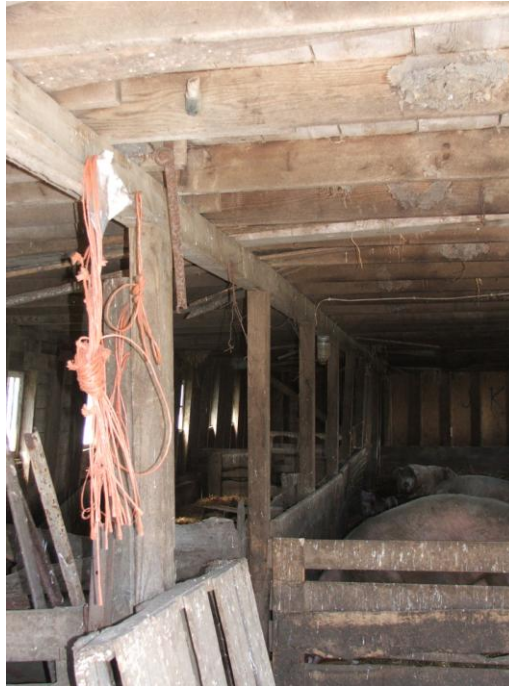
ROLL NUMBER: _____
PHOTO NUMBER: 3

CAMERA DIRECTION: First floor, looking NW,
4x6 posts, 4x6 beam and
2x6 floor joists.

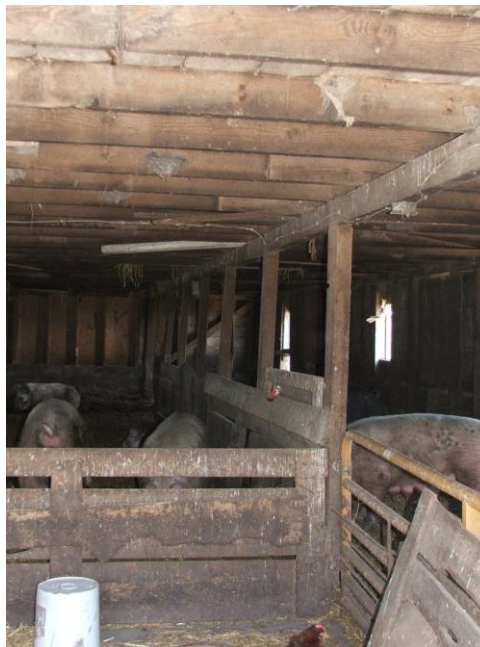
ROLL NUMBER: _____
PHOTO NUMBER: 4

CAMERA DIRECTION: Looking NE, East row
4x6 posts, 4x6 beam and
2x6 floor joists.

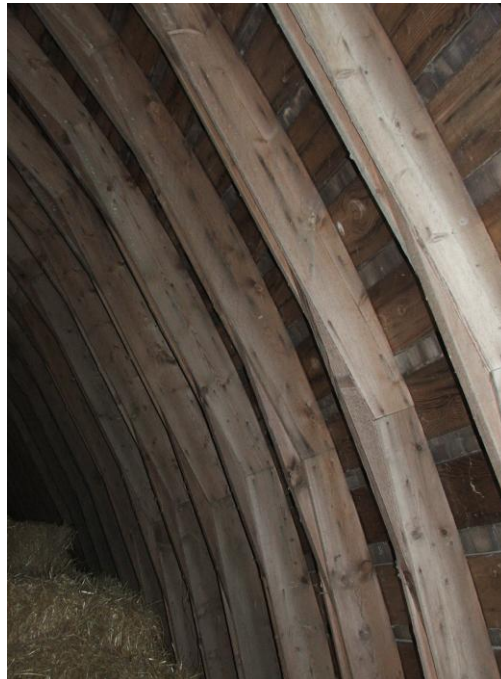
ROLL NUMBER: 5
PHOTO NUMBER: 5

OTHER NOTES: 2x6 stud walls with 1x8 horizontal sheathing on all four walls and horizontal steel roofing. Rafters are three ply, 1x8 cedar, 2x8 and 1x8 cedar all 5' - 2-1/2" long. These laminated round rafters were site built. 24 - 9"x12" four light windows. Steel roofing applied horizontally on the roof over the old cedar shingles.

CAMERA DIRECTION: Hayloft, looking NE, 1x8-
2x8-1x8 3 ply site built
round laminated rafters.

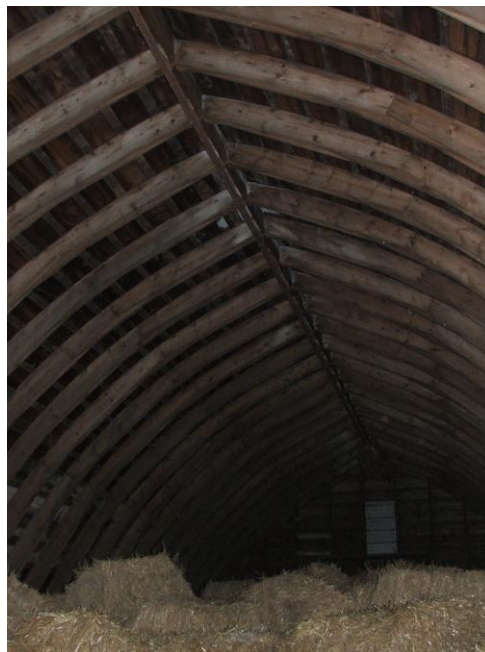
ROLL NUMBER: 6
PHOTO NUMBER: 6

CAMERA DIRECTION: Hayloft, looking North,
rafters, hay track and
North gable end.

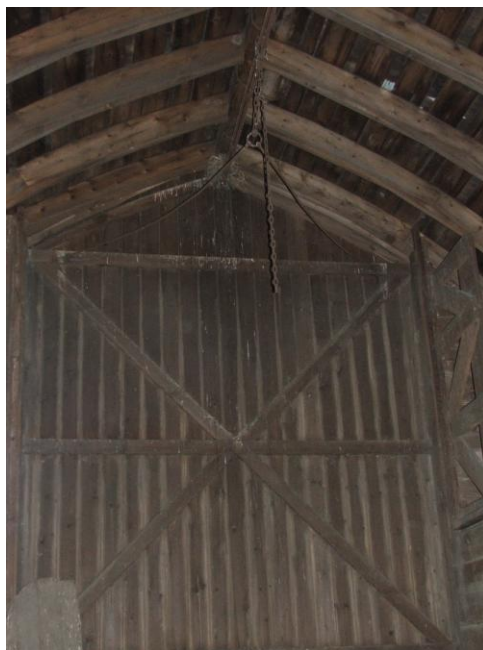
ROLL NUMBER: _____
PHOTO NUMBER: 7

CAMERA DIRECTION: Hayloft, looking South,
hayloft door, note truss
on right to strengthen
gable end wall.
