### SITE INFORMATION

#### STRUCTURE DETAILS

SHPO ID:		_								
*PROPERTY NAME:										
OTHER NAME:										
<b>CURRENT FUNCTION:</b>	Vacant	FOUNDATION:	Poured concrete							
	_		Steel roofing over							
CURRENT SUBFUNCTION:	Storage	ROOF MATERIAL:								
HISTORIC FUNCTION:	Livestock barn	ROOF SHAPE: STRUCTURAL SYSTEM:	Gable							
HISTORIC SUBFUNCTION:	Hay and grain storage	Post frame								
		STYLE:	Western Feeder barn							
OCCUPIED:	No	TYPE:	Livestock barn							
OCCOPIED.	INO	IIPE.	4x6 and 6x6 posts,							
			with 2x6 girts 4' O.

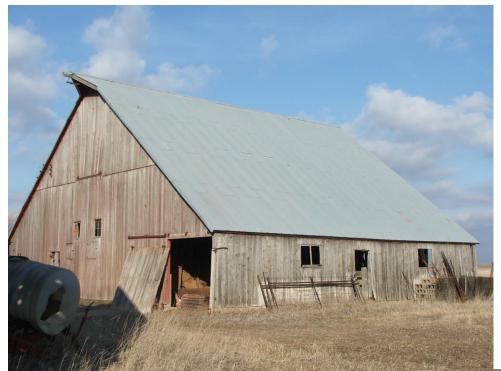
CAMERA DIRECTION: Looking NE, SW corner

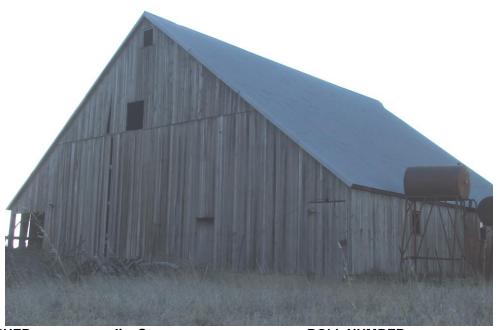
R: \_\_\_\_\_3

CAMERA DIRECTION: Looking SW, NE corner

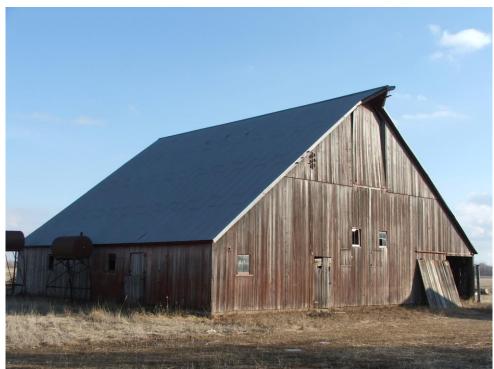
4

CAMERA DIRECTION: Looking SE, NW corner

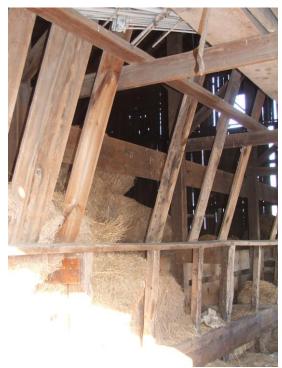
First floor, South side, looking NE, feed bunk

CAMERA DIRECTION: and hay feed rack above

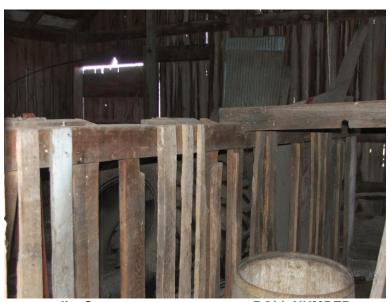
First floor, North side, looking NE, seven milk

CAMERA DIRECTION: cow stanchions
