SITE INFORMATION

STRUCTURE DETAILS			
SHPO ID:	17 CL 00000581	_	
*PROPERTY NAME:	Edward Merrigan barn		
OTHER NAME:			
CURRENT FUNCTION:	Storage	FOUNDATION:	Poured concrete
			Steel roofing over
CURRENT SUBFUNCTION:		ROOF MATERIAL:	Cedar shingles
HISTORIC FUNCTION:	Livestock barn	ROOF SHAPE:	Gambrel
HISTORIC SUBFUNCTION:	Hay and grain storage	STRUCTURAL SYSTEM:	Balloon framing
		STYLE:	Gambrel roof
OCCUPIED:	Yes	TYPE:	Livestock barn
	Yes -with permission from Liz		2x6 w/ sheathing & ½"x6´cedar lap
ACCESSIBLE:	Merrigan	WALLS:	siding
STORIES:	2 5	SIGNIFICANT PERSON: <u>Edwa</u>	rd Merrigan
*DATE OF CONSTRUCTION:	<u>1916</u> CU	LTURAL AFFILIATION:Iris	sh

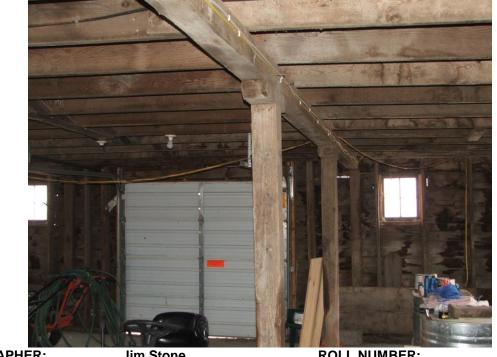
DATE OF PHOTO:
 February 3, 2012
 PHOTO NUMBER:
 4

CAMERA DIRECTION:
 First floor, looking East

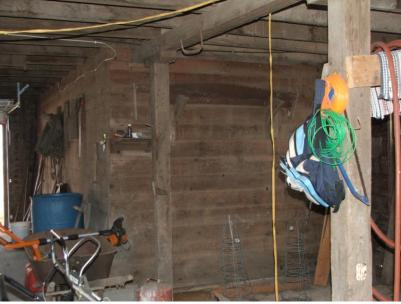
5

First floor, looking NW, CAMERA DIRECTION: granaries in NW corner

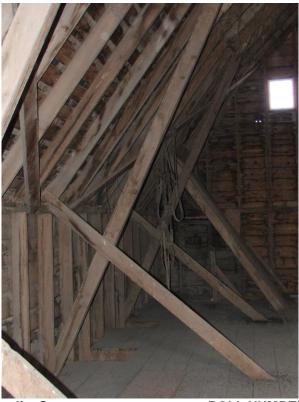
Jim Stone **ROLL NUMBER: PHOTOGRAPHER:** February 3, 2012 6 DATE OF PHOTO: PHOTO NUMBER:

Hayloft, looking West, CAMERA DIRECTION: note lower roof bracing

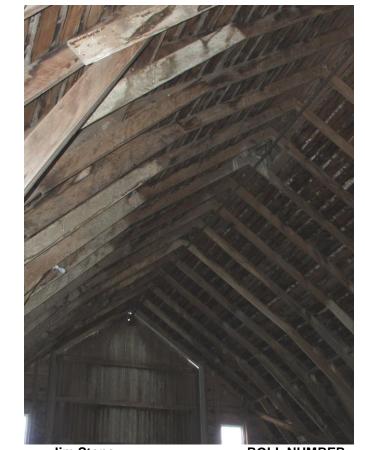
9

Hayloft, looking West, CAMERA DIRECTION: framing at the peak
