SITE INFORMATION									
*SURVEY DATE:	August 4, 2011	*ADDRESS:			31	551 \$	S. D.	Hwy 1	Э
*SURVEYOR:	Jim Stone								
									,
LOCATION DESCRIPTION: Fro	om S. D. Hwy 50 and S	6. D. Hwy 19 1 ½	² miles No	rth on	the	left s	ide o	of	
Hwy 19									
LEGAL DESCRIPTION: NE ¼ o	of SW1/4, except Lot I	1-2, Section 2-9	2-52, Verm	illion	Tow	nshij	D		
		,	,						
*QUARTER 1: SW 1/4		WNER NAME:							
*QUARTER 2:		ER ADDRESS:			y 19				
*TOWNSHIP: <u>Vermillion tv</u>		OWNER CITY:							
*RANGE: <u>52 west</u>		WNER STATE:							
*SECTION: 2		OWNER ZIP:	57069						
ACRES: <u>37.38</u>		QUAD NAME:							
OWNER CODE 1: P									
OWNER CODE 3: F S L	Р								
HISTORIC SIGNIFICANCE									
*DOE:		REGISTER NA	ME						
*DOE DATE:		MULTIPLE PR		JAMF					
				,	· _				
			САТ	EGO	RY:				
NOMINATION STATUS:		SIGNI	FICANCE I	EVEL	. 1:	Ν	S	L	
DATE LISTED:		SIGNI	FICANCE I	EVEL	_ 2:	Ν	S	L	
REFERENCE NUMBER:									
HISTORIC DISTRICT RATING:		CRITE	ERIA 1: A	В	С	D

SHPO ID:	2 CL 0000057	<u>'1</u>	
*PROPERTY NAME:	Martin Weeks Jr. bar	n	
OTHER NAME:			
			Native stone, lime
CURRENT FUNCTION:	Shop and storage	FOUNDATION:	and sand mortar
	Herb drying and herb		Steel over cedar
CURRENT SUBFUNCTION:	st

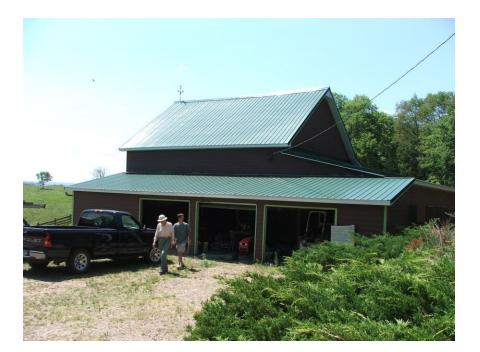
1 Looking Southwest, CAMERA DIRECTION: Northeast corner of barn

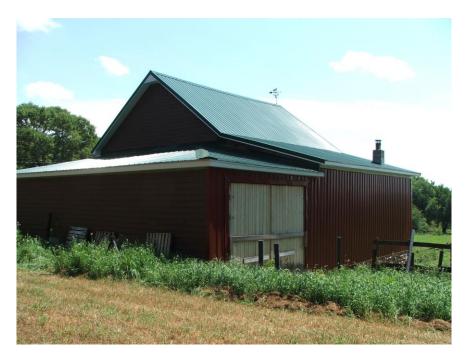
PHOTOGRAPHER: Jim Stone **ROLL NUMBER:** August 4, 2011 PHOTO NUMBER: 2 DATE OF PHOTO: Looking Southeast,

CAMERA DIRECTION: Northwest corner of barn

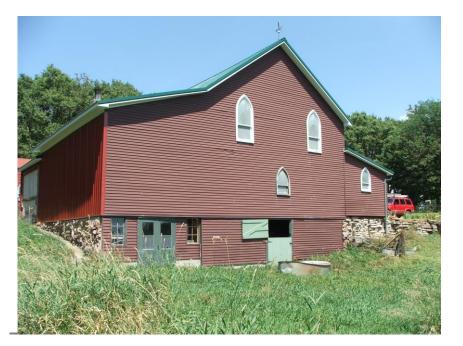
PHOTOGRAPHER:	Jim Stone	ROLL NUMBER:	
DATE OF PHOTO:	August 4, 2011	PHOTO NUMBER:	3
			Looking northeast,

Looking northeast, Southwest corner of barn

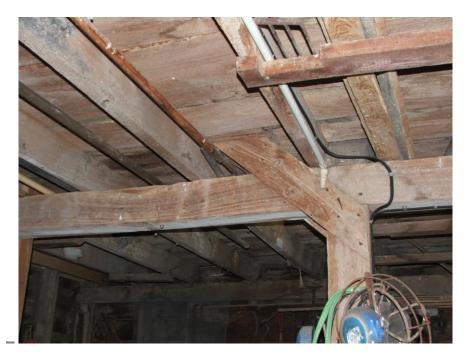
PHOTOGRAPHER:	Jim Stone	ROLL NUMBER:	
DATE OF PHOTO:	August 4, 2011	PHOTO NUMBER:	5
		CAMERA DIRECTION:	First floor, looking south

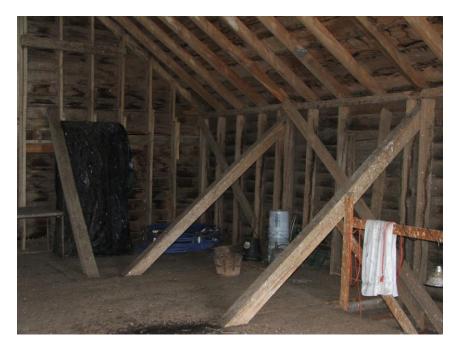
PHOTOGRAPHER:	Jim Stone	ROLL NUMBER:	
DATE OF PHOTO:	August 4, 2011	PHOTO NUMBER:	6
_		CAMERA DIRECTION:	Hayloft, looking NE

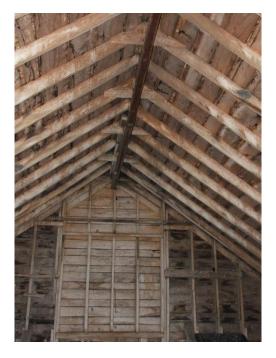
7
Hayloft, looking north
