### SITE INFORMATION

#### STRUCTURE DETAILS

SHPO ID:										
*PROPERTY NAME:										
OTHER NAME:										
<b>CURRENT FUNCTION:</b>	Machinery storage	FOUNDATION								
CURRENT SUBFUNCTION:	Storage	ROOF MATERIAL	Some steel over cedar shingles							
HISTORIC FUNCTION:	Western Feeder barn	ROOF SHAPE								
HISTORIC SUBFUNCTION:	Hay storage	STRUCTURAL SYSTEM								
motoric sobi one flore.	Tiay Storage	SINOCIONAL SISILI	Western feeder							
		STYLE	: barn							
OCCUPIED:	Yes	TYPE	: Livestock barn							
	Yes with									
ACCESSIBLE:	permission	S: _2x6, 1x 8" shiplap								
0700150	4									
STORIES:	1	SIGNIFICANT PERSON:	Elling Myron							
*DATE OF CONSTRUCTION:	1880 to 1890 C	CULTURAL AFFILIATION:	Norwegian							
ALTERER/MOVER NOTES	M 1 1 1		Jaffan - Laan ta an							
<del>-</del>		, reason poured concrete foun								
		ean-to on the South was adde								
built from rough sawn cottonwood. 30' x 60' lean-to built, between 1955 to 1965 on the North. Wooden

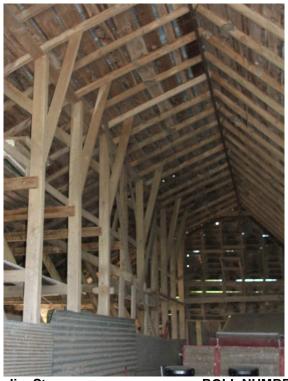
Main barn, looking West, double 2x6 studs 4' O. C.

CAMERA DIRECTION: and 2x4 rafters
