SITE INFORMATION

*SURVEY DATE: <u>March 9, 2012</u> *SURVEYOR: Jim Stone

STRUCTURE DETAILS			
SHPO ID:			
*PROPERTY NAME:	Elmore Gronlund ba	rn	
OTHER NAME:			
CURRENT FUNCTION:	Storage	FOUNDATION:	Poured concrete
			Asphalt shingles
CURRENT SUBFUNCTION:		ROOF MATERIAL:	over wood shingles
HISTORIC FUNCTION:	Livestock barn	ROOF SHAPE:	Gothic round
HISTORIC SUBFUNCTION:	Hay storage	STRUCTURAL SYSTEM:	Balloon framing
		STYLE:	Gothic round barn
OCCUPIED:	Yes	TYPE:	Livestock
			2x6 & 2x8 , ¾" x
	Yes with		12" sheathing,
ACCESSIBLE:	permission	WALLS:	¹ / ₂ "x8" lap siding
STORIES:	2	SIGNIFICANT PERSON: Elmor	e Gronlund
*DATE OF CONSTRUCTION:	1935 - 1936	CULTURAL AFFILIATION: S	wedish

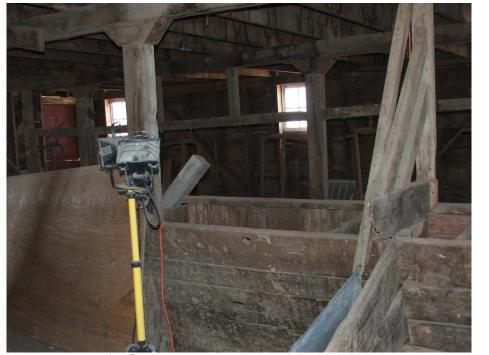
PHOTOGRAPHER: **Jim Stone** DATE OF PHOTO: March 9, 2012

ROLL NUMBER: PHOTO NUMBER: CAMERA DIRECTION: horse stalls

5 First floor, looking West

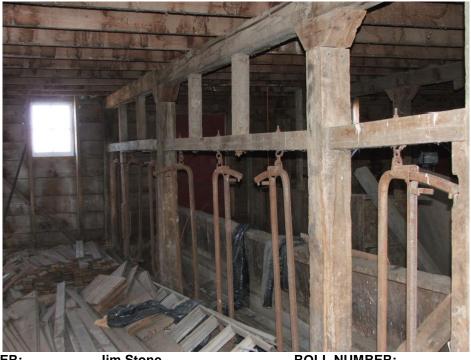
PHOTOGRAPHER:	Jim Stone	ROLL NUMBER:	
DATE OF PHOTO:	March 9, 2012	PHOTO NUMBER:	6
_			First floor, looking North

h, CAMERA DIRECTION: milk cow stanchions

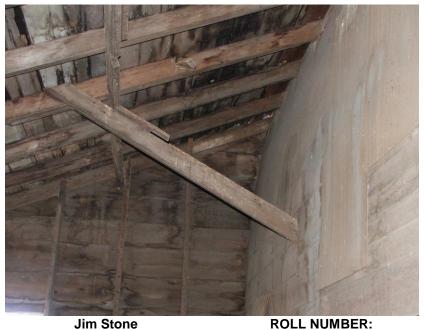
7 Lean-to Note curve of

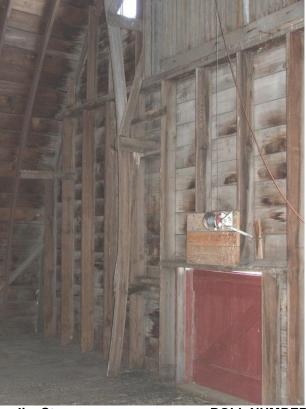
10 Hayloft, note top of CAMERA DIRECTION: curved arch bracing

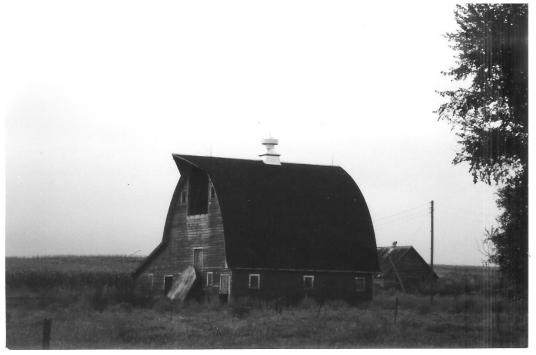
PHOTOGRAPHER:	?	ROLL NUMBER:	
DATE OF PHOTO:	1990's	PHOTO NUMBER:	12
		CAMERA DIRECTION:	Looking SW, NE corner
