SITE INFORMATION

*SURVEY DATE: October 15, 2	15, 2012 *ADDRESS: 45272 312 th Street									
*SURVEYOR: Jim Stone	*COUNTY:	Clay								
·	*CITY:	*CITY: Meckling								
LOCATION DESCRIPTION: From the West edge of Vermillion, South Dakota Highway 50, West to										
Meckling, 4-1/2 miles West to 453 rd Ave, turn left (South), about ¾ mile to 312 th Street, turn right (West)										
about ¼ mile on the right (North) side.										
LEGAL DESCRIPTION: Hanson tract 1, In S 1/2, SE 1/4, 18 – 93 – 53 Meckling Twp.										
	1, 0 1/2, 02 /4, 10 00 00	g	p.							
*QUARTER 1: SE 1/4	OWNER NAME:	Michael Dean Clark								
*QUARTER 2:	OWNER ADDRESS:	2975 Cass Ave.								
*TOWNSHIP: Meckling	OWNER CITY:	Salix								
*RANGE:53	OWNER STATE:	Iowa								
*SECTION:18	OWNER ZIP:	51052								
ACRES: 3.19	QUAD NAME:	i:								
OWNER CODE 1: P										
OWNER CODE 2:										
OWNER CODE 3:										
HISTORIC SIGNIFICANCE										
*DOE:	MULTIPLE DD	REGISTER NAME:

STRUCTURE DETAILS

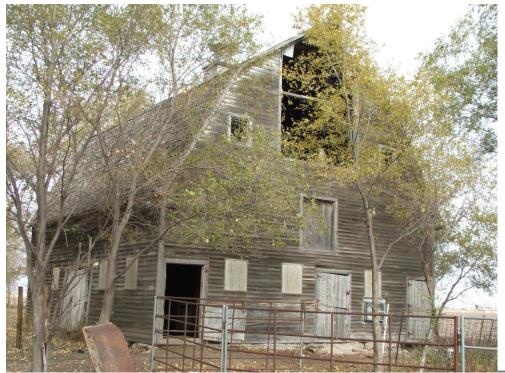
CAMERA DIRECTION: Looking NE, SW corner

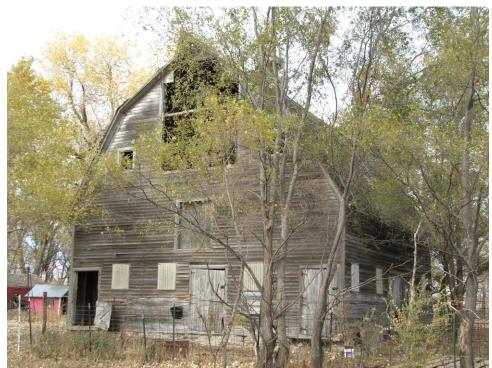
CAMERA DIRECTION: Looking NW, SE corner

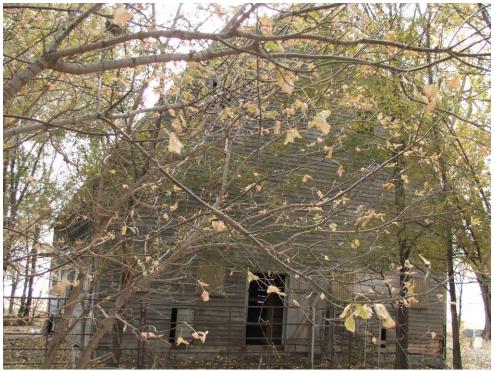
PHOTOGRAPHER: Jim Stone ROLL NUMBER: DATE OF PHOTO: October 15, 2012 PHOTO NUMBER: 3

CAMERA DIRECTION: Looking SW, NE corner

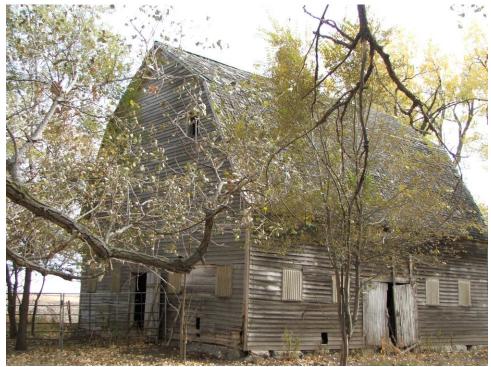
PHOTOGRAPHER: Jim Stone ROLL NUMBER: DATE OF PHOTO: October 15, 2012 PHOTO NUMBER: 4

CAMERA DIRECTION: Looking SE, NW corner

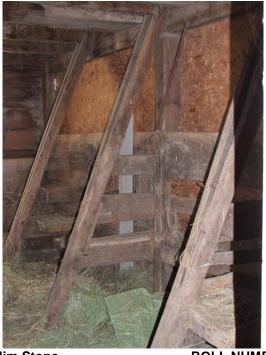
First floor, looking South, stalls of some

CAMERA DIRECTION: type with feed bunks

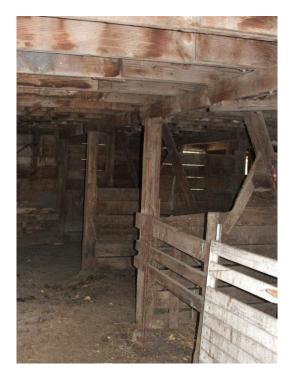
First floor, looking North, CAMERA DIRECTION: double horse stalls

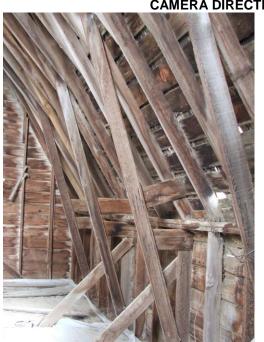
Hayloft. Looking North, lower rafter bracing 6'

CAMERA DIRECTION: O.C.

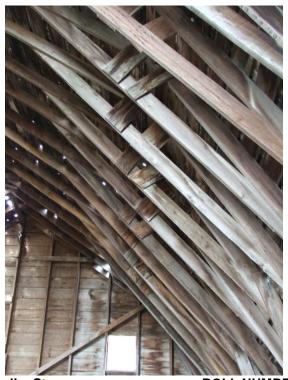
Hayloft, looking North, upper rafter bracing at

CAMERA DIRECTION: hip. 2' O.C.
