**SOUTH DAKOTA STATE HISTORIC PRESERVATION OFFICE
HISTORIC SITES SURVEY STRUCTURE FORM**

*SURVEY DATE: January 16, 2013 *ADDRESS: 30869 467th Ave.
*SURVEYOR: Jim Stone *COUNTY: Clay
*CITY: Beresford

CURRENT FUNCTION: <u>Storage</u>	FOUNDATION: <u>Poured concrete foundation</u>
CURRENT SUBFUNCTION: <u>Storage</u>	ROOF MATERIAL: <u>Steel roofing over cedar shingles</u>
HISTORIC FUNCTION: <u>Livestock barn</u>	ROOF SHAPE: <u>Gambrel</u>
HISTORIC SUBFUNCTION: <u>Hay storage</u>	STRUCTURAL SYSTEM: <u>Balloon framing</u>
OCCUPIED: <u>Yes</u>	STYLE: <u>Gambrel roof barn</u>
ACCESSIBLE: <u>Yes with permission</u>	TYPE: <u>Livestock barn</u>
	<u>2x6 studs, sheathing, 1/2"x6" cedar lap siding</u>
STORIES: <u>2</u>	WALLS: _____
*DATE OF CONSTRUCTION: <u>1915 to 1925</u>	SIGNIFICANT PERSON: <u>Erick Erickson</u>
	CULTURAL AFFILIATION: <u>?</u>

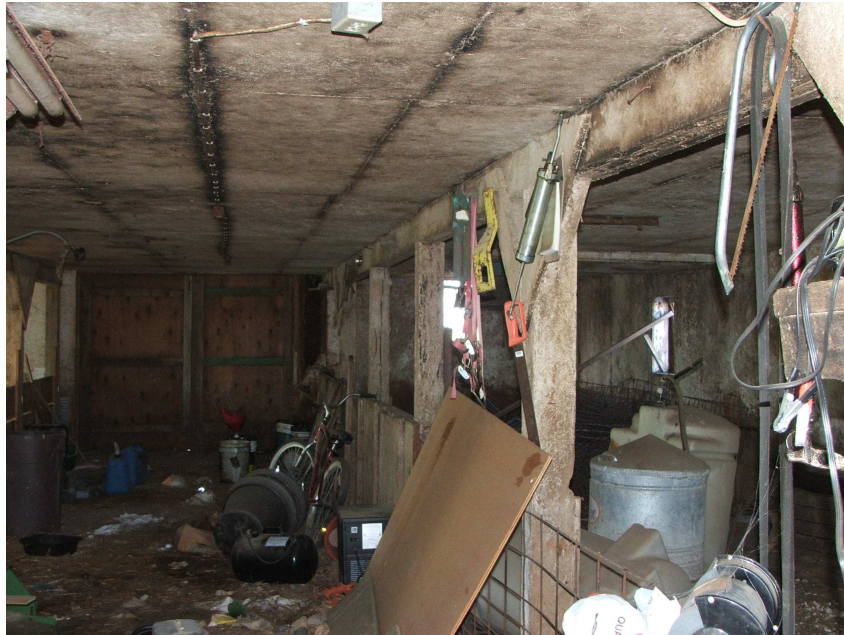
ROLL NUMBER: _____
PHOTO NUMBER: 5

ALTERED/MOVED NOTES: Original site. Any evidence of milk cow stanchions or horse stalls has been removed. White steel roofing installed on roof. All walls on the first floor and the ceiling has been lined when it was remodeled for swine. 8' sliding door framed in on the East wall and a 3' walk door has been installed.

First floor, looking West,
6x6 posts and (3) 2x8's
beam, note lining on

CAMERA DIRECTION: ceiling

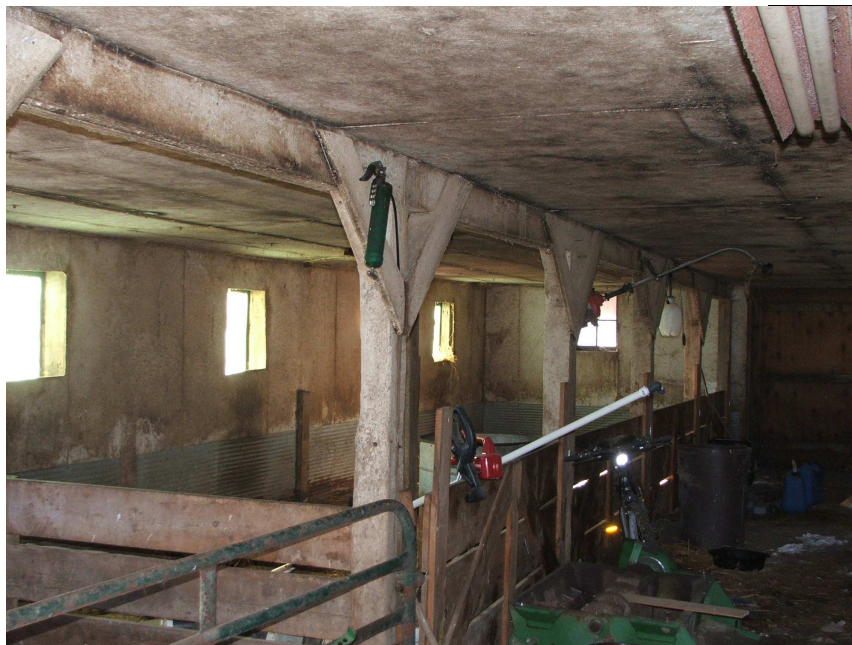
ROLL NUMBER: _____
PHOTO NUMBER: 6

First floor, looking SW,
6x6 posts and (3) 2x8's
beam, ceiling and walls
lined

CAMERA DIRECTION: lined

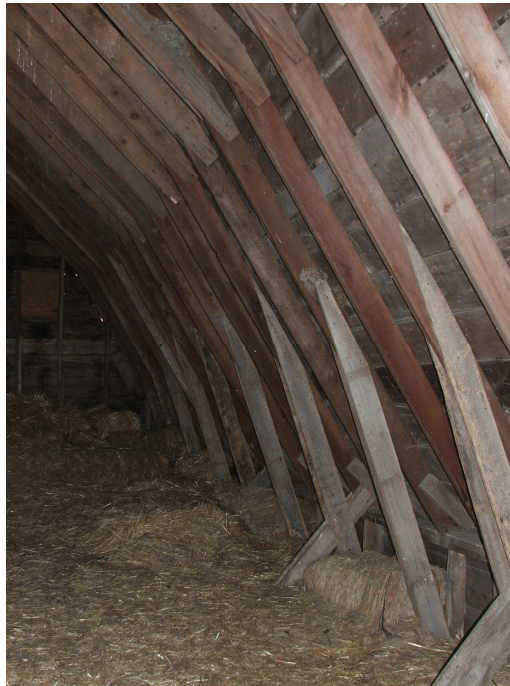
ROLL NUMBER: _____
PHOTO NUMBER: 7

Hayloft, looking NW, two 1x6 braces down to floor and bottom of rafter down to floor.

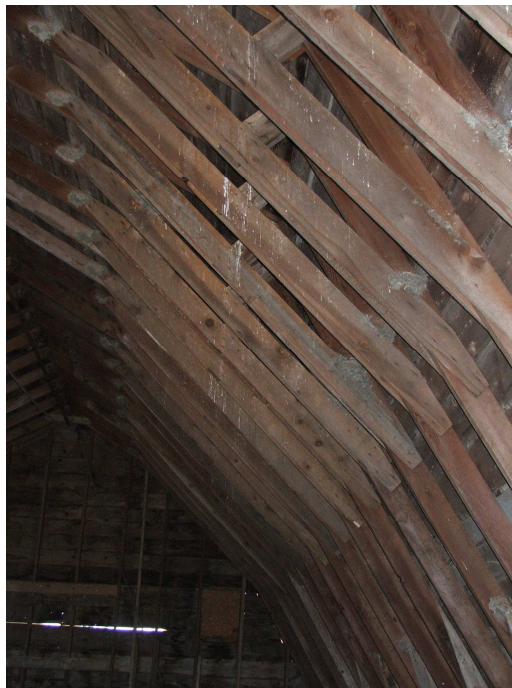
ROLL NUMBER: _____
PHOTO NUMBER: 8

CAMERA DIRECTION: Hayloft, looking NW, two 1x6 bracing on rafter hip.
