**SOUTH DAKOTA STATE HISTORIC PRESERVATION OFFICE
HISTORIC SITES SURVEY STRUCTURE FORM**

*SURVEY DATE: January 15, 2013 *ADDRESS: 30361 Greenfield Road
*SURVEYOR: Jim Stone *COUNTY: Clay
*CITY: Beresford

CURRENT FUNCTION:	<u>Storage</u>	FOUNDATION:	<u>Poured concrete foundation</u>
CURRENT SUBFUNCTION:	<u>Storage</u>	ROOF MATERIAL:	<u>Galv. steel roofing over cedar shingles</u>
HISTORIC FUNCTION:	<u>Livestock barn</u>	ROOF SHAPE:	<u>Gable</u>
HISTORIC SUBFUNCTION:	<u>Hay and grain storage</u>	STRUCTURAL SYSTEM:	<u>Balloon framing Western feeder barn</u>
OCCUPIED:	<u>No</u>	STYLE:	<u>Livestock barn</u>
ACCESSIBLE:	<u>Yes with permission</u>	TYPE:	<u>2x4 studs with 1x6 #106 drop siding</u>
WALLS:			
STORIES:	<u>2</u>	SIGNIFICANT PERSON:	<u>Erick Messler</u>
*DATE OF CONSTRUCTION:	<u>1900 to 1920</u>	CULTURAL AFFILIATION:	<u>Swedish</u>

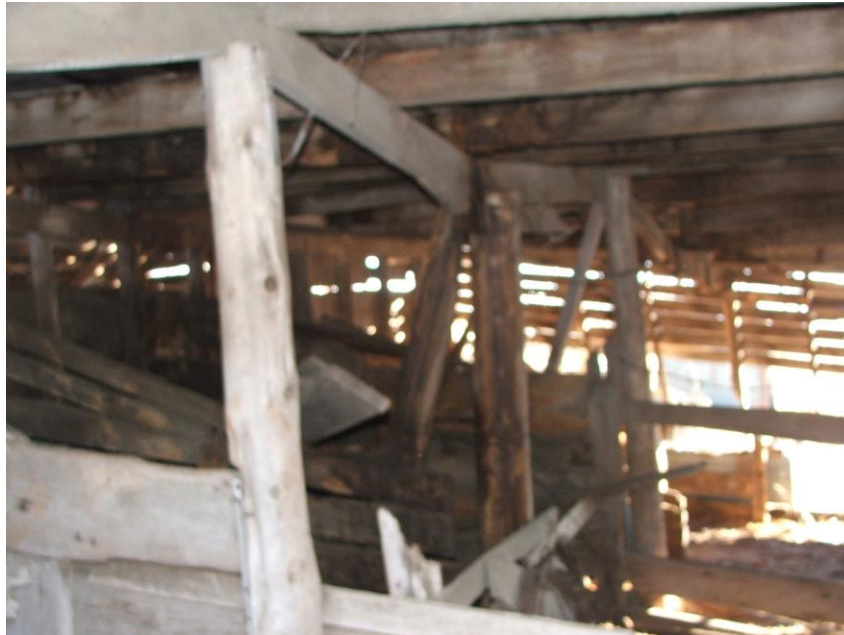
ROLL NUMBER: _____
PHOTO NUMBER: 5

CAMERA DIRECTION: First floor, center area,
looking South, horse
stalls on East wall.

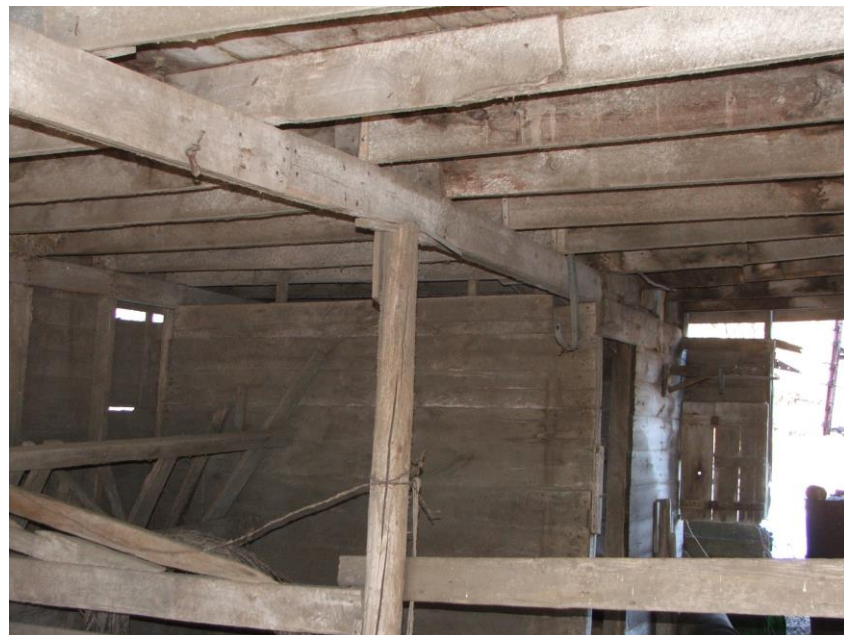
ROLL NUMBER: _____
PHOTO NUMBER: 6

CAMERA DIRECTION: First floor, center area,
looking North, Cow stalls
and granary on West
wall.

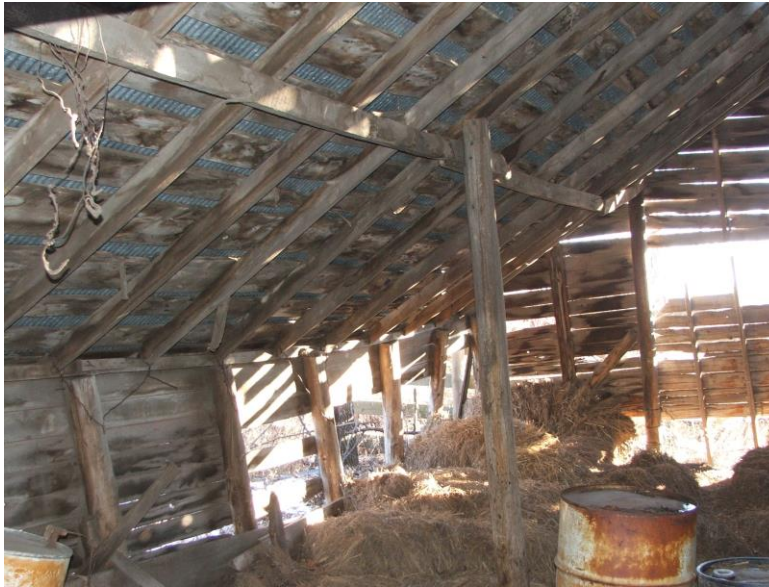
ROLL NUMBER: _____
PHOTO NUMBER: 7

First floor, East lean-to, looking SE, no foundation, posts 3'-6" O. C. and siding for walls.

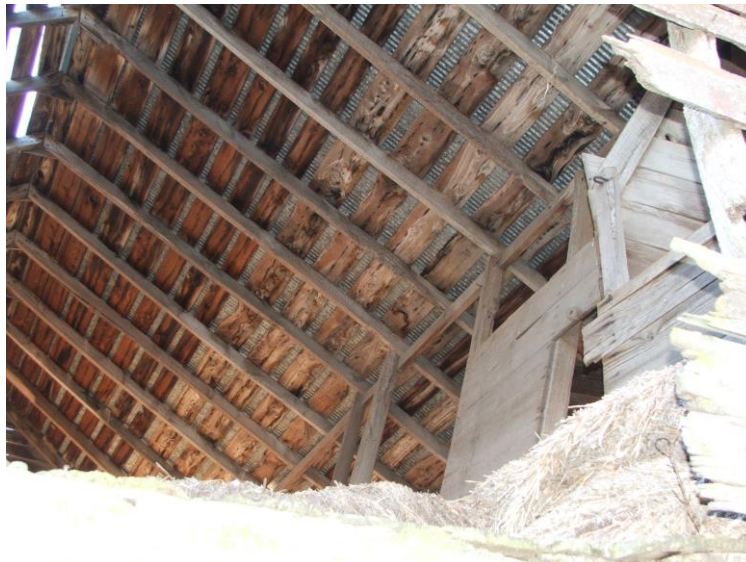
ROLL NUMBER: _____
PHOTO NUMBER: 8

Hayloft, looking South and up into hayloft, 2x4 posts and 2x4 beam supporting rafters, granary in NW corner of hayloft
