```SITE INFORMA	<b>NOITA</b>											
*SURVEY DA	TE:	May 16, 2	2013	*ADDRESS	S: 31450 452nd Ave.							
*SURVEY	е	*COUNTY	Clay									
				*CITY	Beres	sforc	i					
LOCATION DESCRI	LOCATION DESCRIPTION: From Vermillion, South Dakota Highway 50 bi-pass and University Road,											
North 19 miles to 299th Street, turn left, (West) about ½ mile, you will need to walk about ½ mile North												
to vacated farmstead.												
LEGAL DESCRIPTION	ON: <u>W 1</u>	⁄₂, SE ¼, 7	7-95-52 Gle	nwood Twp.								
*QUARTER 1:	SE 1/4			OWNER NAME: Nada Landeen								
*QUARTER 2:					3904 E. 15 th							
*TOWNSHIP:	Glenwo	od		OWNER CITY:								
*RANGE:	51			OWNER STATE:	South	South Dakota						
*SECTION:	7			OWNER ZIP:	57103							
ACRES:	79.69			QUAD NAME:								
OWNER CODE 1:	Р											
OWNER CODE 2:												
OWNER CODE 3:												
HISTORIC SIGNI	FICANC	E										
	_			DEGICTED N	A B 4 🗁							
*DOE:				REGISTER NAME: MULTIPLE PROPERTY NAME:

#### STRUCTURE DETAILS

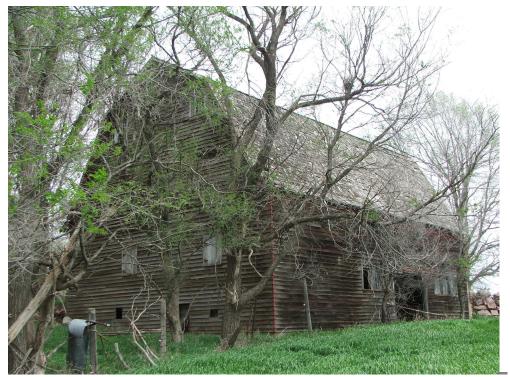
1

CAMERA DIRECTION: Looking NE, SW corner

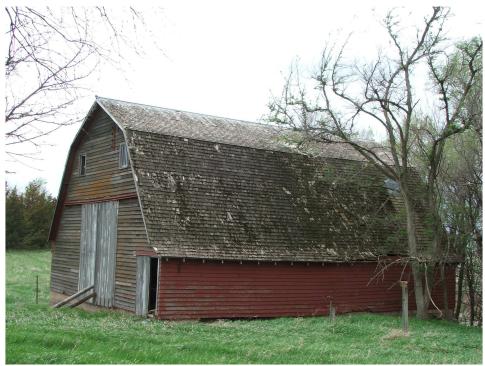
PHOTOGRAPHER: Jim Stone ROLL NUMBER: DATE OF PHOTO: May 16, 2013 PHOTO NUMBER: 3
CAMERA DIRECTION: Looking SW, NE corner

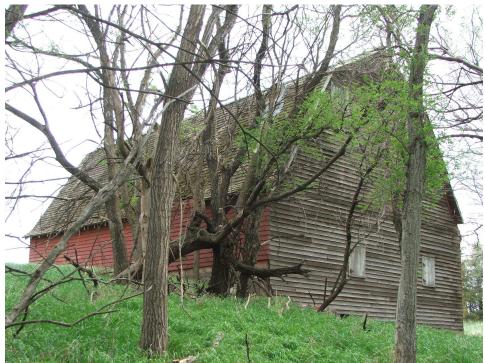
DATE OF PHOTO: May 16, 2013 PHOTO NUMBER: 4

CAMERA DIRECTION: Looking SE, NW corner

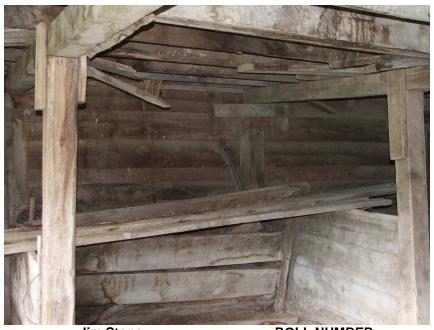
Basement, looking NW, only horse stall still in CAMERA DIRECTION: place on the West side.

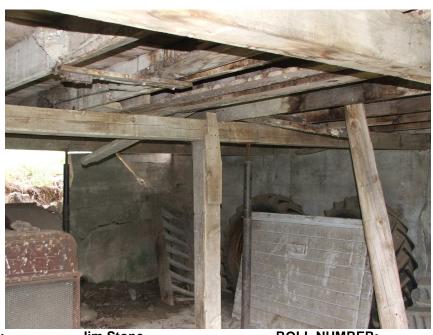
INTERIOR NOTES: Two row	s of 6x6 posts and 6x	6's for beams. Floor joists for the	hayloft floor are 2x8's.						
Three granaries on the West wall. These granaries are all 10' East to West, two are 8' North to South and									
the North granary is 14'. The	se granaries are 13' h	igh and extend into the hayloft 6'.							
OTHER NOTES: The East ar	nd North walls are 6"	x 8' poured concrete. The South a	nd West walls and						
above concrete walls on the l	East and North are 2x	6 stud walls, 1x8 diagonal sheathi	ng and ½"x 6" cedar						
lap siding. Rafters are 2x6's	with a 2x6x4' brace at	the hip and a 2x6 brace from top	of wall down to the						
floor 10' O. C. Barn had no	cupola. 10' x 11' dou	ble sliding doors at ground level i	nto hayloft.						
*PHYSICAL NOTES: Barn is	s in fair condition. A	section of the North concrete wall	has fell in.						
*UTM ZONE:		*RESTRICTED: Y o	r N						
*UTM EASTING:

Basement, looking NE, 6x6 posts, 6x6 beams, 2x8 joists, note section

CAMERA DIRECTION: of North wall that fell in.
