"SITE INFORMATION

STRUCTURE DETAILS										
SHPO ID:										
*PROPERTY NAME:										
OTHER NAME:										
• · · · · · · · · · · · · · · · · · · ·										
CURRENT FUNCTION:	Vacant	FOUNDATION:	Poured concrete							
CURRENT SUBFUNCTION:	Vacant	ROOF MATERIAL:								
			Gable / partial hip							
LUCTORIO FUNCTIONI	I in a sta ala la ann	DOOF CHARE	roof with dormer to							
HISTORIC FUNCTION:	-	ROOF SHAPE:	North							
HISTORIC SUBFUNCTION:	Hay and grain storage									
		STYLE:								
OCCUPIED:	No	TYPE:								
			2x6 studs, 1x10							
ACCECCIDI E	Yes with	MALL C.	shiplap, ½"x 6"							
ACCESSIBLE:	permission	WALLS:	cedar lap siding							
STORIES:	. 2 S	SIGNIFICANT PERSON:	Frick Swedherg							
*DATE OF CONSTRUCTION:		LTURAL AFFILIATION:	Swedish							
DATE OF CONSTRUCTION.	1910 10 1920	LIONAL AITILIATION.	OWCUISII							
ALTERED/MOVED NOTES: Original site.										
ALTEREDINIOVED NOTES.	Original Site.									
INTERIOR NOTES: Two row	vs of (3) nly 2x6 nosts 4	6 heams and 2x6 floor joists fo	or the havioft and

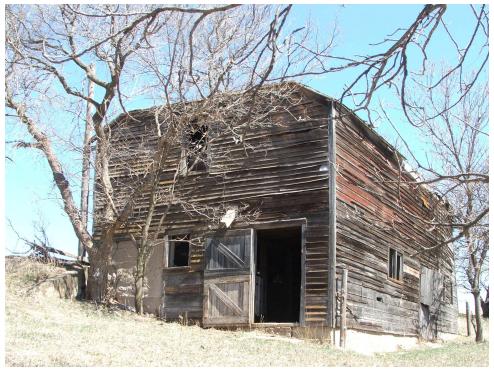
PHOTOGRAPHER: Jim Stone ROLL NUMBER: DATE OF PHOTO: April 8, 2014 PHOTO NUMBER: 1

CAMERA DIRECTION: Looking NE, SW corner

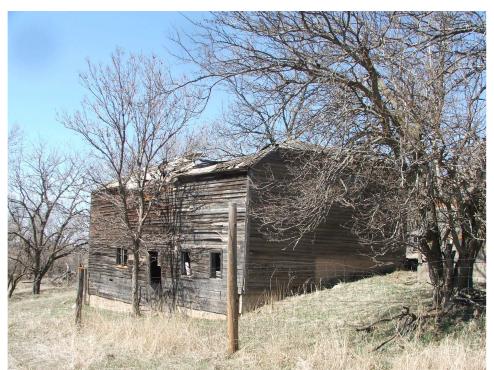
PHOTOGRAPHER: Jim Stone ROLL NUMBER: DATE OF PHOTO: April 8, 2014 PHOTO NUMBER: CAMERA DIRECTION: Looking NW, SE corner

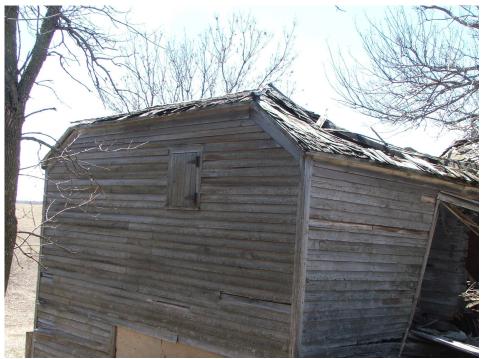
PHOTOGRAPHER: Jim Stone ROLL NUMBER: DATE OF PHOTO: April, 2014 PHOTO NUMBER: 3

CAMERA DIRECTION: Looking SW, NE corner

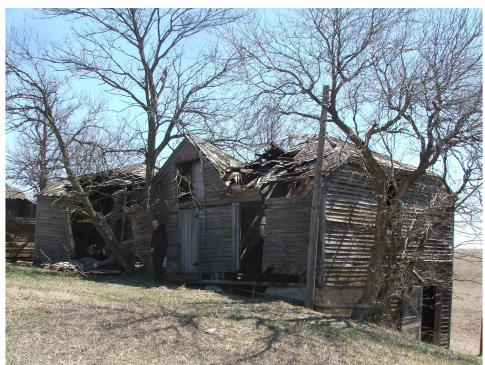
PHOTOGRAPHER: Jim Stone ROLL NUMBER: DATE OF PHOTO: April 8, 2014 PHOTO NUMBER: 4

CAMERA DIRECTION: Looking SE, NW corner

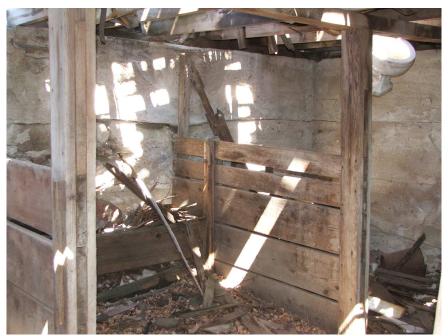
Basement, looking NE at double milk cow stanchions on the North

CAMERA DIRECTION: wall at the East end.

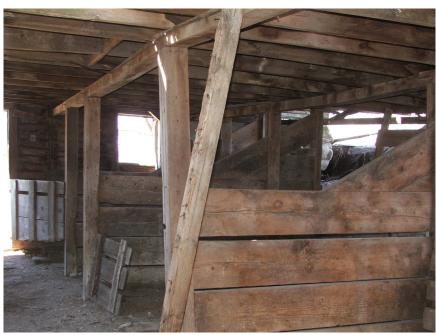
Basement, looking NW, horse stalls on the west

CAMERA DIRECTION: side, facing North.

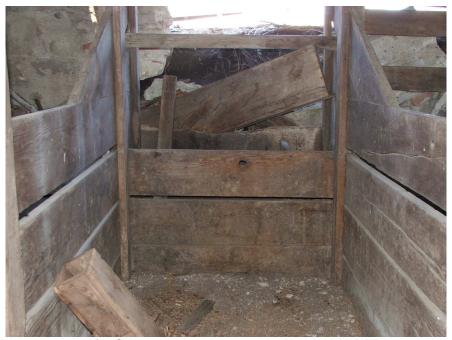
Basement. Looking North into a single horse

CAMERA DIRECTION: stall.

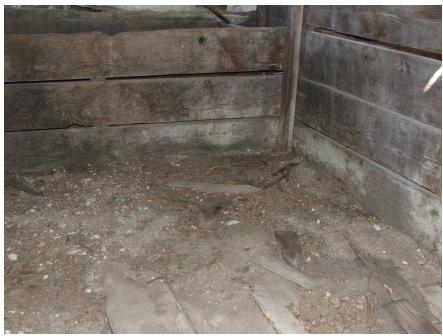
Basement, looking NE into a double horse stall,

CAMERA DIRECTION: note plank floor.

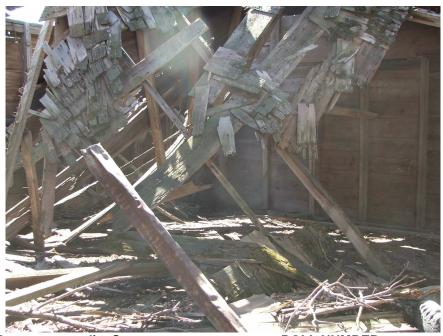
First floor, looking SW into 20' x 20' hayloft

CAMERA DIRECTION: area.

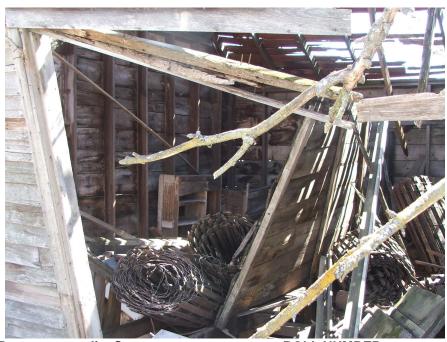
10

First floor, looking SE into two granaries on the

CAMERA DIRECTION: East side.
