SOUTH DAKOTA STATE HISTORIC PRESERVATION OFFICE
HISTORIC SITES SURVEY STRUCTURE FORM

*SURVEY DATE: March 10, 2014
*SURVEYOR: Jim Stone

*ADDRESS: 30031 461 Ave.
*COUNTY: Clay
*CITY: Centerville

SHPO ID: _____			
*PROPERTY NAME: _____			
OTHER NAME: _____			
CURRENT FUNCTION: <u>Vacant</u>	FOUNDATION: <u>Poured concrete and 3-1/2 courses 8" conc. block</u>	ROOF MATERIAL: <u>Asphalt shingles over cedar shingles</u>	
CURRENT SUBFUNCTION: <u>Storage</u>	ROOF SHAPE: <u>Gothic round roof</u>	STRUCTURAL SYSTEM: <u>Balloon framing</u>	
HISTORIC FUNCTION: <u>Livestock barn</u>		STYLE: <u>Gothic round roof barn</u>	
HISTORIC SUBFUNCTION: <u>Hay storage</u>		TYPE: <u>Livestock barn</u>	
OCCUPIED: <u>Yes</u>			
ACCESSIBLE: <u>Yes with permission</u>	WALLS: <u>2x6 studs, 1x6 # 106 drop siding and 1/2" x 6" cedar lap siding</u>		
STORIES: <u>2</u>	SIGNIFICANT PERSON: <u>Erick Swedberg</u>		
*DATE OF CONSTRUCTION: <u>1915 to 1925</u>	CULTURAL AFFILIATION: _____

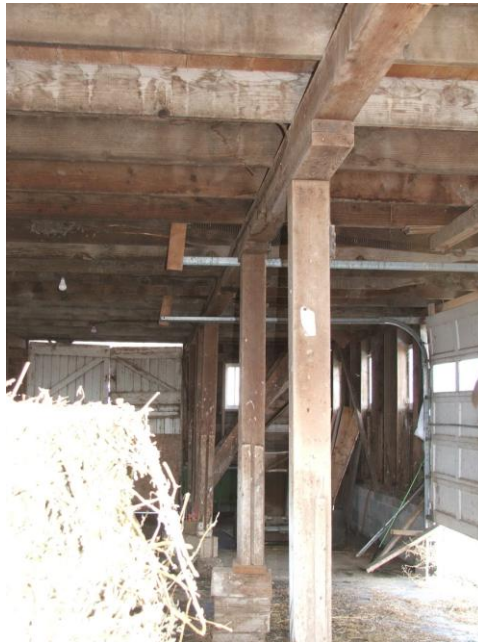
ROLL NUMBER: 5
PHOTO NUMBER: 5

CAMERA DIRECTION: First floor, looking NE at
6x6 posts, 6x6 beams
and 2x8 floor joists.

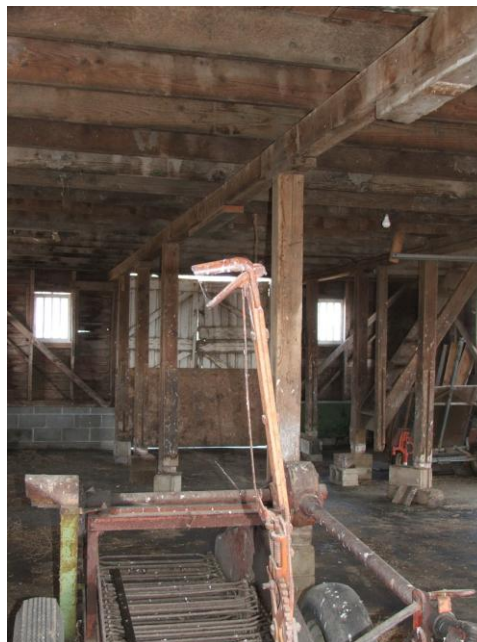
ROLL NUMBER: 6
PHOTO NUMBER: 6

CAMERA DIRECTION: First floor, looking NE,
6x6 posts, 6x6 beam and
2x8 floor joists, not
blocking under each
post.

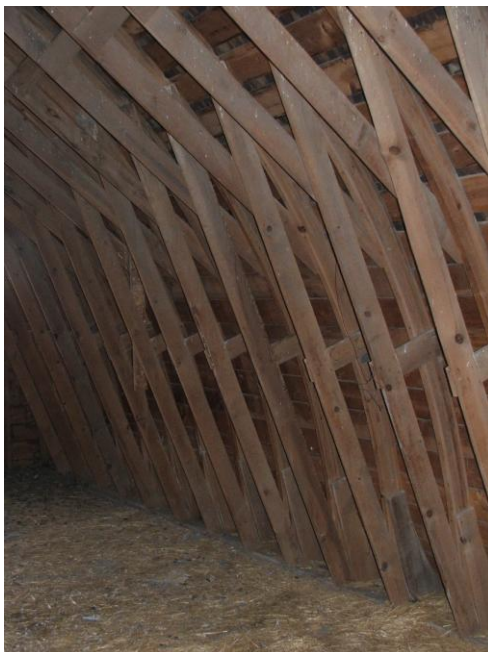
ROLL NUMBER: _____
PHOTO NUMBER: 7

INTERIOR NOTES: Two rows of 6x6 posts, 6x6 beams and 2x8 floor joists for the hayloft floor. Barn may have been uses for farrowing swine. Extra 1x6 bracing on the rafters is not needed, it is actual over built.

CAMERA DIRECTION: Hayloft, looking SW,
lower 1x6 bracing 2' O.
C.

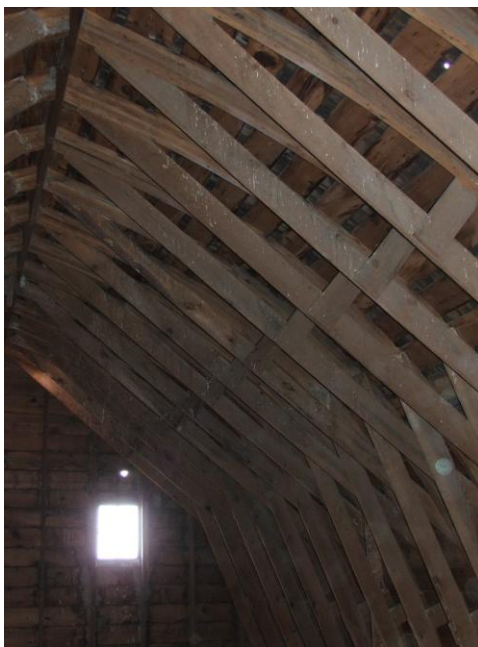
ROLL NUMBER: _____
PHOTO NUMBER: 8

CAMERA DIRECTION: Hayloft, looking SW,
upper 1x6 bracing 2' O.
C.

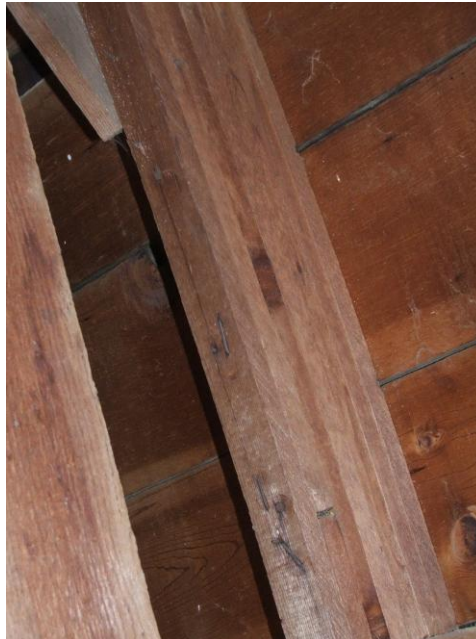
ROLL NUMBER: _____
PHOTO NUMBER: 9

CAMERA DIRECTION: Hayloft, looking NE, 7
plies $\frac{3}{4}$ " x full 2" cedar
laminated gothic round
rafter.

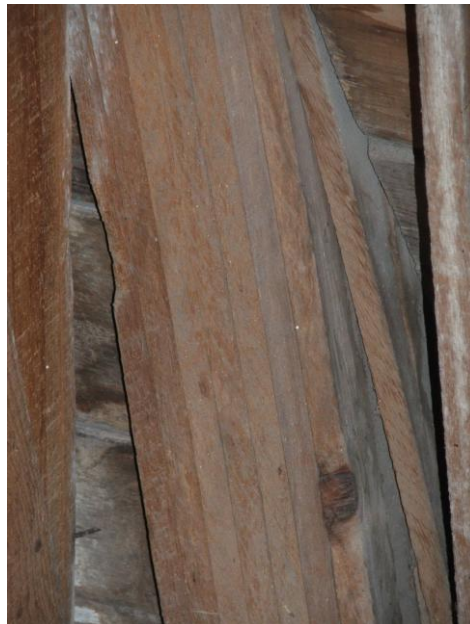
ROLL NUMBER: _____
PHOTO NUMBER: 10

CAMERA DIRECTION: Hayloft, looking East,
lower part of $\frac{3}{4}$ " x 4"
laminated dormer rafter.

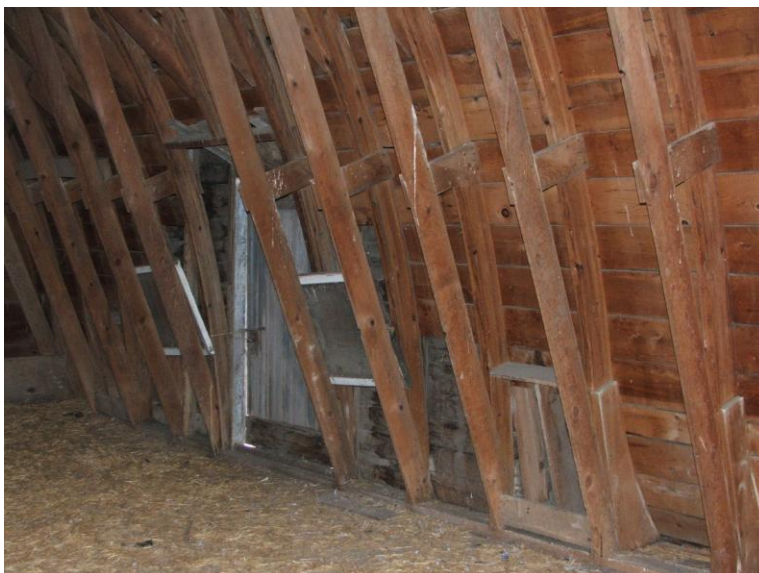
ROLL NUMBER: _____
PHOTO NUMBER: 11

CAMERA DIRECTION: Hayloft, hayloft door in 14' dormer, all dormer framing is outside of the main barn roof.
