"SITE INFORMA"	<u> </u>								
*SURVEY DAT	E: Decembe	er 16, 2013 *ADD	RESS:	31449 University Road					
*SURVEYO	-		OUNTY:						
				Vermillion	1				
LOCATION DESCRIPTION: From Vermillion, intersection of South Dakota Highway 50 bi-pass and									
University Road, North about 2-1/2 miles on the left (West) side.									
LEGAL DESCRIPTION: _Turner Tract 2, SE ¼, NE 1/4 & NE ¼, NE 1/4, 36 – 93 – 52 Spirit Mound Twp.									
*QUARTER 1:	NE 1⁄4	OWNER I	NAME:	Roger E. T	urner				
*QUARTER 2:		OWNER ADD	RESS:	ESS: 31449 University Road					
*TOWNSHIP:	Spirit Mound	OWNER	CITY:	Vermillion					
*RANGE:	52	OWNER S	TATE:	South Dakota					
*SECTION:	36	OWNE	R ZIP:	57069					
ACRES:	8.05	QUAD N	IAME:						
OWNER CODE 1:	P								
OWNER CODE 2:									
OWNER CODE 3:									
HISTORIC SIGNIF	ICANCE								
*DOE	REGIS	REGISTER NAME:							
*DOE DATE		MULTIPLE PROPERTY NAME:							
REASON INELIGIBLE				_					
		CATEGORY:

STRUCTURE DETAILS

SKETCH MAP

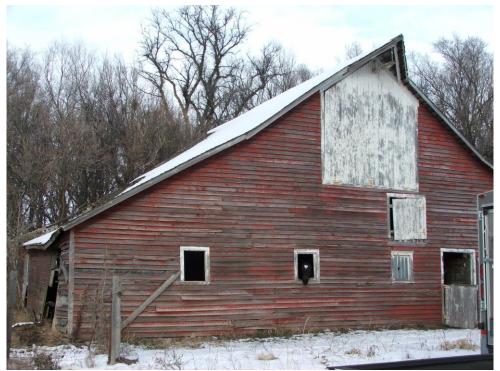
Looking NE, SW corner

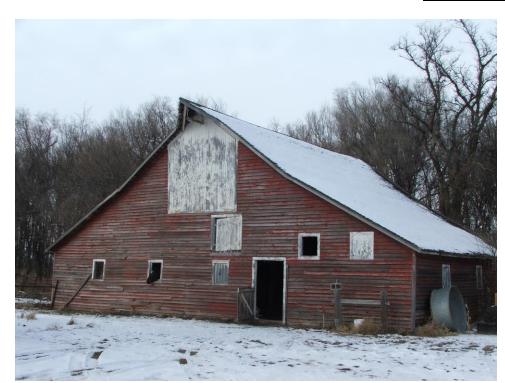
2

CAMERA DIRECTION: Looking NW, SE corner

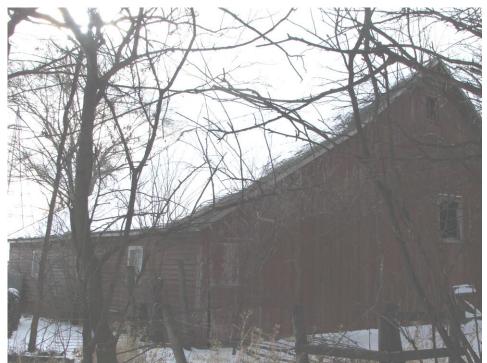
PHOTOGRAPHER: Jim Stone ROLL NUMBER: DATE OF PHOTO: December 16, 2013 PHOTO NUMBER: 3

CAMERA DIRECTION: Looking SW, NE corner

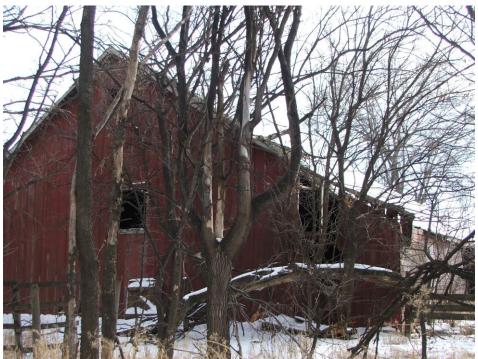
PHOTOGRAPHER: Jim Stone ROLL NUMBER: DATE OF PHOTO: December 16, 2013 PHOTO NUMBER: 4

CAMERA DIRECTION: Looking SE, NW corner

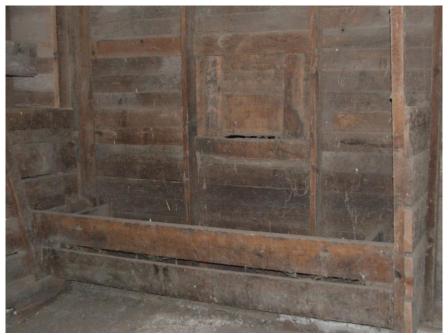
First floor, East lean-to, looking NW at double

CAMERA DIRECTION: horse stall.

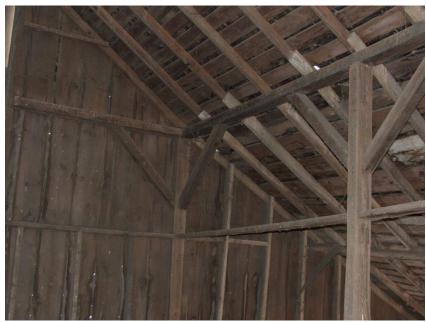
Hayloft, looking SW, 4x6 posts, 4x6 girts and beams with 4x4 angle

CAMERA DIRECTION: bracing at the top.

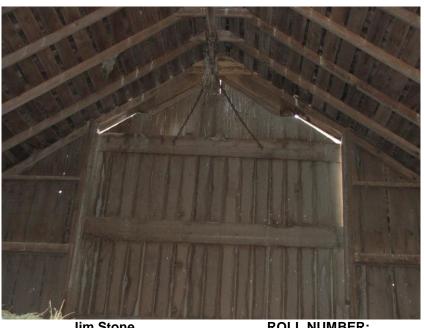
Hayloft, looking South,

South gable end and

CAMERA DIRECTION: hayloft door.
