**SOUTH DAKOTA STATE HISTORIC PRESERVATION OFFICE
HISTORIC SITES SURVEY STRUCTURE FORM**

*SURVEY DATE: March 20, 2013 *ADDRESS: 30047 Greenfield Road
*SURVEYOR: Jim Stone *COUNTY: Clay
*CITY: Beresford

CURRENT FUNCTION: Calving barn FOUNDATION: Poured concrete
Steel over cedar

HISTORIC FUNCTION: Livestock barn ROOF SHAPE: Gambrel

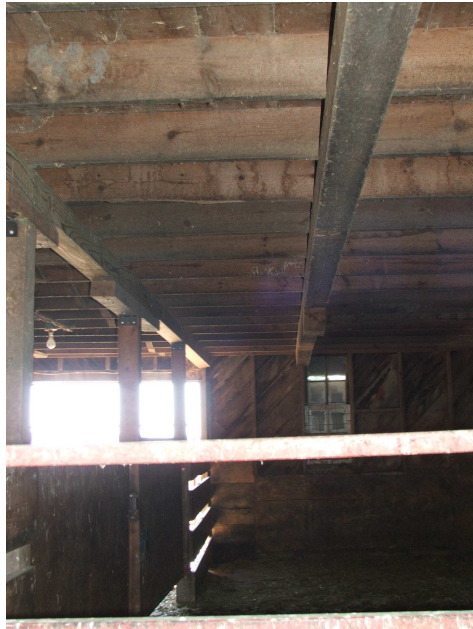
ROLL NUMBER: 5
PHOTO NUMBER: 5

INTERIOR NOTES: The original barn has two rows of 6x6 posts and 6x6 for a beam. The beams have been moved from 8' in from walls to 12' in from walls. This was to allow for two 12' x 16' calving pens on the East and West sides. The floor joists for the hayloft floor are 2x8's. 2x6 floor joists in lean-to.

CAMERA DIRECTION: First floor, looking SE,
6x6 posts & 6x6 beams,
note beam moved and
old beam still in place.

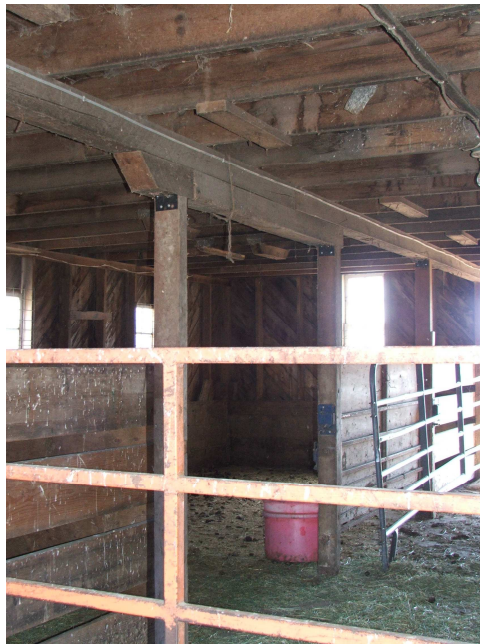
ROLL NUMBER: 6
PHOTO NUMBER: 6

CAMERA DIRECTION: First floor, looking SE,
calving pens on East
side.

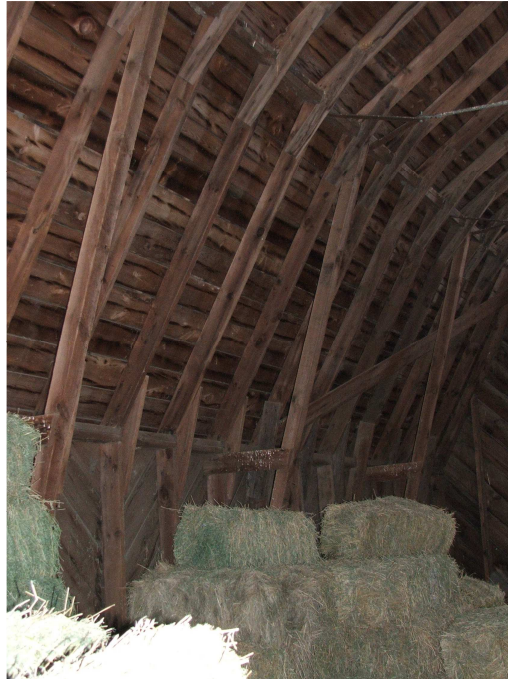
ROLL NUMBER: _____
PHOTO NUMBER: 7

Hayloft, looking SE, 4x4 posts 8' O. C. supporting hip

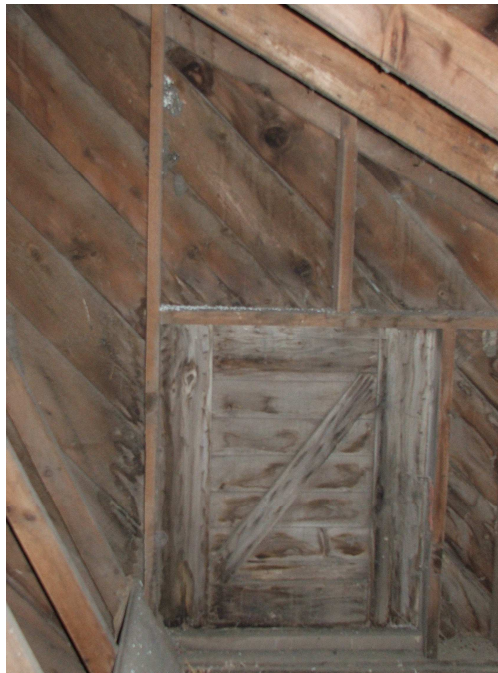
ROLL NUMBER: _____
PHOTO NUMBER: 8

Hayloft, looking South, hayloft door on the South wall to pitch hay into loft on lean-to.

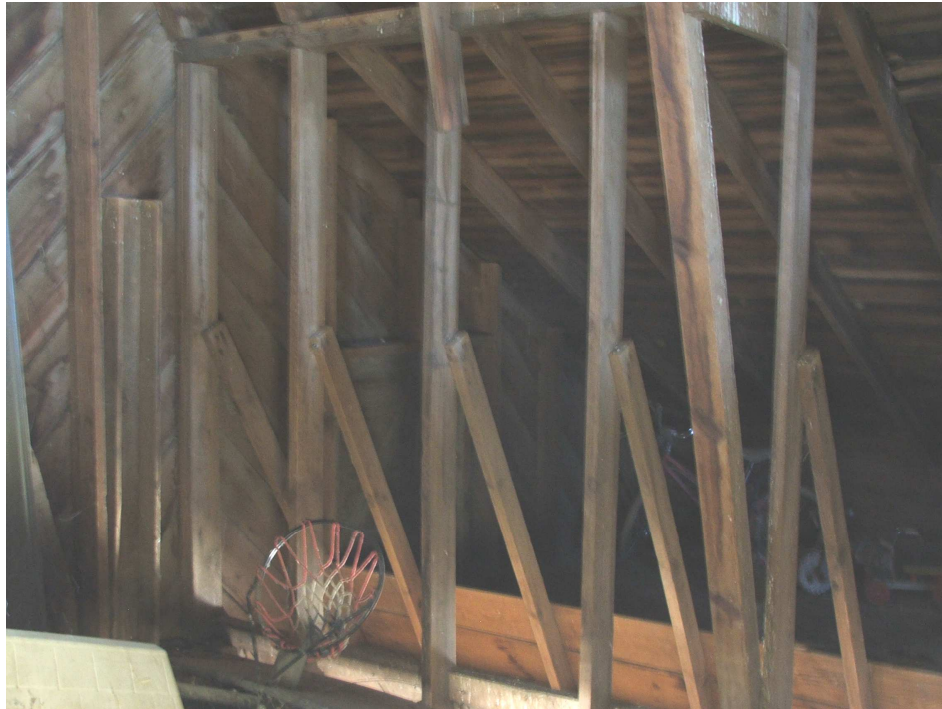
ROLL NUMBER: _____
PHOTO NUMBER: 9

CAMERA DIRECTION: Hayloft, looking SW into hayloft above lean-to, note 2x4 slanted wall to hold hay back from opening to feed hay down into lean-to.
