**SOUTH DAKOTA STATE HISTORIC PRESERVATION OFFICE
HISTORIC SITES SURVEY STRUCTURE FORM**

*SURVEY DATE: August 20, 2011 *ADDRESS: 125 Center Street
*SURVEYOR: Jim Stone *COUNTY: Clay
*CITY: Vermillion

SHPO ID: 13 CL 0000578
 *PROPERTY NAME: Farabee town barn
 OTHER NAME: _____
 CURRENT FUNCTION: _____ FOUNDATION: Poured concrete
 CURRENT SUBFUNCTION: _____ ROOF MATERIAL: Asphalt shingles
 HISTORIC FUNCTION: _____ ROOF SHAPE: over Cedar
 HISTORIC SUBFUNCTION: _____ STRUCTURAL SYSTEM: shingles
 OCCUPIED: Yes TYPE: Gable and flat roof
 ACCESSIBLE: Yes WALLS: Balloon framing
 STORIES: 2 SIGNIFICANT PERSON: ?
 *DATE OF CONSTRUCTION: Early 1900's CULTURAL AFFILIATION: ?

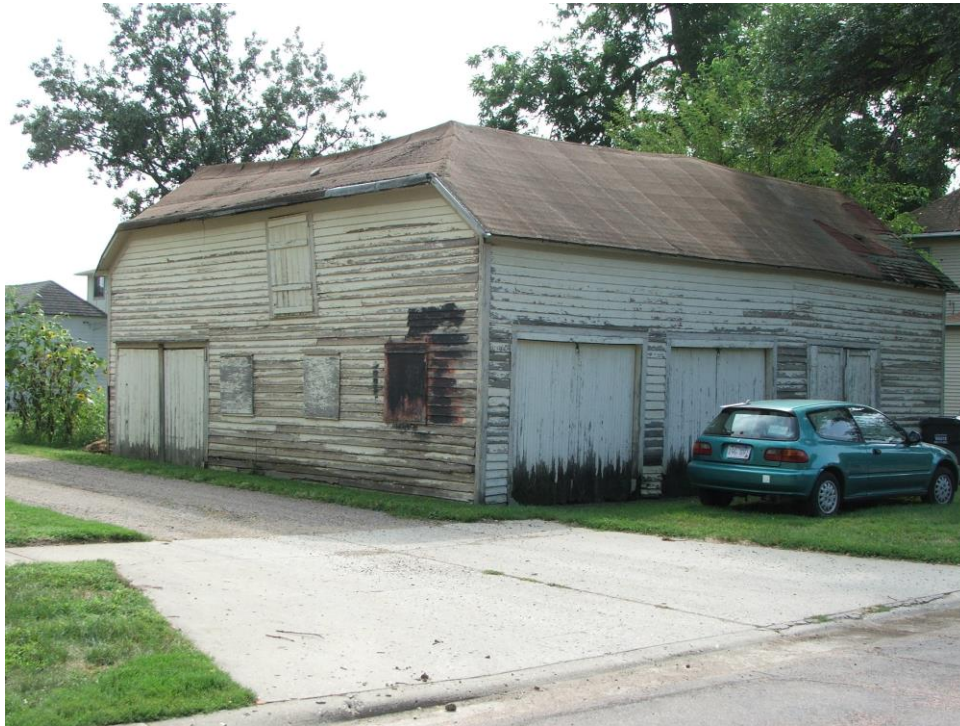
ROLL NUMBER: _____
PHOTO NUMBER: 1
CAMERA DIRECTION: Looking SW, NE corner

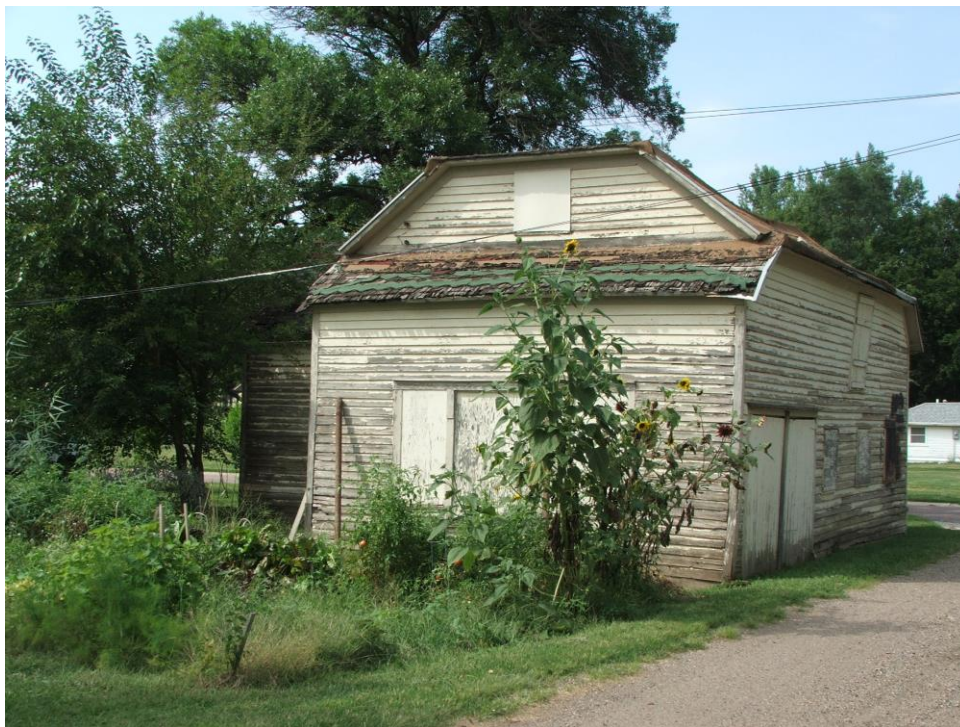
ROLL NUMBER: _____
PHOTO NUMBER: 2
CAMERA DIRECTION: Looking NW, SE corner

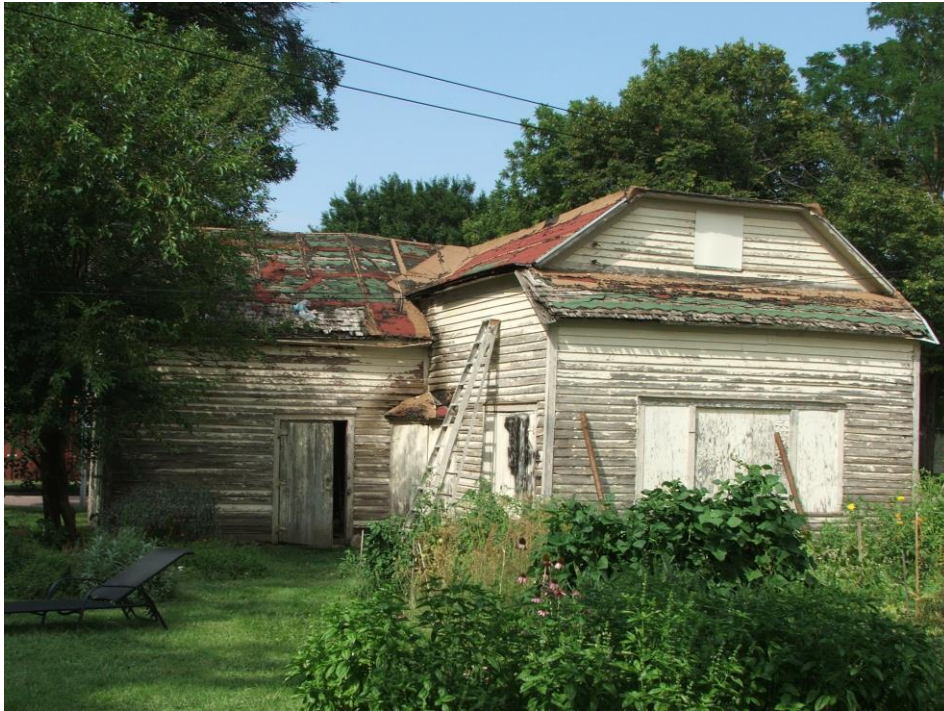
ROLL NUMBER: _____
PHOTO NUMBER: 3
CAMERA DIRECTION: Looking NE, SW corner

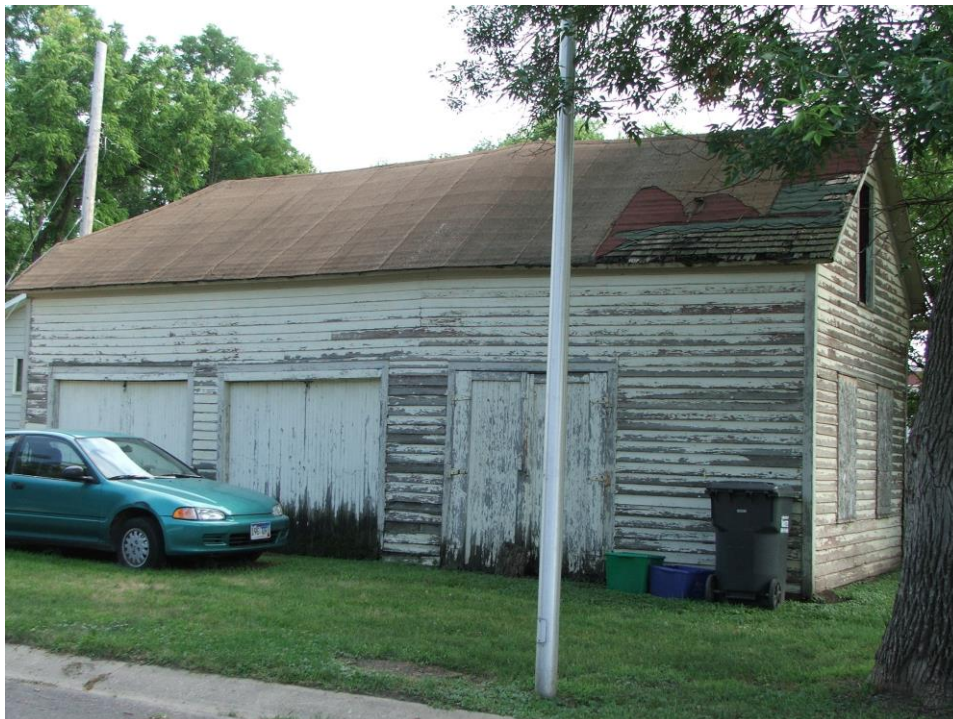
ROLL NUMBER: _____
PHOTO NUMBER: 4
CAMERA DIRECTION: Looking SE, NW corner

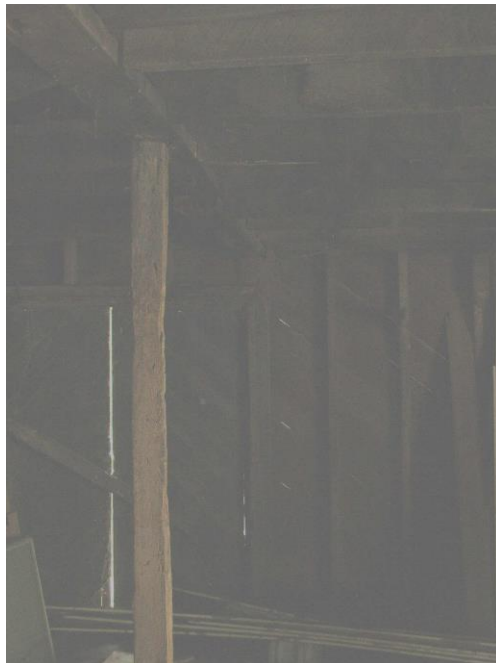
ROLL NUMBER: _____
PHOTO NUMBER: 6
CAMERA DIRECTION: Looking at East wall, first
floor

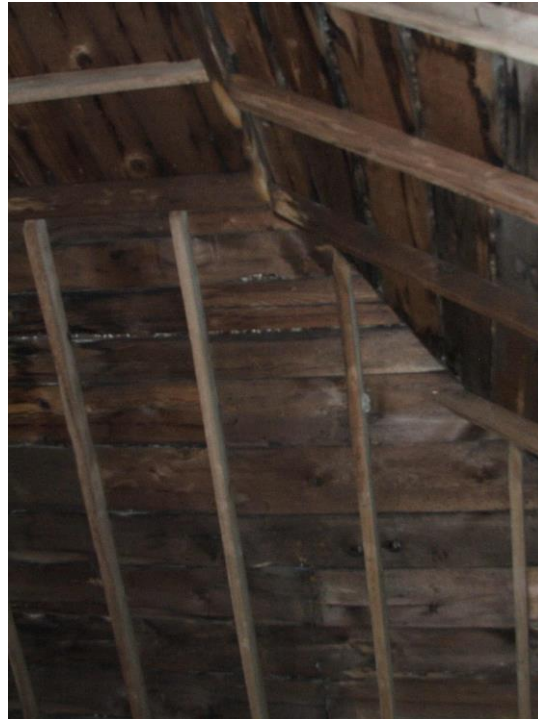
ROLL NUMBER: _____
PHOTO NUMBER: 7
CAMERA DIRECTION: Looking North, rafters in hayloft

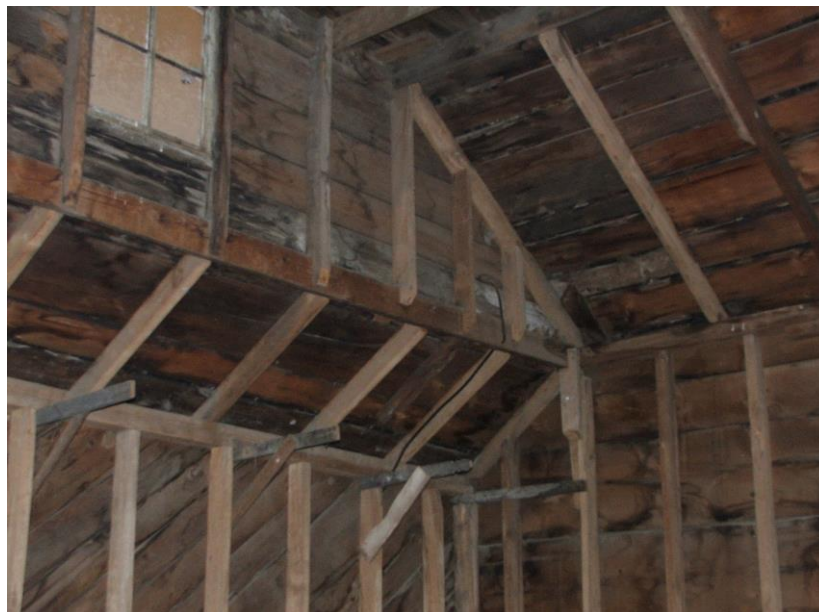
ROLL NUMBER: _____
PHOTO NUMBER: 8
CAMERA DIRECTION: Looking SW in hayloft, 4" addition ?
