SITE INFORMATION

*ADDRESS: <u>31828 Fairview Ave.</u>

SHPO ID:		_	
*PROPERTY NAME:			
OTHER NAME:			
CURRENT FUNCTION:	Livestock	FOUNDATION:	Brick foundation
CURRENT SUBFUNCTION:	Straw and grain storage	ROOF MATERIAL:	Asphalt shingles over cedar shingles
HISTORIC FUNCTION:	Livestock barn	ROOF SHAPE:	Gable
HISTORIC SUBFUNCTION:	Hay and grain storage	STRUCTURAL SYSTEM:	Balloon framing
		STYLE:	Western feeder barn
OCCUPIED:	Yes	TYPE:	Livestock barn
ACCESSIBLE:	Yes with permission	WALLS:	2x4 stud with 1x6 #106 drop siding.
STORIES:	2	SIGNIFICANT PERSON:F	ranklin Taylor
*DATE OF CONSTRUCTION:	1905 CU	ILTURAL AFFILIATION:	English

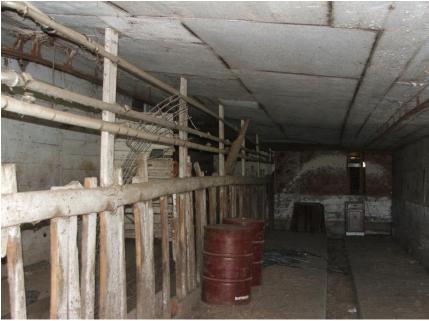
7

First floor, looking South in East lean-to. Milk cow CAMERA DIRECTION: stanchions

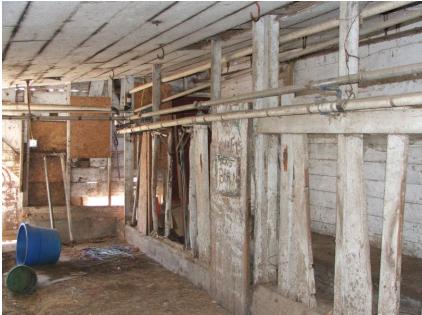
original stanchions at CAMERA DIRECTION: the South end.
