SITE INFORMATION

STRUCTURE DETAILS								
SHPO ID:								
*PROPERTY NAME:		-						
OTHER NAME:								
• · · · · · · · · · · · · · · · · · · ·								
CURRENT FUNCTION:	Vacant	FOUNDATION:	Poured concrete					
CURRENT SUBFUNCTION:	Storage	ROOF MATERIAL:	Galv. Corr. steel					
HISTORIC FUNCTION:	Livestock barn	ROOF SHAPE:	Gable					
HISTORIC SUBFUNCTION:	Hay and grain storage	STRUCTURAL SYSTEM:	Post and Beam

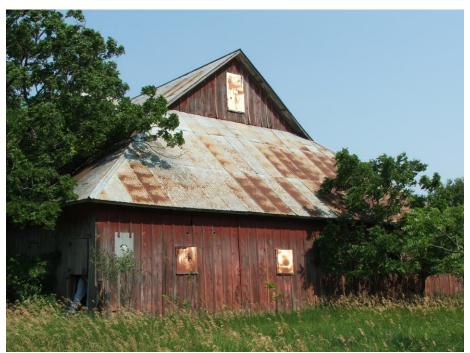
PHOTOGRAPHER: Jim Stone ROLL NUMBER: DATE OF PHOTO: July 2, 2012 PHOTO NUMBER: 3

CAMERA DIRECTION: Looking SW, NE corner

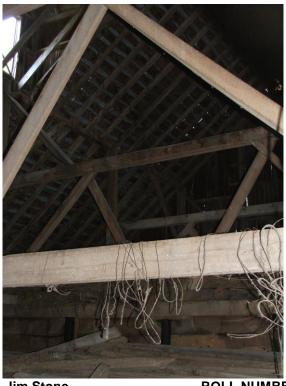
First floor, looking North, 8x8 posts w/ 6x8 beams mortise and tendon

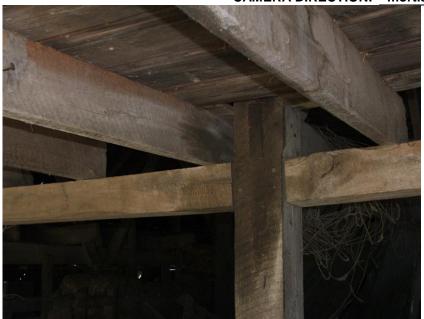
CAMERA DIRECTION: beams center structure

First floor, posts and

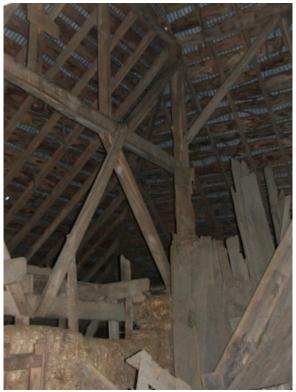
First floor, posts and beams on the West end **CAMERA DIRECTION:** next to West lean-to.
