**SOUTH DAKOTA STATE HISTORIC PRESERVATION OFFICE
HISTORIC SITES SURVEY STRUCTURE FORM**

*SURVEY DATE: Aug. 17, 2012 *ADDRESS: 45667 Jetley Park Street
*SURVEYOR: Jim Stone *COUNTY: Clay
*CITY: Meckling

CURRENT FUNCTION: <u>Vacant</u>	FOUNDATION: <u>None – built on poles</u>
CURRENT SUBFUNCTION: <u>storage</u>	ROOF MATERIAL: <u>steel over sheathing</u>
HISTORIC FUNCTION: <u>Western feeder barn</u>	ROOF SHAPE: <u>Gable</u>
HISTORIC SUBFUNCTION: <u>Hay storage</u>	STRUCTURAL SYSTEM: <u>Pole barn</u>
	STYLE: <u>Western feeder barn</u>
OCCUPIED: <u>Yes</u>	TYPE: <u>Livestock barn</u>
	WALLS: <u>Untreated poles & logs, girts 4' O.C.</u>
ACCESSIBLE: <u>Yes with permission</u>	WALLS: <u>vertical 1x12 siding</u>
STORIES: <u>1</u>	SIGNIFICANT PERSON: <u>Fred Demann</u>
*DATE OF CONSTRUCTION: <u>?</u>	CULTURAL AFFILIATION: <u>German</u>

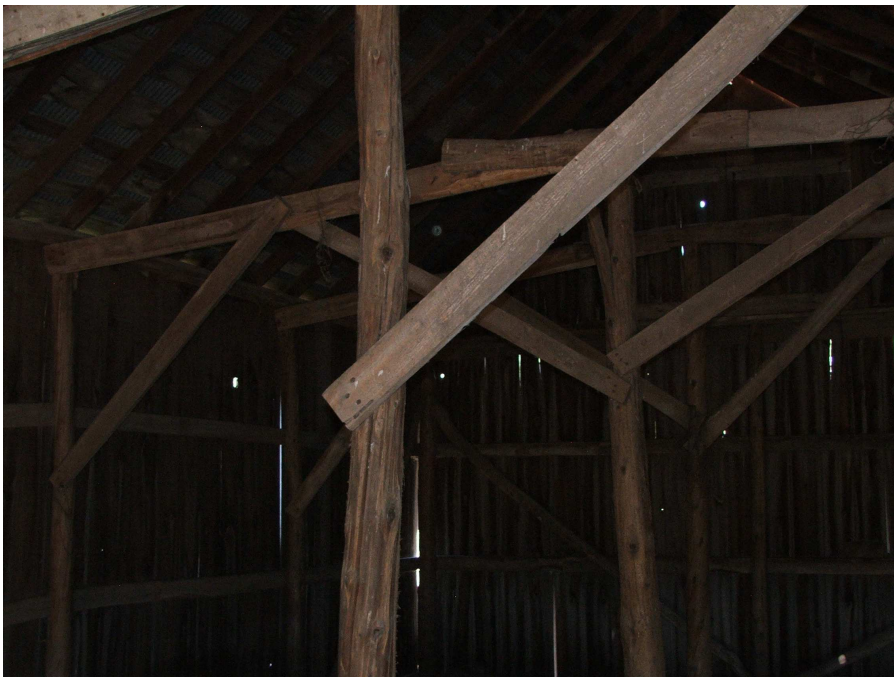
ROLL NUMBER: _____
PHOTO NUMBER: 4
CAMERA DIRECTION: Main barn, looking NW, poles and bracing

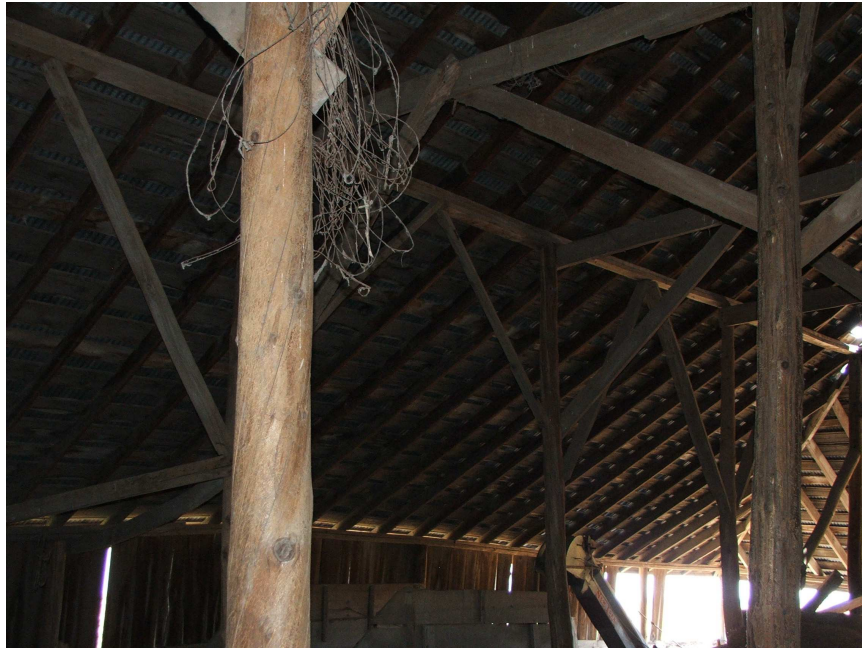
ROLL NUMBER: _____
PHOTO NUMBER: 5

CAMERA DIRECTION: Main barn, looking SE,
poles, bracing and hip
roof on lean-to's

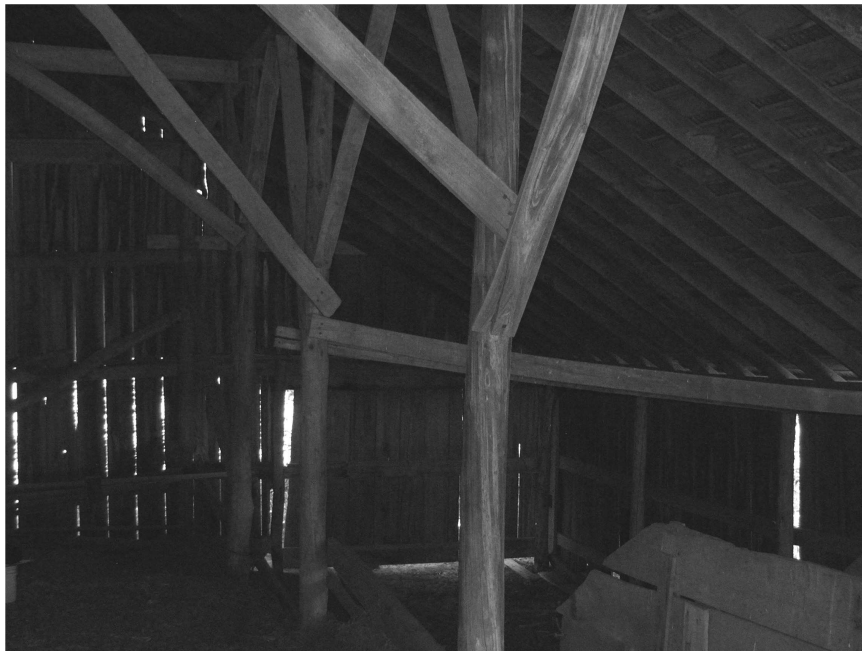
ROLL NUMBER: _____
PHOTO NUMBER: 6

CAMERA DIRECTION: Main barn, looking NE,
East wall and NE corner
of lean-to
