SITE INFORMATION

*SURVEY DATE: July 9, 2012			45753 Timber Road							
*SURVEYOR: Jim Si	tone									
		*CITY:	Vermillio	n						
LOCATION DESCRIPTION: From intersection of South Dakota Highway 50 bi-pass and South Dakota Highway 19, West about 1mile to South Dakota Highway 19 South, turn left about 300' to Timber Road,										
ingina, 10, 1100, about fillio to count banda inginay to count, turn for about ood to filliber Road,										
turn right (West) about 5-1/2 miles to Benson Landing, turn left (South) about ¼ mile, take left lane at the										
Y in the road and fallow in the farm.										
LEGAL DESCRIPTION: Weber Tract 1, SW ¼, SE ¼, 14 – 92 – 53 Norway Twp.										
*QUARTER 1: SE 1/4	(OWNER NAME:			Terry J. Linda L. Weber					
*QUARTER 2:		OWNER ADDRESS:								
*TOWNSHIP: Norway		OWNER CITY:								
*RANGE: 53		OWNER STATE:								
*SECTION: 14		OWNER ZIP:								
ACRES: 9.98		QUAD NAME:								
OWNER CODE 1: P

STRUCTURE DETAILS									
SHPO ID:									
*PROPERTY NAME:									
OTHER NAME:									
O MER NAME.									
CURRENT FUNCTION:	Livestock	FOUNDATION							
CURRENT SUBFUNCTION:	Storage	ROOF MATERIAL	Steel over cedar .: shingles						
HISTORIC FUNCTION:

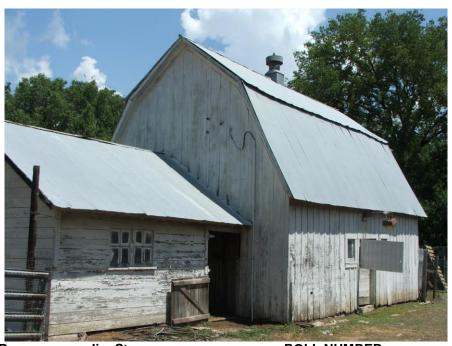
CAMERA DIRECTION: Looking NE, SW corner

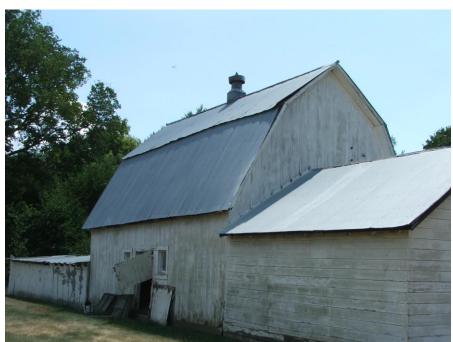
CAMERA DIRECTION: Looking SE, NW corner

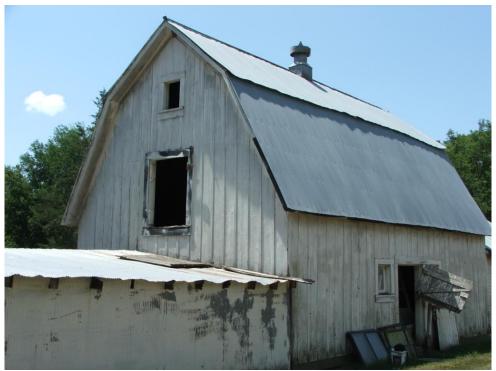
PHOTOGRAPHER: Jim Stone ROLL NUMBER: DATE OF PHOTO: July 9, 2012 PHOTO NUMBER: 3

CAMERA DIRECTION: Looking SW, NE corner

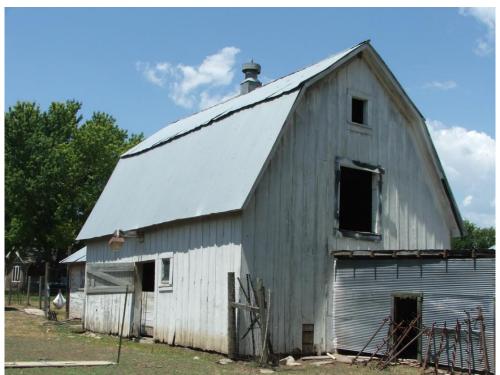
PHOTOGRAPHER: Jim Stone ROLL NUMBER: DATE OF PHOTO: July 9, 2012 PHOTO NUMBER: 4

CAMERA DIRECTION: Looking NW, SE corner

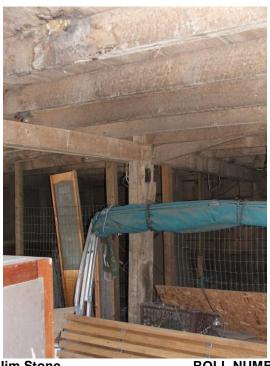
First floor, looking East, (3) 2x6's for post and (3) 2x6's for beam, 2x6

CAMERA DIRECTION: joists

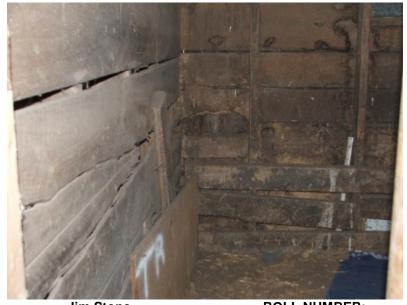
6

First floor, Looking East, CAMERA DIRECTION: Horse stall in SE corner

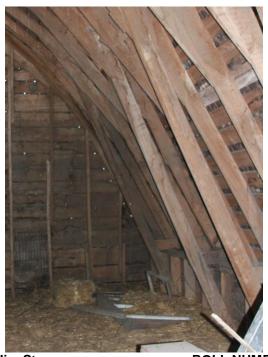
CAMERA DIRECTION: lower rafter bracing

Hayloft, looking West,
