**SOUTH DAKOTA STATE HISTORIC PRESERVATION OFFICE
HISTORIC SITES SURVEY STRUCTURE FORM**

*SURVEY DATE: February 5, 2013 *ADDRESS: 30267 464th Ave.
*SURVEYOR: Jim Stone *COUNTY: Clay
*CITY: Centerville

CURRENT FUNCTION:	<u>Calving barn</u>	FOUNDATION:	<u>Poured concrete</u>
CURRENT SUBFUNCTION:	<u>Storage</u>	ROOF MATERIAL:	<u>Steel over cedar shingles</u>
HISTORIC FUNCTION:	<u>Livestock barn</u>	ROOF SHAPE:	<u>Gambrel</u>
HISTORIC SUBFUNCTION:	<u>Hay & grain storage</u>	STRUCTURAL SYSTEM:	<u>Balloon framing</u>
OCCUPIED:	<u>No</u>	STYLE:	<u>Gambrel roof barn</u>
ACCESSIBLE:	<u>Yes with permission</u>	TYPE:	<u>Livestock barn</u>
		WALLS:	<u>2x6 studs, 1x6 #106 drop siding & steel roofing</u>
STORIES:	<u>2</u>	SIGNIFICANT PERSON:	<u>George Engberg</u>
*DATE OF CONSTRUCTION:	<u>1910 to 1920</u>	CULTURAL AFFILIATION:	<u>?</u>

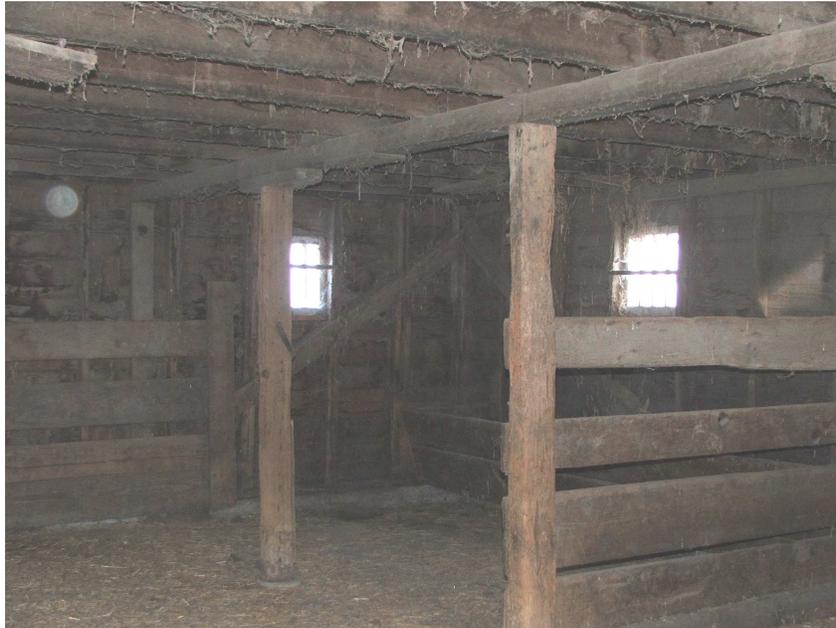
ROLL NUMBER: _____
PHOTO NUMBER: 5

CAMERA DIRECTION: First floor, looking NE,
remains of horse stalls,
center partition between
stalls removed.

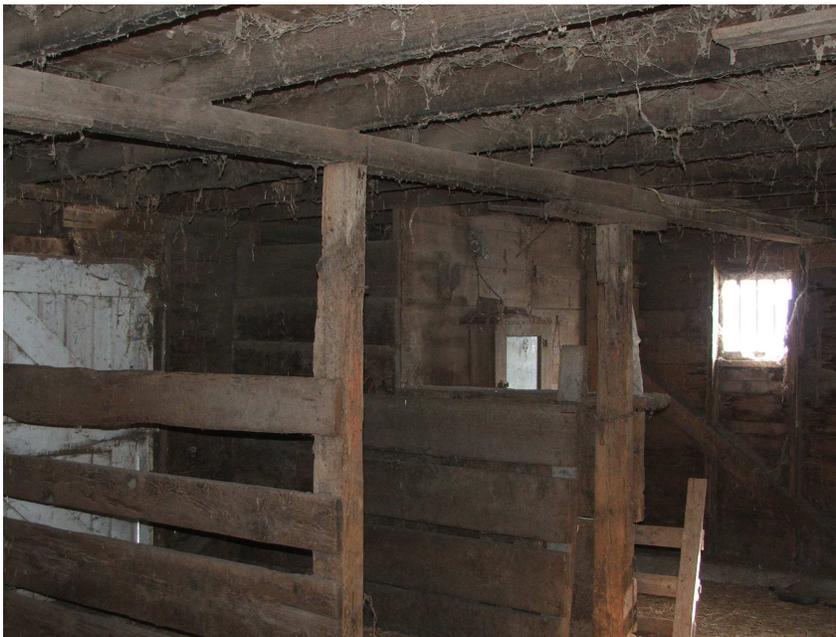
ROLL NUMBER: _____
PHOTO NUMBER: 6

CAMERA DIRECTION: First floor, looking SE,
alley for East door,
granary in the SE corner.

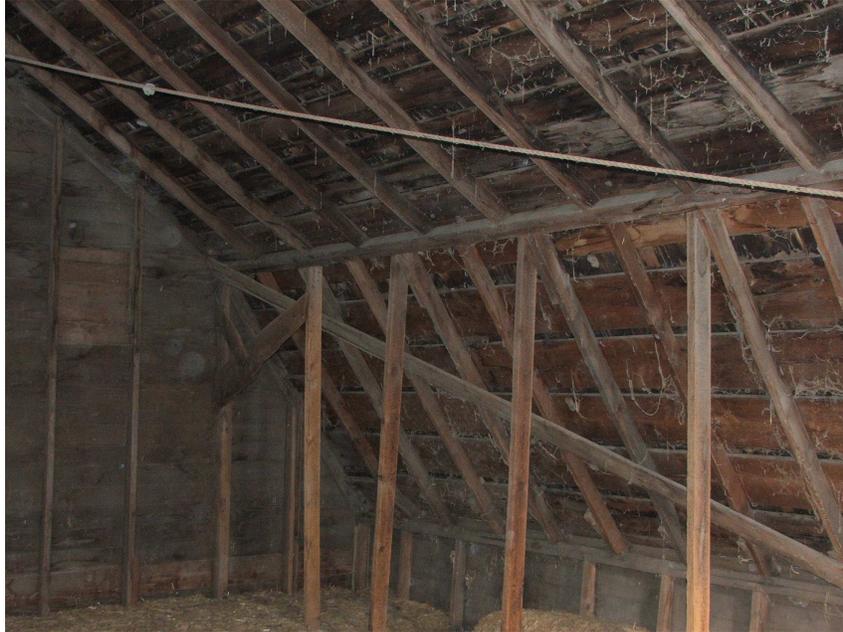
ROLL NUMBER: _____
PHOTO NUMBER: 7

CAMERA DIRECTION: Hayloft, looking NE, 2x4
4' O. C. posts supporting
hip.

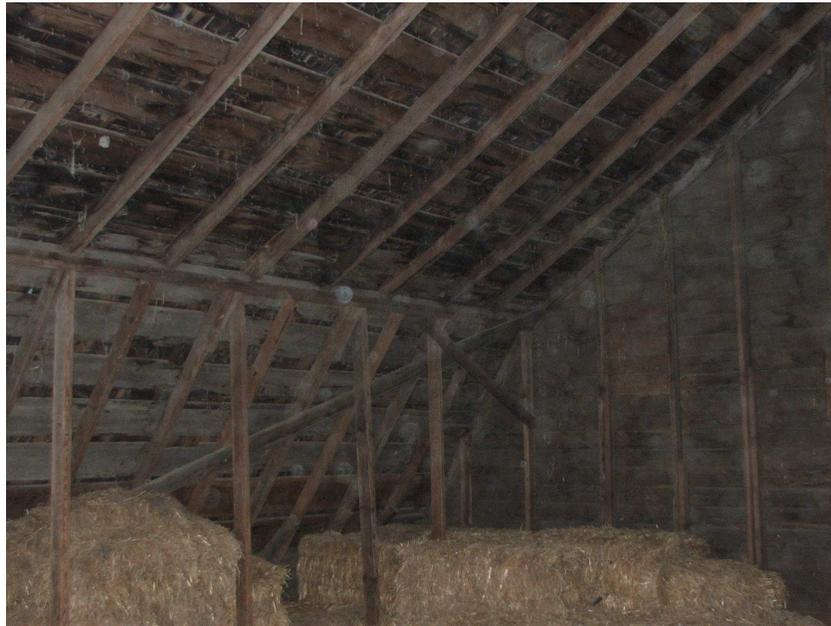
ROLL NUMBER: _____
PHOTO NUMBER: 8

CAMERA DIRECTION: Hayloft, looking NW, 2x4
posts 4' O. C. supporting
hip
