""SITE INFORMATION							
*SURVEY DATE: July 24,	2013 *ADDRESS:	RESS: 31310 459 th Ave.					
*SURVEYOR: Jim Stor		Clay					
	*CITY:	Meckling					
LOCATION DESCRIPTION: From Ve	ermillion, intersection of South I	Dakota Highway 50 bi-pass and					
South Dakota Highway 19, North about 1-1/4 miles to Bluff Road, turn left (West), fallow Bluff Road about							
3-1/2 miles to 312 th Street, turn left (West) 2 miles to 459 th Ave., turn left (South), about 1/8 mile, on the							
left, (East) side.							
LEGAL DESCRIPTION: W ½, NW ¼, 29 – 93 – 52 Spirit Mound Twp							
*QUARTER 1: NW 1/4	OWNED NAME.	Dorene Becker ETAL					
*QUARTER 1: NW 1/4	-						
*TOWNSHIP: Spirit Mound	-	OWNER ADDRESS: 31341 459 th Ave.					
*RANGE: 52	OWNER STATE:						
*SECTION: 29	-	OWNER STATE: South Dakota OWNER ZIP: 57069					
ACRES: 80.24	QUAD NAME:	37003					
OWNER CODE 1: P							
OWNER CODE 2:							
OWNER CODE 3:							
HISTORIC SIGNIFICANCE

STRUCTURE DETAILS

SHPO ID:						
*PROPERTY NAME:						
OTHER NAME:						
CURRENT FUNCTION:	Vacant	FOUNDA'	TION:	Poured concrete		
			•	Asphalt shingles over cedar shingles		
CURRENT SUBFUNCTION:	JRRENT SUBFUNCTION: Storage		ROOF MATERIAL:			
HISTORIC FUNCTION: Live

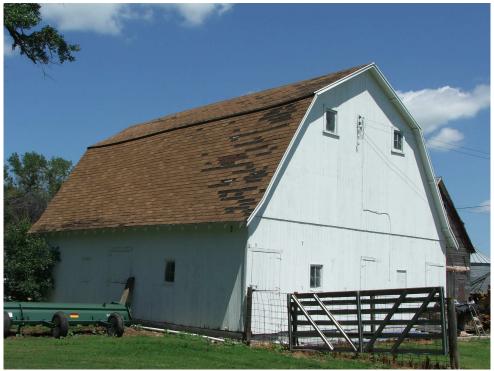
PHOTOGRAPHER: Jim Stone ROLL NUMBER: DATE OF PHOTO: July 23, 2013 PHOTO NUMBER: 1

CAMERA DIRECTION: Looking NE, SW corner

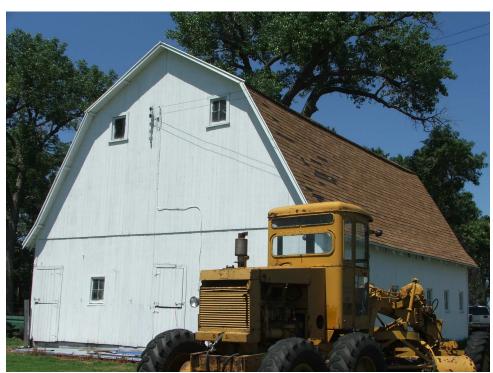
PHOTOGRAPHER: Jim Stone ROLL NUMBER: DATE OF PHOTO: July 23, 2013 PHOTO NUMBER: 2

CAMERA DIRECTION: Looking NW, SE corner

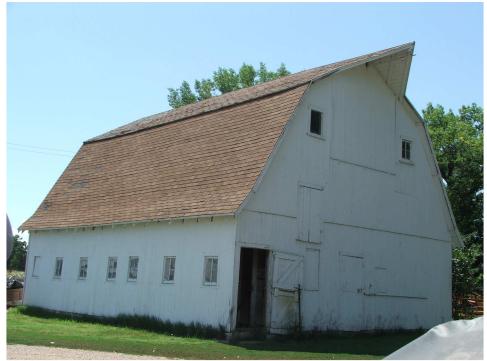
PHOTOGRAPHER: Jim Stone ROLL NUMBER: DATE OF PHOTO: July 23, 2013 PHOTO NUMBER: 3
CAMERA DIRECTION: Looking SW, NE corner

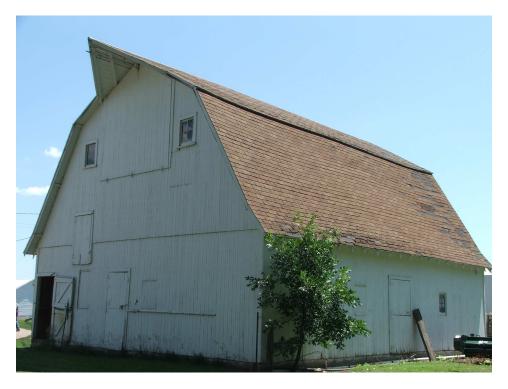
PHOTOGRAPHER: Jim Stone ROLL NUMBER: DATE OF PHOTO: July 23, 2013 PHOTO NUMBER: 4
CAMERA DIRECTION: Looking SE, NW corner

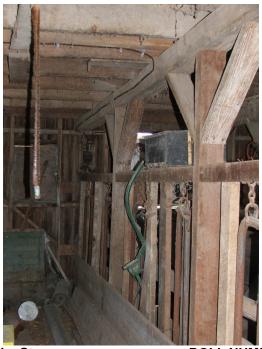
First floor, looking SW, 4x6 post, (3) 2x6's beam, 2x8 joists and milk cow CAMERA DIRECTION: stanchions on East side.

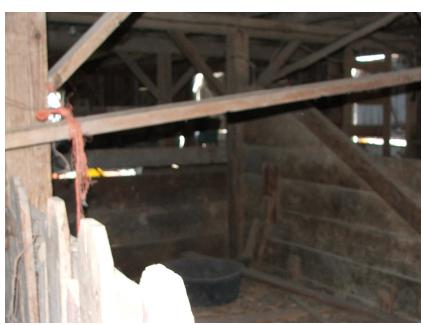
First floor, looking SE, double horse stall still in

CAMERA DIRECTION: place

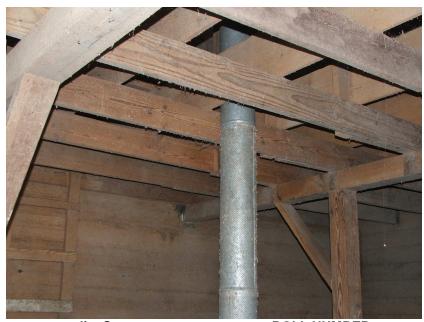
7

First floor, looking SW, into 22'x14' granary the goes up 5'-10" into havloft.

CAMERA DIRECTION: hayloft.

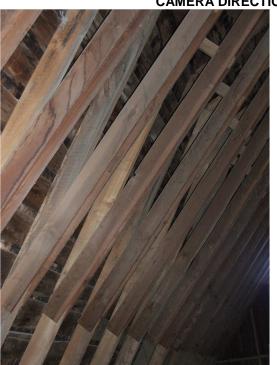
Hayloft. looking SE, (2) 1x6's bracing rafters at

CAMERA DIRECTION: _the hip.

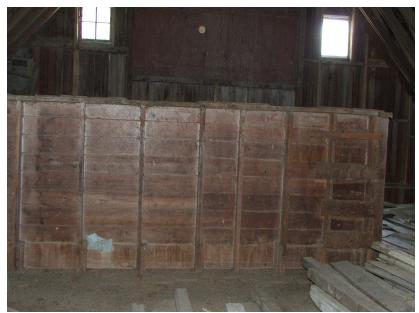
11

Hayloft. looking North, 22'x14' granary 5'-10" up into hayloft. Had a floor over the granary for hay storage above granary, floor partially

CAMERA DIRECTION: removed.
