SOUTH DAKOTA STATE HISTORIC PRESERVATION OFFICE
HISTORIC SITES SURVEY STRUCTURE FORM

*ADDRESS: 31293 Bluff Road
*COUNTY: Clay
*CITY: Vermillion

CURRENT FUNCTION: <u>Horse barn</u>	FOUNDATION: <u>Poured concrete</u>
CURRENT SUBFUNCTION: <u>Horse barn</u>	ROOF MATERIAL: <u>Steel roofing over cedar shingles</u>
HISTORIC FUNCTION: <u>Livestock barn</u>	ROOF SHAPE: <u>Gable roof</u>
HISTORIC SUBFUNCTION: <u>Hay storage</u>	STRUCTURAL SYSTEM: <u>Balloon framing</u>
	STYLE: <u>Gable roof barn</u>
OCCUPIED: <u>Yes</u>	TYPE: <u>Livestock barn</u>
	<u>2x6 studs, 1x10 shiplap, 1/2"x6" cedar lap siding</u>
ACCESSIBLE: <u>Yes with permission</u>	WALLS: _____
STORIES: <u>2</u>	SIGNIFICANT PERSON: <u>George F. Groves</u>
*DATE OF CONSTRUCTION: <u>Early 1900's</u>	CULTURAL AFFILIATION: <u>?</u>

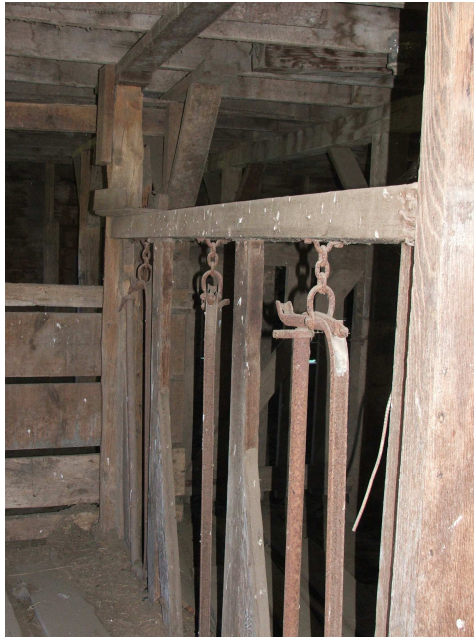
ROLL NUMBER: _____
PHOTO NUMBER: 5

CAMERA DIRECTION: First floor, looking NE,
three milk cow
stanchions still in place.

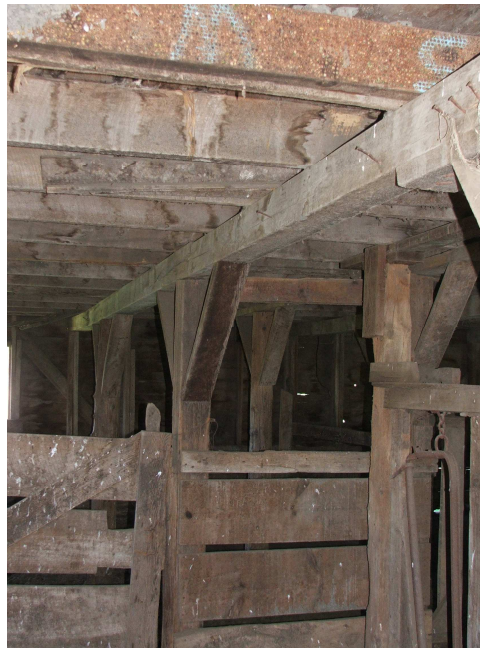
ROLL NUMBER: _____
PHOTO NUMBER: 6

CAMERA DIRECTION: First floor, looking NE,
6x6 posts, 6x6 beam, 2x8
floor joists.

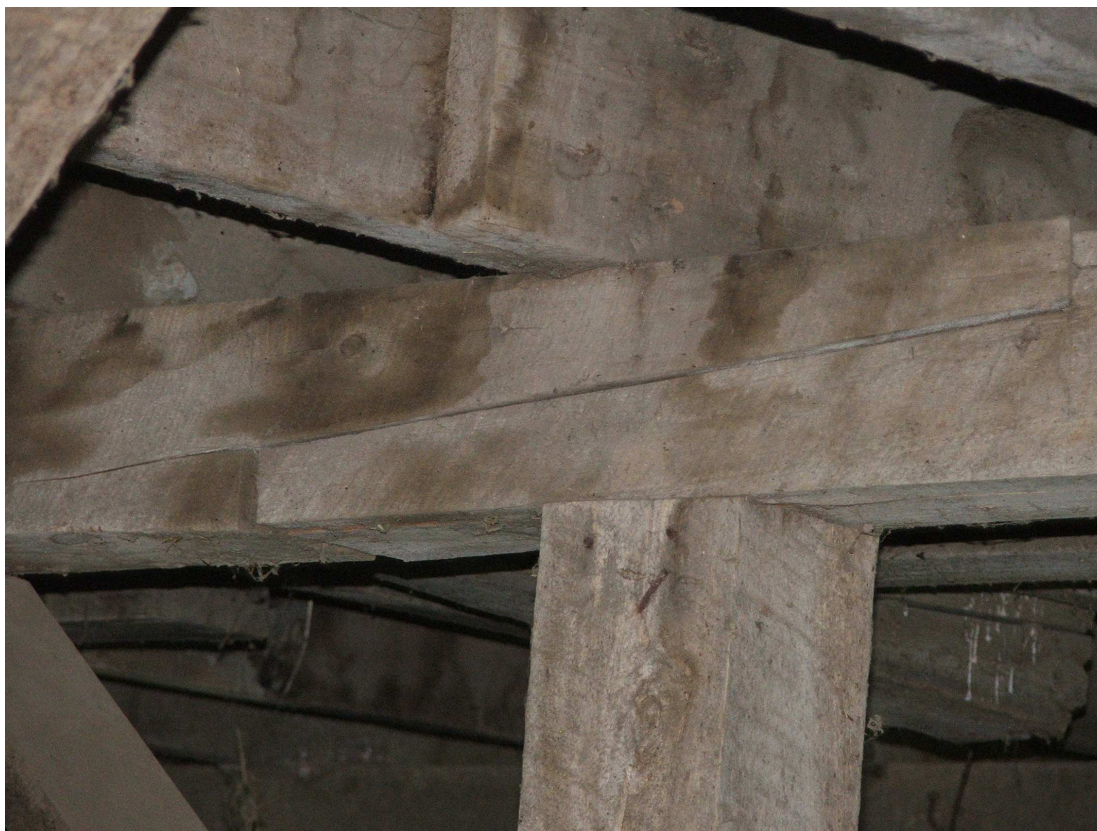
ROLL NUMBER: _____
PHOTO NUMBER: 7

CAMERA DIRECTION: First floor, looking NE,
scarf joint on 6x6 beam
in the center of barn.
