<u>```SITE INFORM</u>	ATION											
*SURVEY D	ATE: July 2	24, 2013	*ADDRESS:	31327 459 th Ave.								
*SURVE	YOR: Jim S	tone	*COUNTY:	Clay								
			*CITY:	Meckling								
LOCATION DESCRIPTION: From Vermillion, from intersection of South Dakota Highway 50 bi-pass and												
South Dakota Highway 19, North about 1-1/4 miles to Bluff road, turn left (West), fallow Bluff Road about												
3-1/2 miles to 313th Street, turn left (West), 2 miles to 459th Ave., turn left (South) about ¼ mile on the right												
(West) side.												
LEGAL DESCRIPTION: E ½, NE ¼ Ex 412.85' of N 637.9' of S 1098.86' of SE ¼, NE ¼, 30 – 93 – 52												
Spirit Mound Twp.												
*QUARTER 1:	NE 1/4		OWNER NAME:	Dorene Be	cker ET	AL						
*QUARTER 2:		ow	NER ADDRESS:	31341 459 th Ave.								
*TOWNSHIP:	Spirit Mound		OWNER CITY:	Meckling	Meckling							
*RANGE:	52		OWNER STATE:	South Dak	South Dakota

STRUCTURE DETAILS

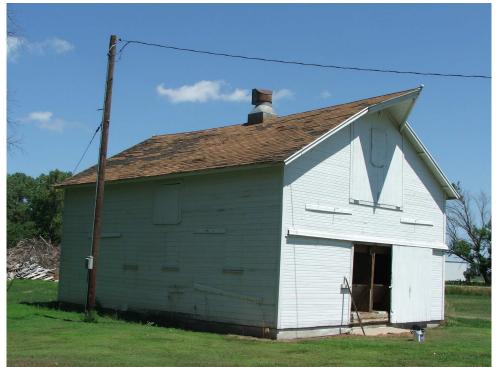
PHOTOGRAPHER: Jim Stone ROLL NUMBER: DATE OF PHOTO: July 23, 2013 PHOTO NUMBER: 1

CAMERA DIRECTION: Looking NE, SW corner

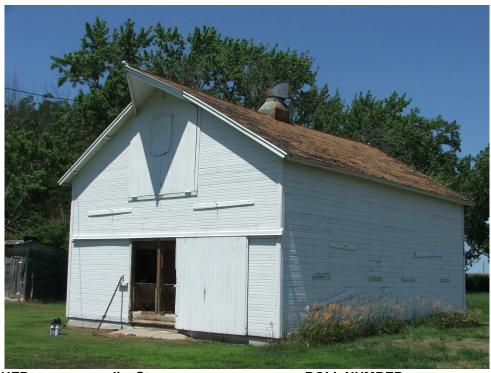
PHOTOGRAPHER: Jim Stone ROLL NUMBER: DATE OF PHOTO: July 23, 2013 PHOTO NUMBER: 2

CAMERA DIRECTION: Looking NW, SE corner

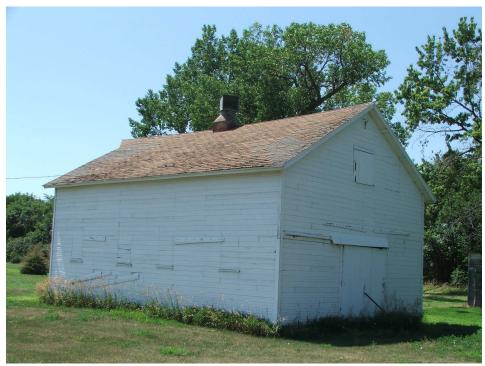
DATE OF PHOTO: July 23, 2013 PHOTO NUMBER: 3

CAMERA DIRECTION: Looking SW, NE corner

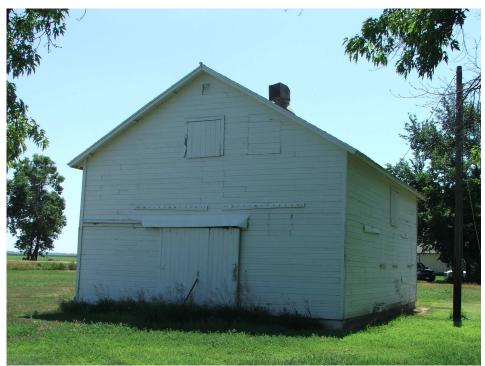
DATE OF PHOTO: July 23, 2013 PHOTO NUMBER: 4

CAMERA DIRECTION: Looking SE, NW corner

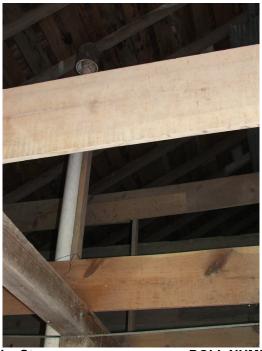
First floor, looking NW, 6x6 post, 6x6 beam, 2x8 joists, note 1x12 bracing
