SITE INFORMATION

SURVEY DATE:	October 26, 2012	*ADDRESS:	32028 Ponderosa Drive
*SURVEYOR:	Jim Stone	*COUNTY:	Clay
		*CITY:	Burbank

STRUCTURE DETAILS

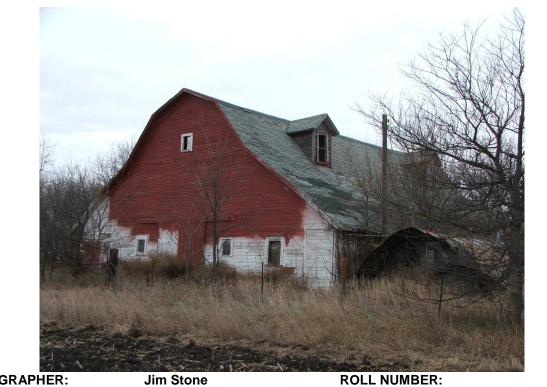
CAMERA DIRECTION:
 Looking NE, SW corner

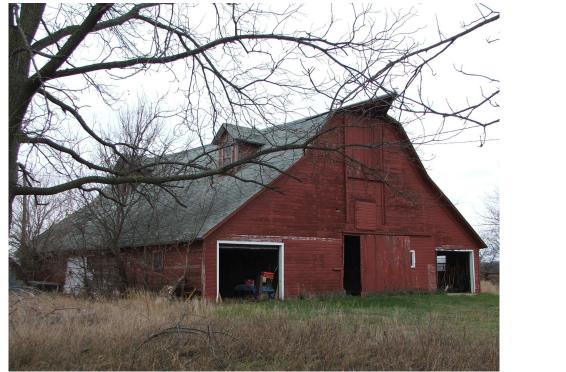
PHOTO NUMBER: 2 CAMERA DIRECTION: Looking NW, SE corner

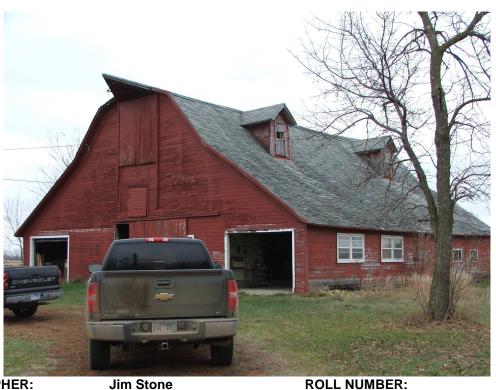
CAMERA DIRECTION:
 Looking SW, NE corner

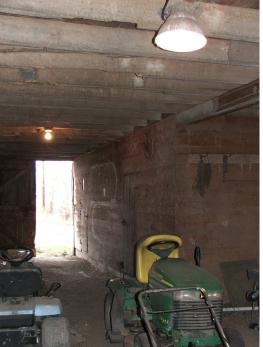
PHOTO NUMBER: 6 First floor, center of barn, looking South, posts, beam and box CAMERA DIRECTION: stall in SW corner

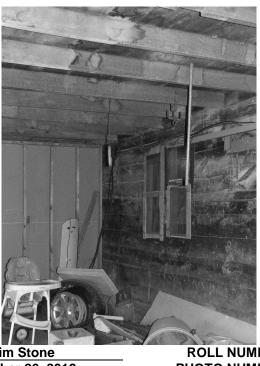
7 First floor, center of barn, looking North, CAMERA DIRECTION: granaries in NE corner
