STRUCTURE DETAILS					
SHPO ID:					
*PROPERTY NAME:	Chaney barn				
OTHER NAME:					
CURRENT FUNCTION:	Hay & machinery storage	FOUNDATION:	Poured concrete		
CURRENT SUBFUNCTION:	Hay & machinery storage	ROOF MATERIAL:			
	Livestock barn	ROOF SHAPE:			
HISTORIC SUBFUNCTION:	Hay and grain storage	STRUCTURAL SYSTEM:			
		STYLE:	Ground floor with huge hayloft		
OCCUPIED:	YES		Livestock barn		
	YES with		2x6 with 1x6 #106		
ACCESSIBLE:	permission	WALLS:	drop siding		
STORIES:	2S	SIGNIFICANT PERSON:	George Jasperson		
*DATE OF CONSTRUCTION:	1920 to 1930 CU	LTURAL AFFILIATION:	?		
ALTERED/MOVED NOTES: Original site. In 1999 all but the north ten feet of hayloft has been removed and 20' x 15'-6" overhead door installed on the South side for hay and machinery storage.					
INTERIOR NOTES: Origi	nal barn had two rows 6x	6 posts with (4) 2x6's nailed to	gether for a beam		
which ran North and South. Posts were 10' O.C. North to South and 12' O.C. East to West. Hayloft floor

SOUTH DAKOTA STATE HISTORIC PRESERVATION OFFICE HISTORIC SITES SURVEY STRUCTURE FORM

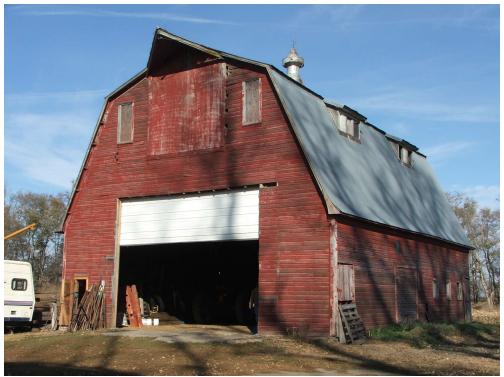
PHOTOGRAPHER: Jim Stone ROLL NUMBER: DATE OF PHOTO: November 4, 2011 PHOTO NUMBER: 1
CAMERA DIRECTION: Looking NW, SE corner

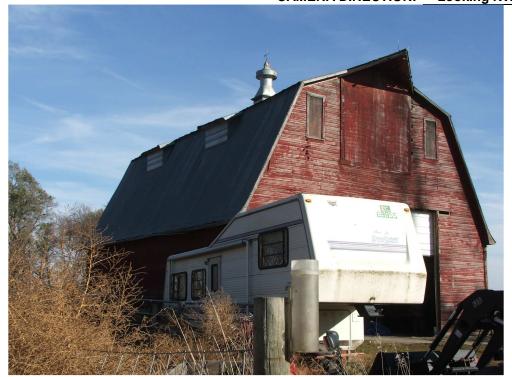
DATE OF PHOTO: November 4, 2011 PHOTO NUMBER: 2

CAMERA DIRECTION: Looking NE, SW corner

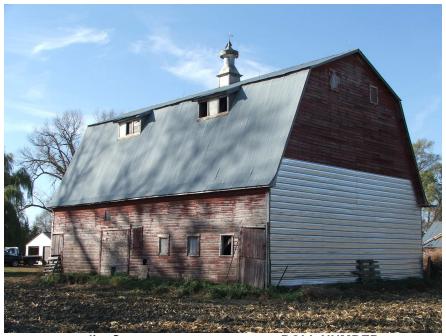
CAMERA DIRECTION: Looking SW, NE corner

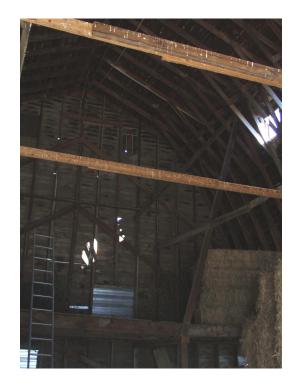
Looking NE, Rafters and

CAMERA DIRECTION: existing 10' of hayloft

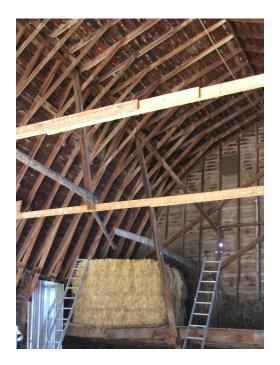
PHOTO NUMBER: 5

Looking NW, Rafters and CAMERA DIRECTION: existing 10' of hayloft

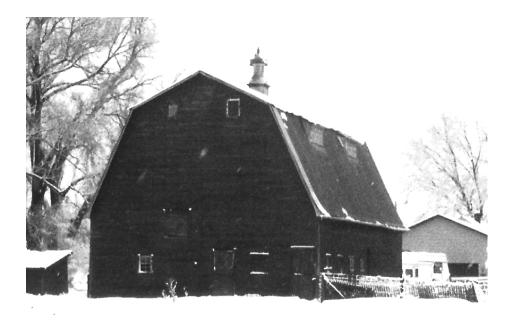
Looking SE, NW corner of barn

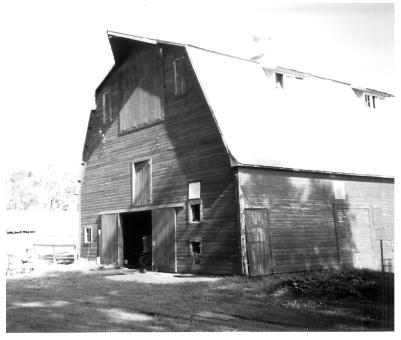
**ROLL NUMBER:** PHOTO NUMBER: 8

Looking NW, SE corner
