SITE INFORMATION

STRUCTURE DETAILS

CLAY CO., SD

HISTORY

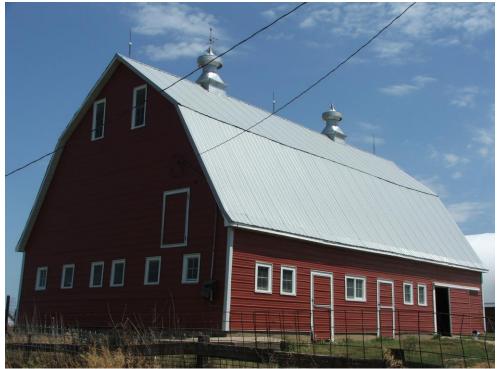
DATE OF PHOTO: July 20, 2012 PHOTO NUMBER: 1

CAMERA DIRECTION: Looking NE, SW corner

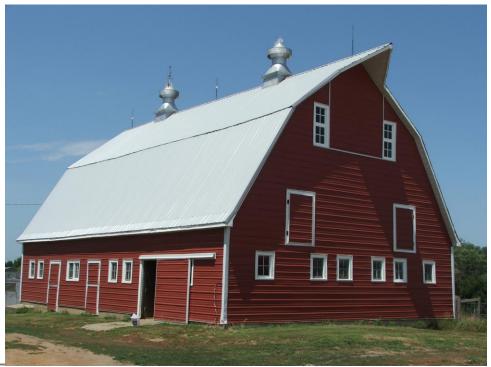
PHOTOGRAPHER: Jim Stone ROLL NUMBER: DATE OF PHOTO: July 20, 2012 PHOTO NUMBER: 2
CAMERA DIRECTION: Looking NW, SE corner

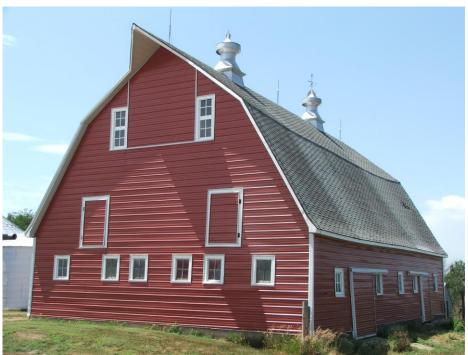
PHOTOGRAPHER: Jim Stone ROLL NUMBER: DATE OF PHOTO: July 20, 2012 PHOTO NUMBER: 3

CAMERA DIRECTION: Looking SW, NE corner

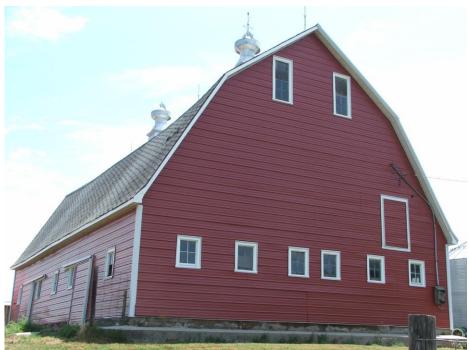
PHOTOGRAPHER: Jim Stone ROLL NUMBER: DATE OF PHOTO: July 20, 2012 PHOTO NUMBER: 4

CAMERA DIRECTION: Looking SE, NW corner

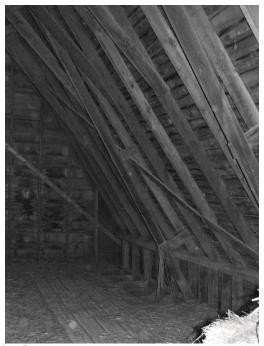
Hayloft, looking West, lower wall and rafter

CAMERA DIRECTION: bracing

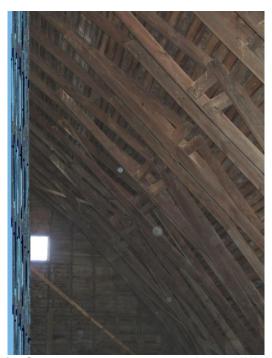
10

CAMERA DIRECTION: upper rafter bracing

Hayloft, looking West,
