SITE INFORMATION					
*SURVEY DATE: December 2,	2013 *ADDRESS: 926 E. 316 th Street				
*SURVEYOR: Jim Stone					
	*CITY: Vermillion				
LOCATION DESCRIPTION: From Vermillion, from intersection of South Dakota Highway 50 bi-pass and					
University Road, North 1 mile to 316th Street, turn right (East) about ¼ mile on the left (North) side					
LEGAL DESCRIPTION: Lot C of Lot 1 in SW ¼, 6 – 92 – 51 Vermillion Twp.					
*QUARTER 1:SW 1/4	OWNER NAME:Jeffery S. & Carolyn A. Jensen				
*QUARTER 2:	OWNER ADDRESS: 926 E. 316th Street				
*TOWNSHIP: Vermillion	OWNER CITY: Vermillion				
*RANGE: <u>51</u>	OWNER STATE: South Dakota				
*SECTION: 6	OWNER ZIP: 57069				
ACRES: 3.91	QUAD NAME:				
OWNER CODE 1: P					
OWNER CODE 2:					
OWNER CODE 3:					
HISTORIC SIGNIFICANCE					
HISTORIC SIGNIFICANCE					
*DOE:	REGISTER NAME:				
*DOE DATE:	MULTIPLE PROPERTY NAME:				
REASON INELIGIBLE:					
	CATEGORY:				
NOMINATION STATUS:	SIGNIFICANCE LEVEL 1: N S L

STRUCTURE DETAILS

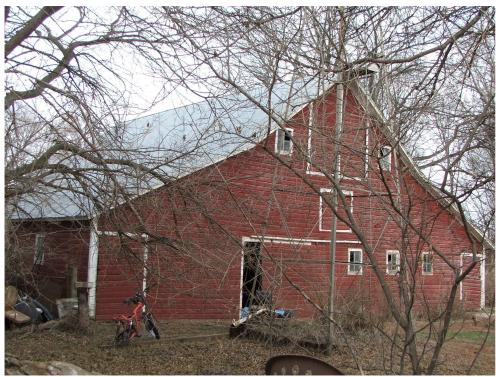
Looking NE, SW corner

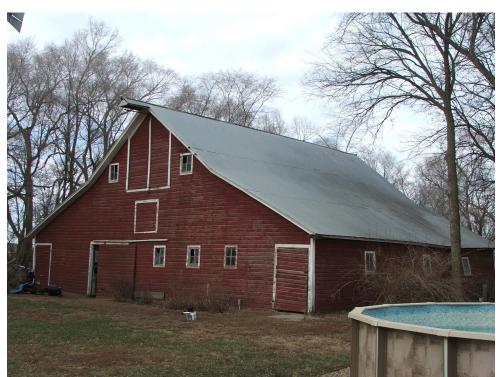
CAMERA DIRECTION: Looking NW, SE corner

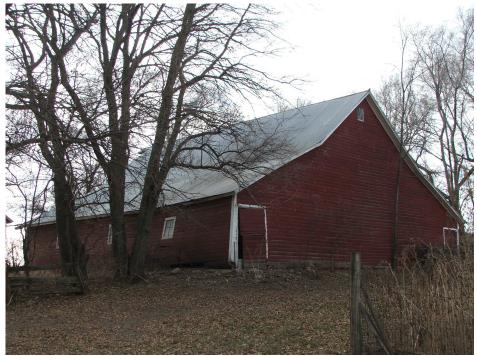
CAMERA DIRECTION: Looking SW, NE corner

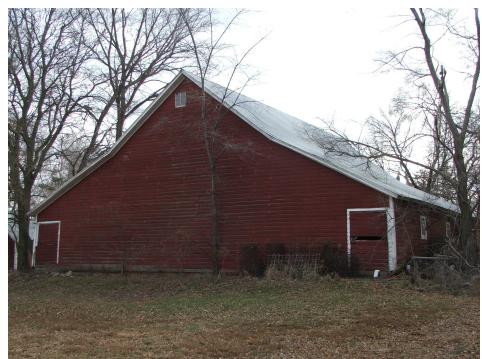
CAMERA DIRECTION: Looking SE, NW corner

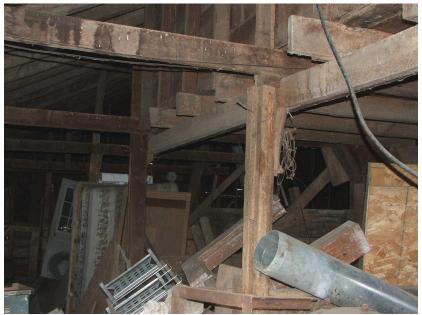
First floor, West lean-to looking NE, double horse stalls on West side, note hayloft above two South

CAMERA DIRECTION: stalls.

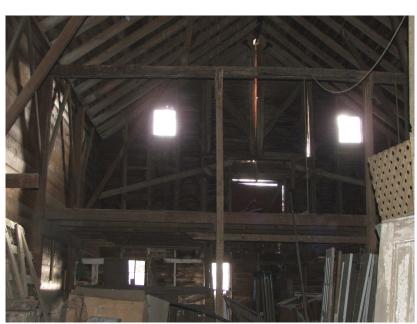
First floor, looking South, hayloft floor at

CAMERA DIRECTION: the South 16'.

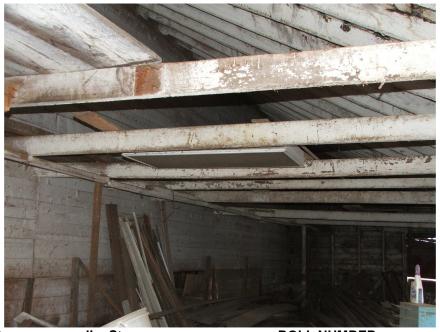
First floor, East lean-to, looking NW, where the milk cow stanchions were, note 1x8 shiplap on West wall and 2x6

CAMERA DIRECTION: open joists 4' O. C.
