**SOUTH DAKOTA STATE HISTORIC PRESERVATION OFFICE
HISTORIC SITES SURVEY STRUCTURE FORM**

*SURVEY DATE: February 1, 2013 *ADDRESS: 30165 University Road
*SURVEYOR: Jim Stone *COUNTY: Clay
*CITY: Beresford

CURRENT FUNCTION: <u>Vacant</u>	FOUNDATION: <u>Poured concrete foundation</u>
CURRENT SUBFUNCTION: <u>Vacant</u>	ROOF MATERIAL: <u>Steel roofing over cedar shingles</u>
HISTORIC FUNCTION: <u>Livestock barn</u>	ROOF SHAPE: <u>Gable</u>
HISTORIC SUBFUNCTION: <u>Hay and grain storage</u>	STRUCTURAL SYSTEM: <u>Balloon framing</u>
OCCUPIED: <u>Yes</u>	STYLE: <u>Gable roof barn</u>
ACCESSIBLE: <u>Yes with permission</u>	TYPE: <u>Livestock barn</u>
	<u>2x6 studs, 1x6 #106 drop siding & steel roofing</u>
WALLS: _____	
STORIES: <u>2</u>	SIGNIFICANT PERSON: <u>H. J. Carlson</u>
*DATE OF CONSTRUCTION: <u>1890 to 1910</u>	CULTURAL AFFILIATION: <u>Swedish</u>

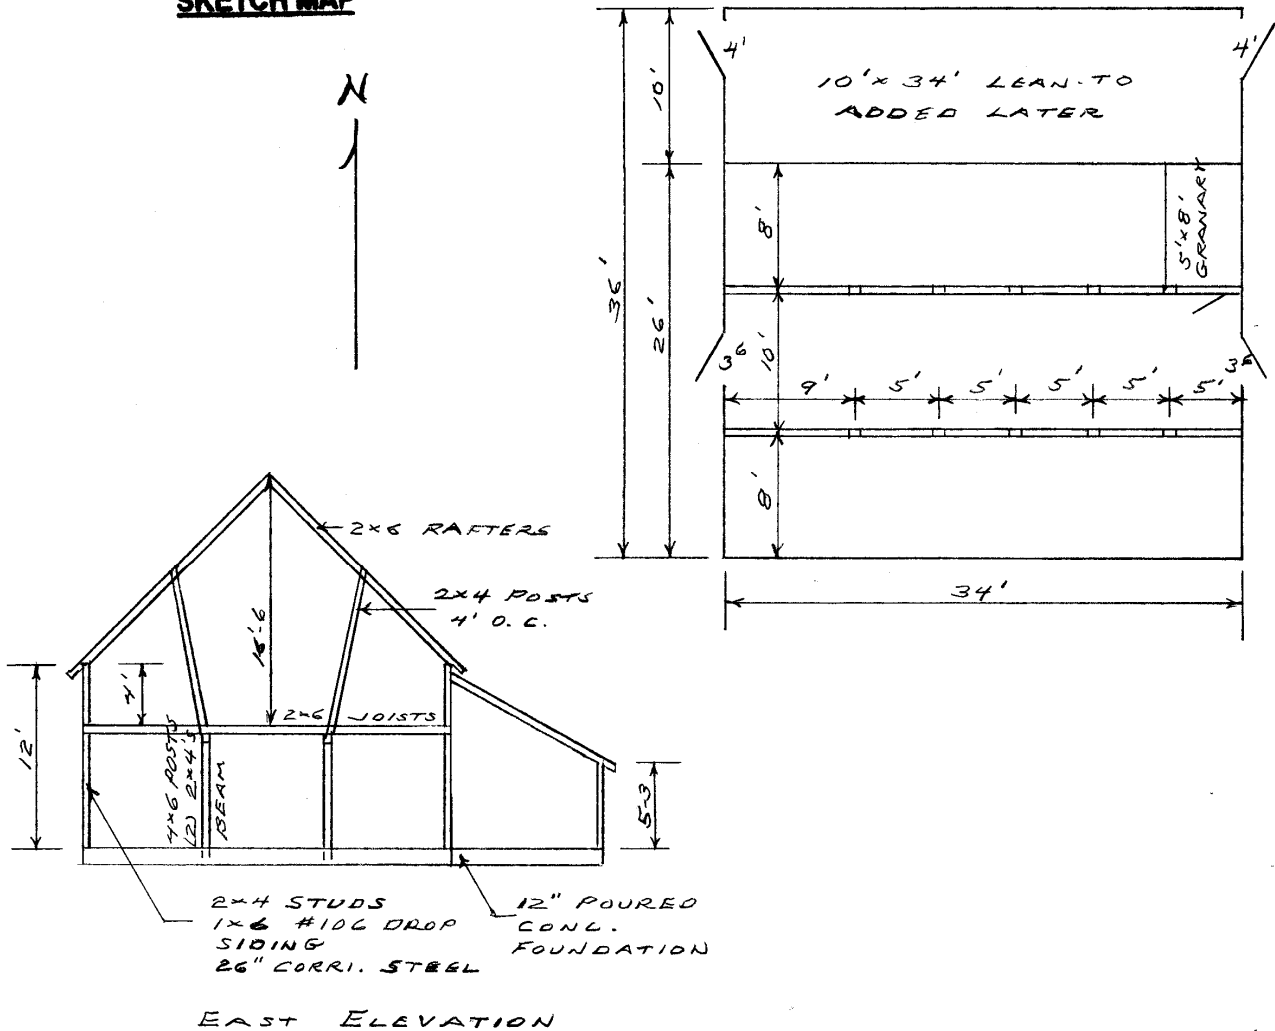
EAST ELEVATION

2x4 STUDS
1x6 #106 DROP SIDING
26" CORR. STEEL
12" POURED CONG. FOUNDATION

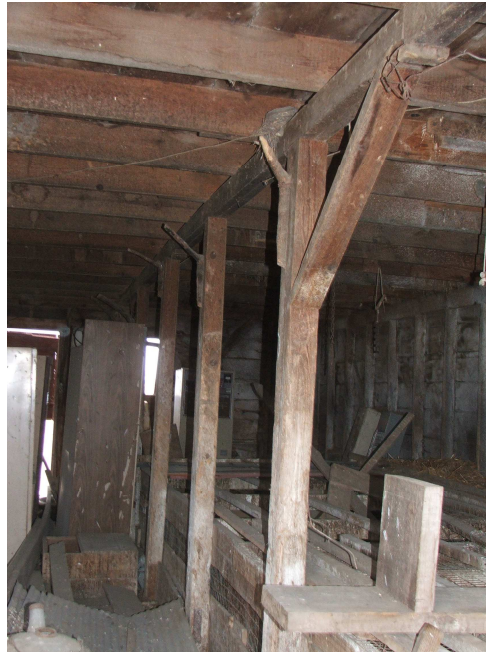
ROLL NUMBER: _____
PHOTO NUMBER: 5

CAMERA DIRECTION: First floor, looking SE,
Double 2x4 beam, 4x6
posts, 5' O. C.

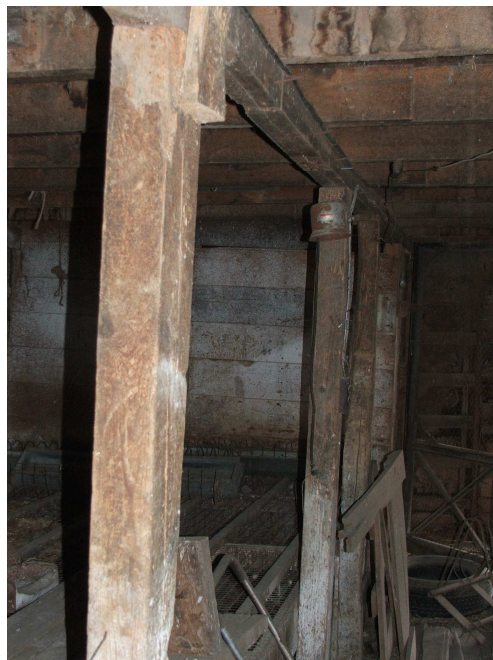
ROLL NUMBER: _____
PHOTO NUMBER: 6

CAMERA DIRECTION: First floor, looking NE,
posts and beam and
granary in the NE corner

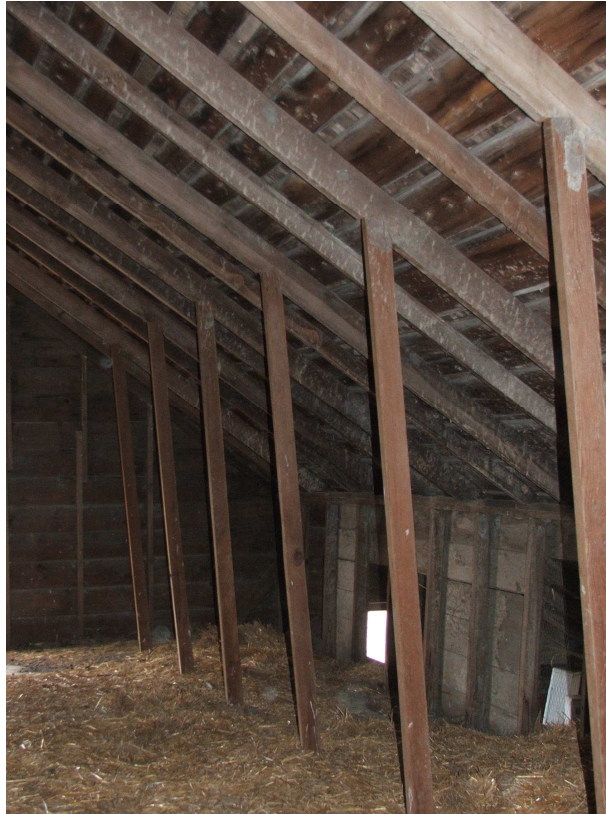
ROLL NUMBER: _____
PHOTO NUMBER: 7

CAMERA DIRECTION: Hayloft, looking NW, 2x4 posts 4' O. C. supporting rafters.
