SITE INFORM	ATION											
*SURVEY DATE: August 16, 2		6, 2013	30376 458 th Ave.									
*SURVEYOR: Jim Stone			*COUNTY:	NTY: Clay								
			*CITY:	Wako	nda							
LOCATION DESCR												
South Dakota Highway 19, North about 13 miles to 304 th Street, turn left (West) about 4 miles to 458 th Ave., turn right (North) about ½ mile, on the right (East) side.

STRUCTURE DETAILS

CLAY CO., SD

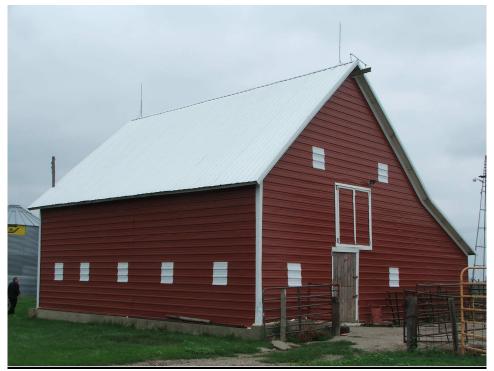
Looking NE, SW corner

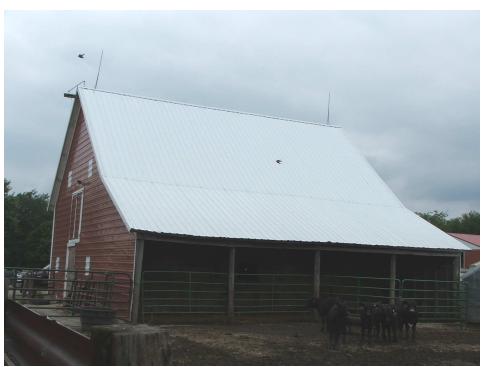
CAMERA DIRECTION: Looking NW, SE corner

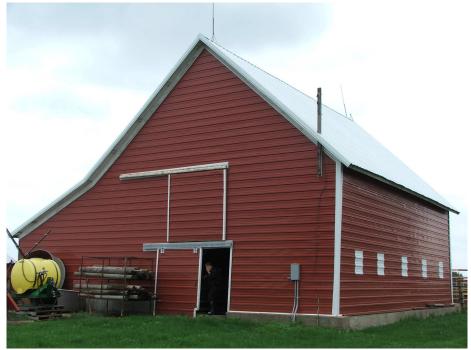
PHOTOGRAPHER: Jim Stone ROLL NUMBER: DATE OF PHOTO: August 16, 2013 PHOTO NUMBER: 3

CAMERA DIRECTION: Looking SE, NW corner
