**SOUTH DAKOTA STATE HISTORIC PRESERVATION OFFICE
HISTORIC SITES SURVEY STRUCTURE FORM**

*SURVEY DATE: December 2, 2013 *ADDRESS: 30630 Frog Creek Road
*SURVEYOR: Jim Stone *COUNTY: Clay
*CITY: Wakonda

CURRENT FUNCTION: Cattle shelter and calving barn

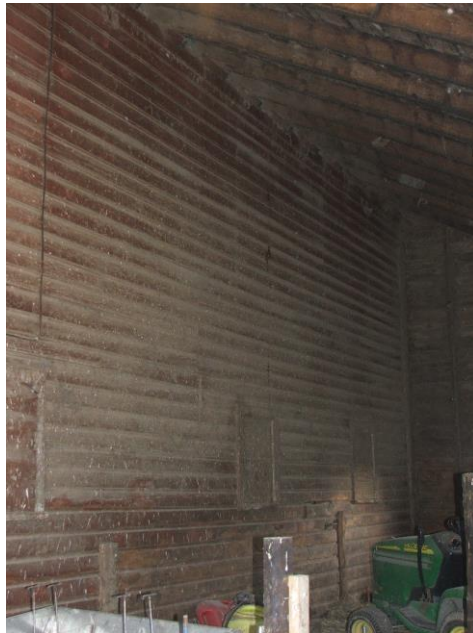
ROLL NUMBER: _____
PHOTO NUMBER: 5

CAMERA DIRECTION: First floor, West lean-to, looking SE, 16' tall wall on the West side of original barn.

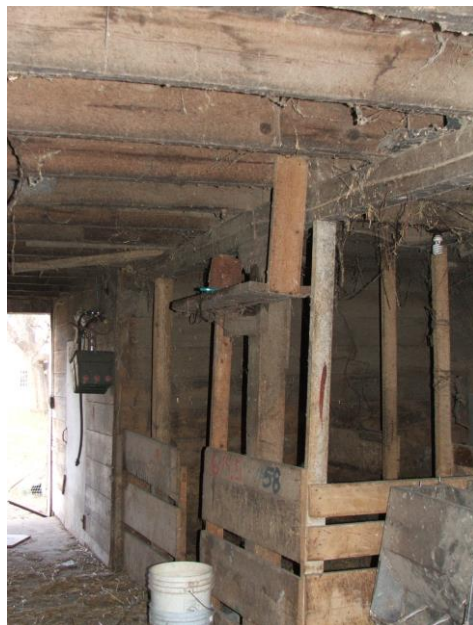
ROLL NUMBER: _____
PHOTO NUMBER: 6

CAMERA DIRECTION: First floor, center barn, looking NE, 4x6 posts, 4x6 beam, 2x8 floor joists, Granary in the NE corner.
