**SOUTH DAKOTA STATE HISTORIC PRESERVATION OFFICE
HISTORIC SITES SURVEY STRUCTURE FORM**

*SURVEY DATE: December 2, 2013 *ADDRESS: 30630 Frog Creek Road
*SURVEYOR: Jim Stone *COUNTY: Clay
*CITY: Wakonda

<p>CURRENT FUNCTION: <u>Cattle shelter and calving barn</u></p> <p>CURRENT SUBFUNCTION: <u>Storage</u></p> <p>HISTORIC FUNCTION: <u>Livestock barn</u></p> <p>HISTORIC SUBFUNCTION: <u>Hay and grain storage</u></p> <p>OCCUPIED: <u>Tes</u></p> <p>ACCESSIBLE: <u>Yes with permission</u></p> <p>STORIES: <u>2</u></p> <p>*DATE OF CONSTRUCTION: <u>1910 to 1925</u></p>	<p>FOUNDATION: <u>Poured concrete</u></p> <p>ROOF MATERIAL: <u>Steel roofing over cedar shingles</u></p> <p>ROOF SHAPE: <u>Gable roof</u></p> <p>STRUCTURAL SYSTEM: <u>Balloon framing</u></p> <p>STYLE: <u>Western feeder barn</u></p> <p>TYPE: <u>Livestock barn</u></p> <p><u>2x6 studs, 1x6 #106 drop siding and some steel roofing</u></p> <p>WALLS: _____</p> <p>SIGNIFICANT PERSON: <u>Hans Bilden</u></p> <p>CULTURAL AFFILIATION: <u>?</u></p>
---	---

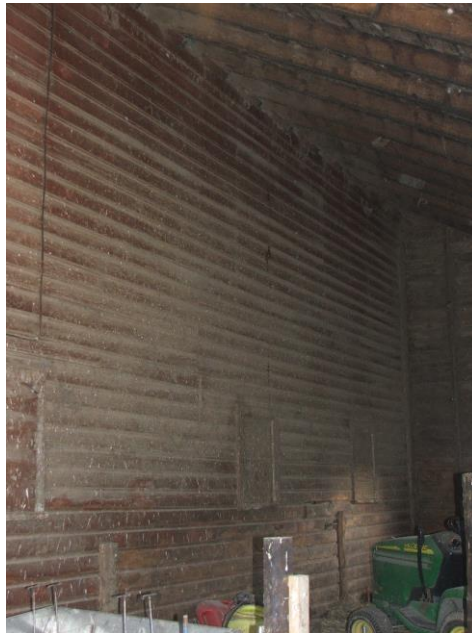
ROLL NUMBER: _____
PHOTO NUMBER: 5

CAMERA DIRECTION: First floor, West lean-to, looking SE, 16' tall wall on the West side of original barn.

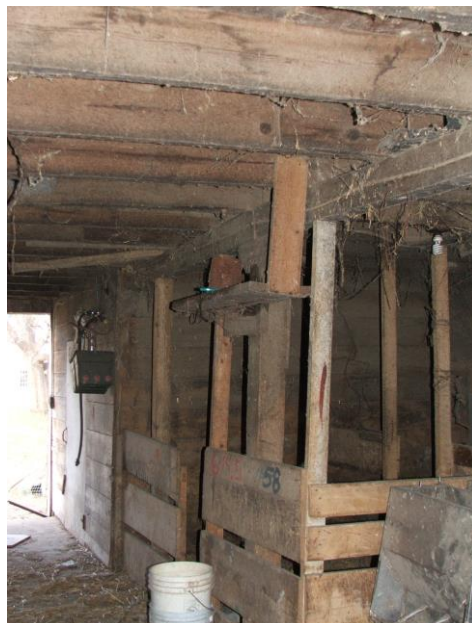
ROLL NUMBER: _____
PHOTO NUMBER: 6

INTERIOR NOTES: Two rows of 4x6 posts and 4x6 beams with 2x8 floor joists for the hayloft floor. 10'x10' granary still in place in the NE corner of the original barn. 3 double horse stalls were on the East wall of the center barn. 6' x 10' calf pens have been added on the West side in the center barn.

CAMERA DIRECTION: First floor, center barn, looking NE, 4x6 posts, 4x6 beam, 2x8 floor joists, Granary in the NE corner.

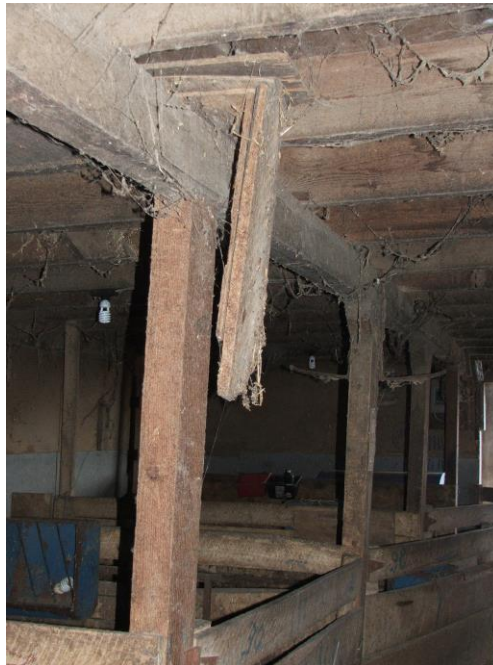
ROLL NUMBER: _____
PHOTO NUMBER: 7

**First floor, center barn,
looking NW, 4x6 posts ,
4x6 beam, 2x8 floor
joists for the hayloft
floor.**

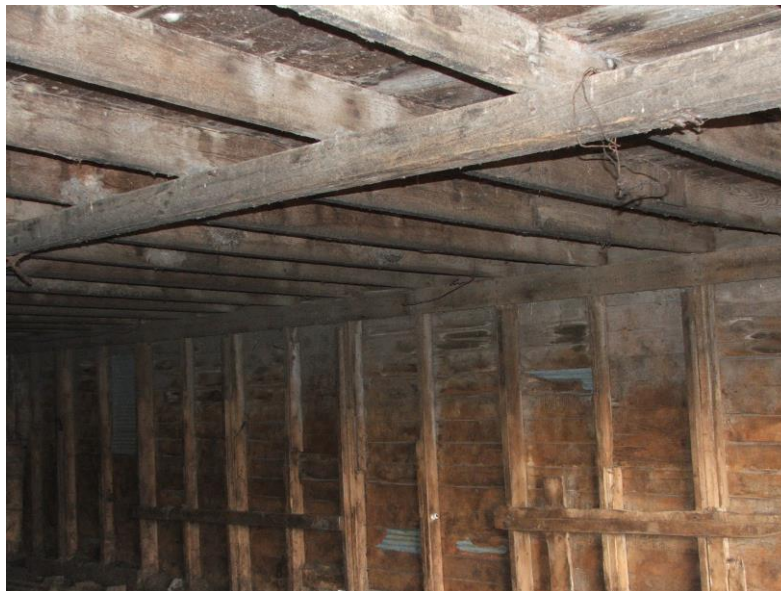
ROLL NUMBER: _____
PHOTO NUMBER: 8

**First floor, East lean-to,
looking NE, 2x6 stud
walls and 2x8 joists for
hayloft floor.**

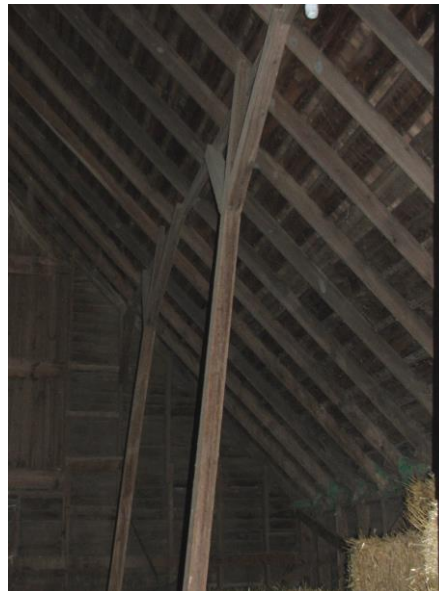
ROLL NUMBER: _____
PHOTO NUMBER: 9

OTHER NOTES: 2x6 stud walls with 1x6 #106 drop siding on all exterior walls and on the two tall walls of the original barn which are now inside the added lean-to's. Rafters are 2x6's. Two rows of 4x4 posts and a 2x6 beam support the center of the rafters in the hayloft. The posts are 10' - 8' - 8' - 10' O. C.

**Hayloft, looking SW,
West row of 4x4 posts
and 2x6 beam
supporting center of
rafters.**

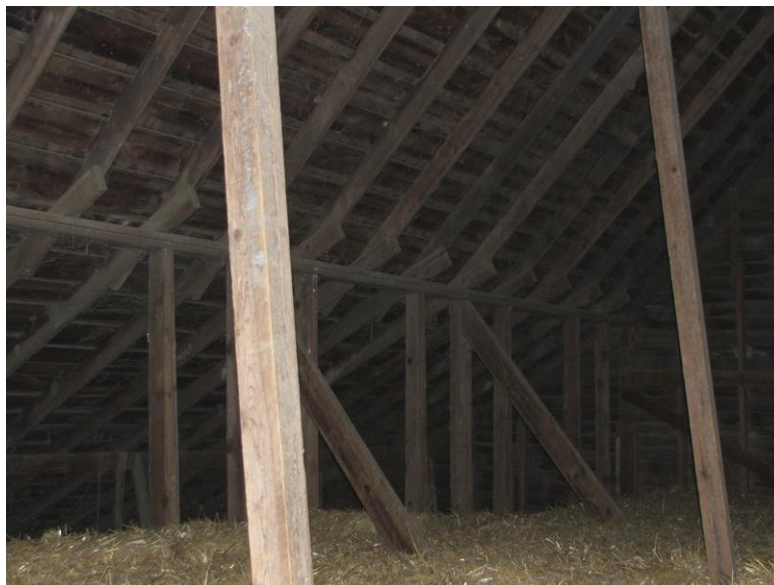
ROLL NUMBER: _____
PHOTO NUMBER: 10

A 2x8 brace from the top of the wall on the hayloft down to the floor also are 10' - 8' - 8' - 10' O. C. Windows are 4" x 24" four light. Cupola has been removed. Foundation is higher on the West lean-to and lower on the East lean-to to fit the slope of the hillside.

**Hayloft, looking into
hayloft over East lean-to,
note open studs and 2x8
bracing from top of wall
down to the floor,**

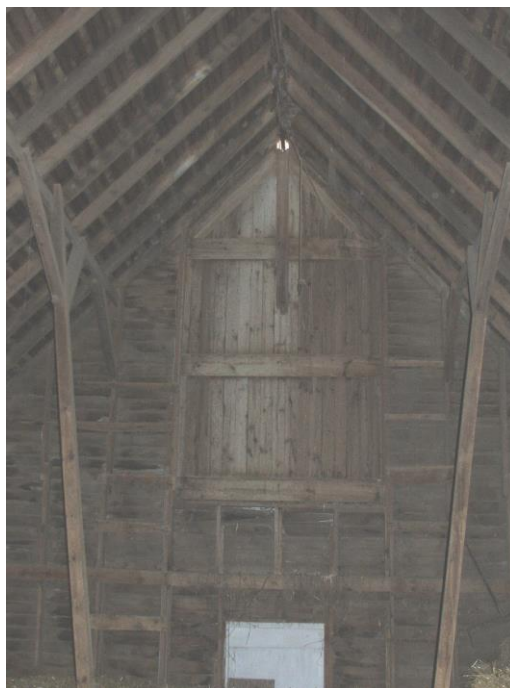
ROLL NUMBER: _____
PHOTO NUMBER: 11

CAMERA DIRECTION: Hayloft, looking South,
South gable end wall and
hayloft door.
