**SOUTH DAKOTA STATE HISTORIC PRESERVATION OFFICE
HISTORIC SITES SURVEY STRUCTURE FORM**

*SURVEY DATE: March 15, 2013 *ADDRESS: 29781 470th Ave.
*SURVEYOR: Jim Stone *COUNTY: Clay
*CITY: Beresford

CURRENT FUNCTION:	<u>Cattle</u>	FOUNDATION:	<u>Poured concrete</u>
CURRENT SUBFUNCTION:	<u>Hay storage</u>	ROOF MATERIAL:	<u>Steel over cedar shingles</u>
HISTORIC FUNCTION:	<u>Livestock barn</u>	ROOF SHAPE:	<u>Gable</u>
HISTORIC SUBFUNCTION:	<u>Hay storage</u>	STRUCTURAL SYSTEM:	<u>Balloon framing</u>
		STYLE:	<u>Gable roof barn</u>
OCCUPIED:	<u>Yes</u>	TYPE:	<u>Livestock barn</u>
			<u>2x6 studs, 1x4</u>
ACCESSIBLE:	<u>Yes with permission</u>	WALLS:	<u>#106 drop siding & steel roofing</u>
STORIES:	<u>2</u>	SIGNIFICANT PERSON:	<u>Hans Christenson</u>
*DATE OF CONSTRUCTION:	<u>Early 1900's</u>	CULTURAL AFFILIATION:	<u>?</u>

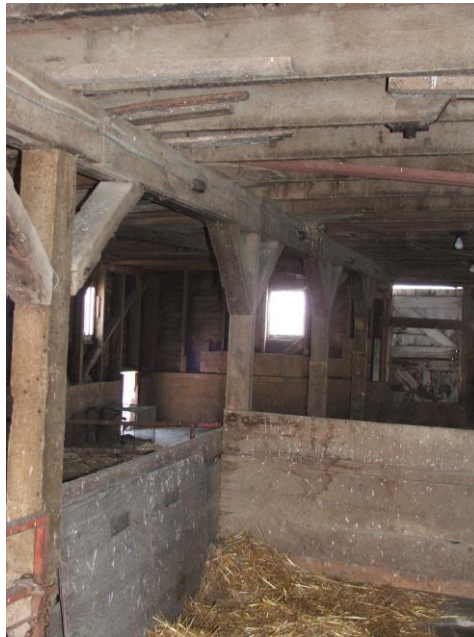
ROLL NUMBER: _____
PHOTO NUMBER: 5

CAMERA DIRECTION: First floor, looking SE,
4x6 posts, (4) 2x8's
laminated beam & 2x8
floor joists

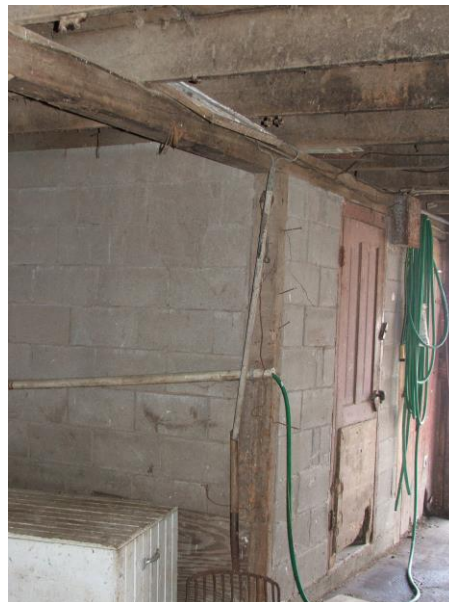
ROLL NUMBER: _____
PHOTO NUMBER: 6

CAMERA DIRECTION: First floor, looking NW,
6' x 8' concrete block
milk room and 4' x 8'
granary in NW corner of
main barn

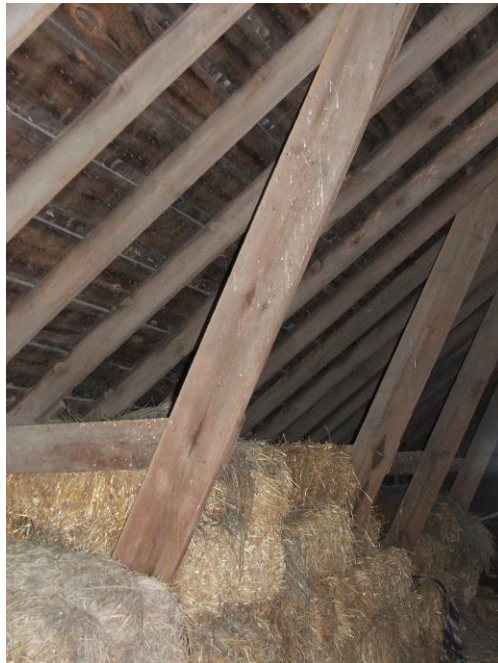
ROLL NUMBER: _____
PHOTO NUMBER: 7

**Hayloft, looking SE, 2x6
rafters and 2x10 brace 8'
O. C.**

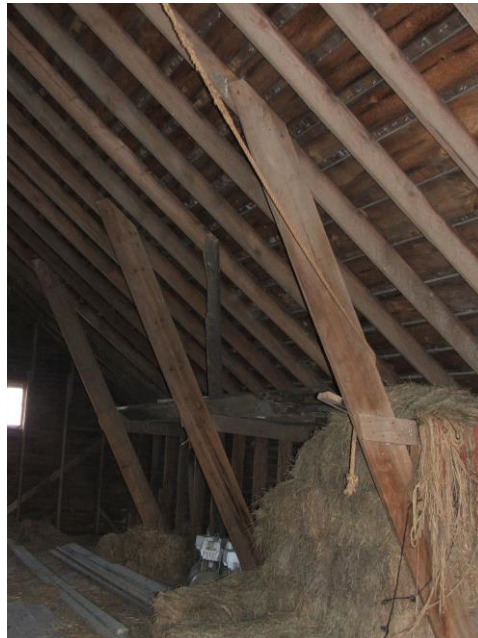
ROLL NUMBER: _____
PHOTO NUMBER: 8

**Hayloft, looking SW,
2x10 brace 8' O. C. and
4x6 studs supporting
floor and roof between
barn and lean-to**
