**SOUTH DAKOTA STATE HISTORIC PRESERVATION OFFICE  
HISTORIC SITES SURVEY STRUCTURE FORM**

\*SURVEY DATE: October 6, 2012 \*ADDRESS: 30917 466th Ave.

\*SURVEYOR: Jim Stone \*COUNTY: Clay  
\*CITY: Vermillion

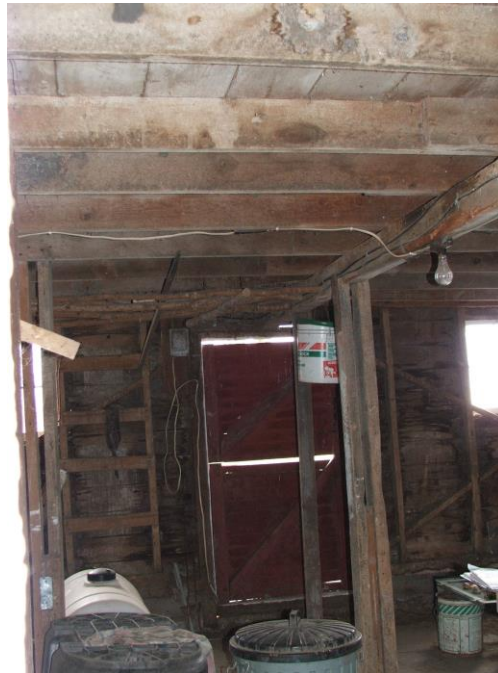
**ROLL NUMBER:** 5  
**PHOTO NUMBER:** 5

**CAMERA DIRECTION:** First floor, looking South, posts, 4x6 beam and 2x6 floor joists

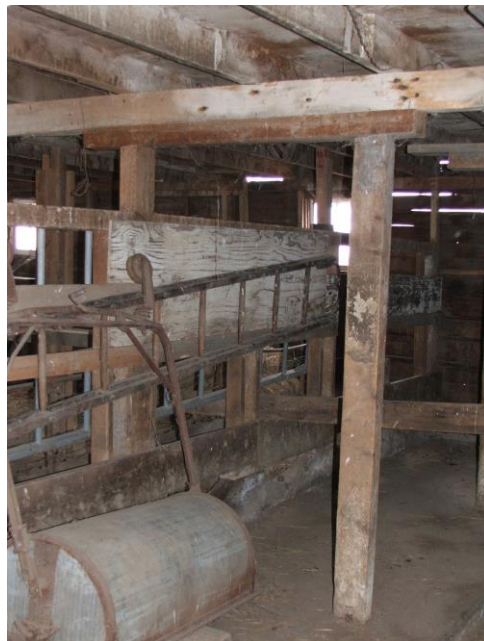
**ROLL NUMBER:** 6  
**PHOTO NUMBER:** 6

**ALTERED/MOVED NOTES:** Original site. Roof has been covered with 26" wide galvanized corrugated steel roofing. Horse stalls have been removed. Milk cow stanchions have been removed, but feed trough is still in place. Some of the 4x6 posts have been replaced with round posts.

**CAMERA DIRECTION:** First floor, looking SW, location of milk cow stanchions, note feed trough

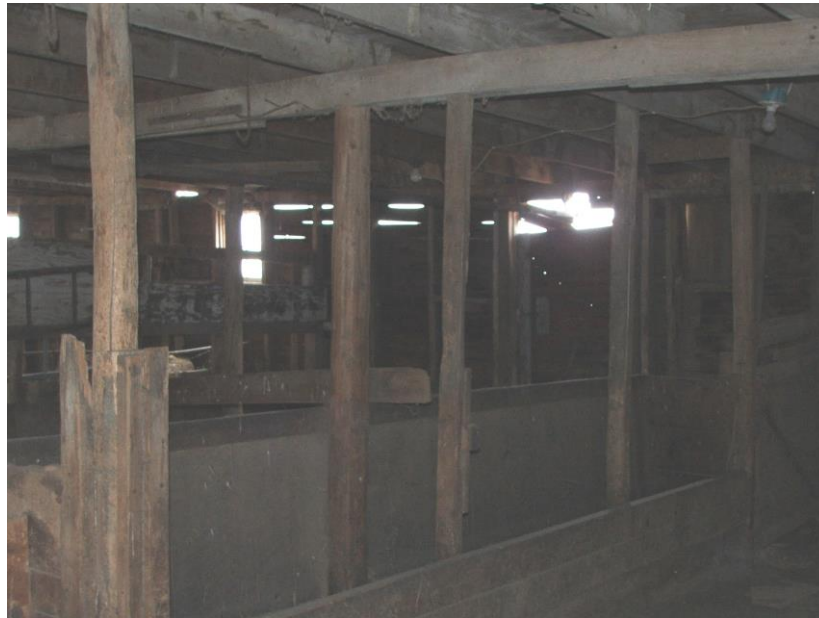
**ROLL NUMBER:** \_\_\_\_\_  
**PHOTO NUMBER:** 7

**CAMERA DIRECTION:** First floor, looking SW,  
silage feed bunk for milk  
cows

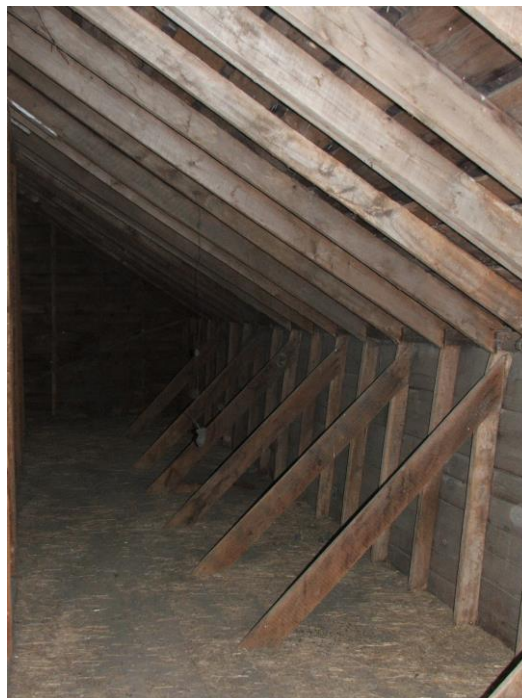
**ROLL NUMBER:** \_\_\_\_\_  
**PHOTO NUMBER:** 8

**\*PHYSICAL NOTES:** Barn is in good condition. Needs some work and needs tie bracing at the top of the East and West walls, which are bowing out slightly. Janet Beeman painted a barn quilt on the East gable end. No history on the design, just a design that Janet picked out. Janet is an art teacher in the Vermillion Public Schools.

**CAMERA DIRECTION:** Hayloft, looking North,  
1 x 6 bracing from top of  
wall down to floor joists

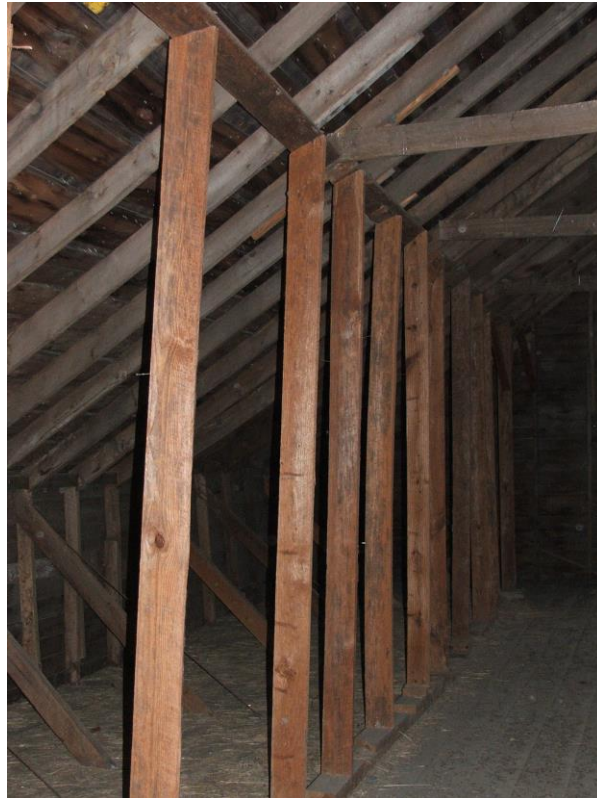
**ROLL NUMBER:** 9  
**PHOTO NUMBER:** 9

**CAMERA DIRECTION:** Hayloft, looking North,  
2x6 posts 4' O.C.  
supporting center of  
rafters, all rough sawn  
cottonwood
