**SOUTH DAKOTA STATE HISTORIC PRESERVATION OFFICE
HISTORIC SITES SURVEY STRUCTURE FORM**

*SURVEY DATE: October 30, 2012 *ADDRESS: 46951 306th Street
*SURVEYOR: Jim Stone *COUNTY: Clay
*CITY: Beresford

CURRENT FUNCTION: Storage

HISTORIC FUNCTION: Livestock barn

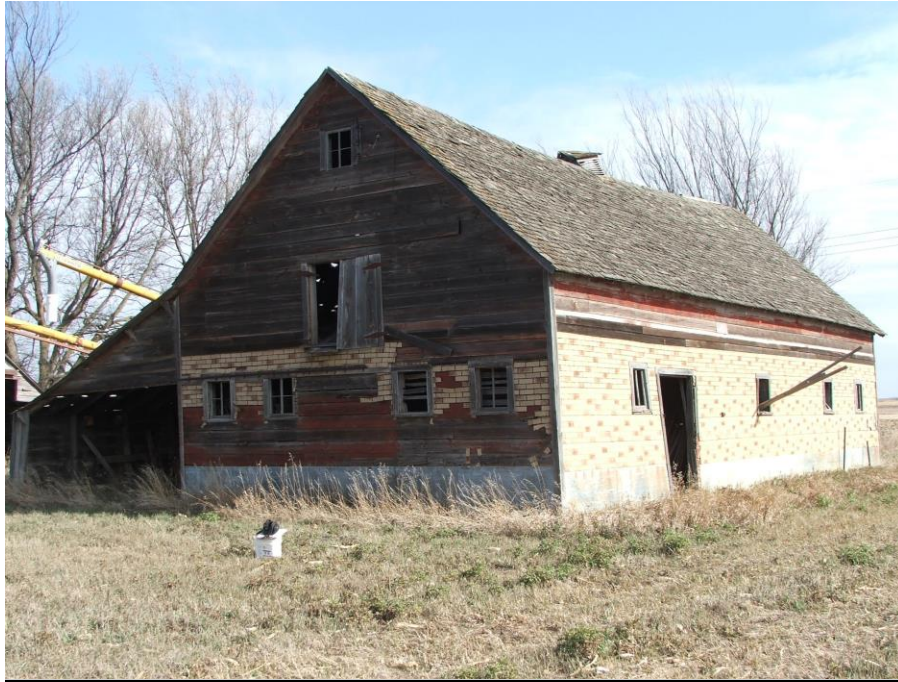
ROLL NUMBER: _____
PHOTO NUMBER: 1
CAMERA DIRECTION: Looking NE, SW corner

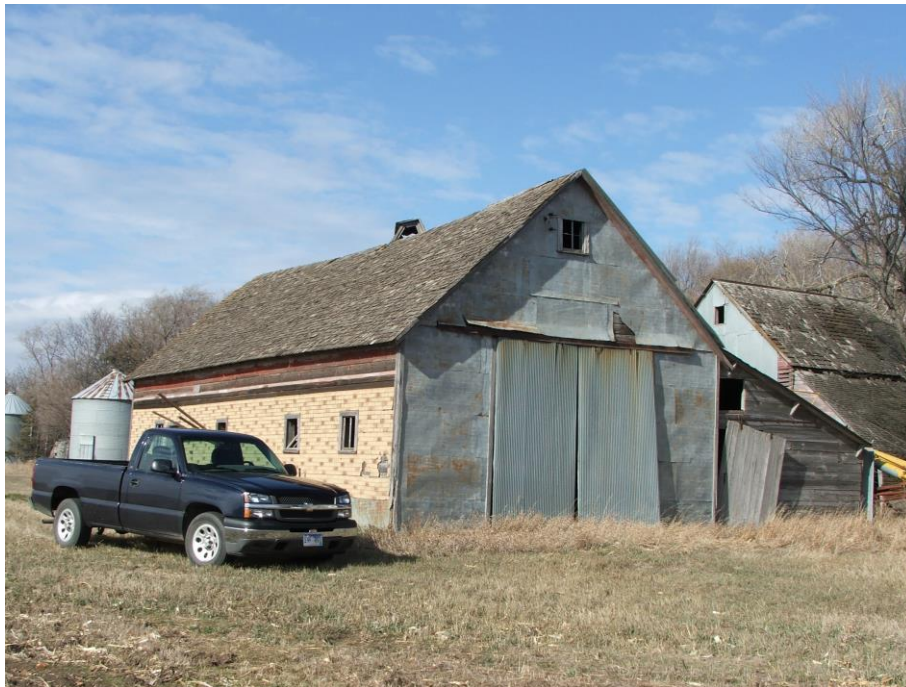
ROLL NUMBER: _____
PHOTO NUMBER: 2
CAMERA DIRECTION: Looking NW, SE corner

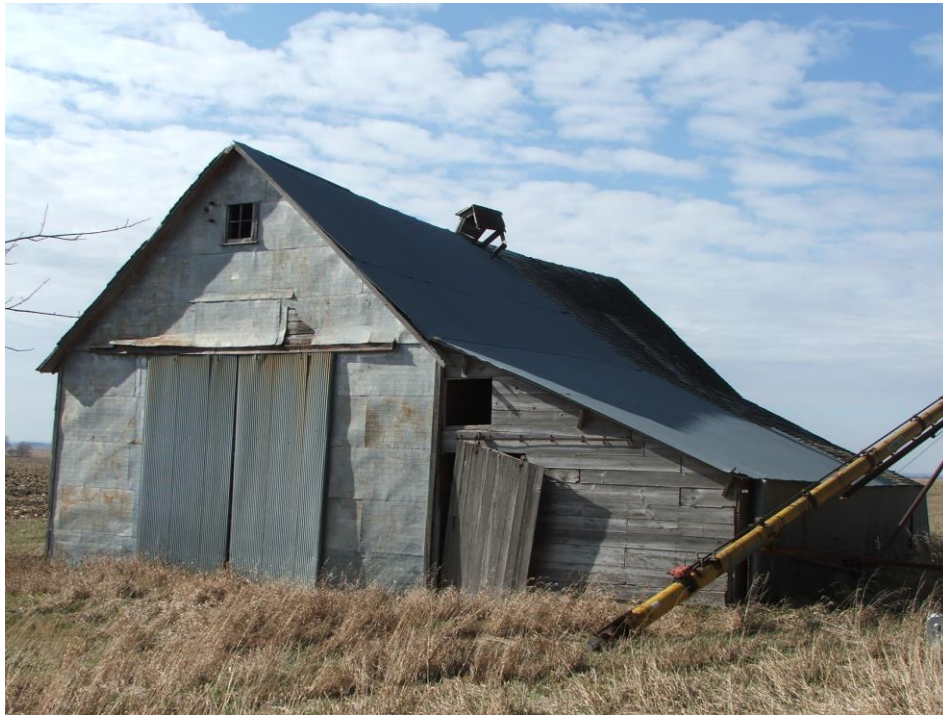
ROLL NUMBER: _____
PHOTO NUMBER: 3
CAMERA DIRECTION: Looking SW, NE corner

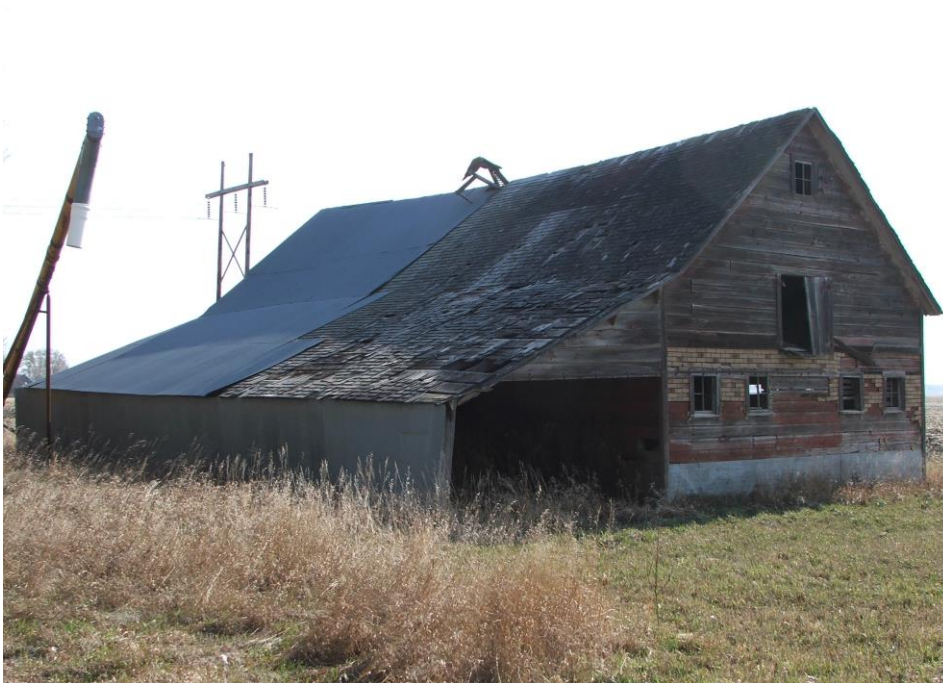
ROLL NUMBER: _____
PHOTO NUMBER: 4
CAMERA DIRECTION: Looking SE, NW corner

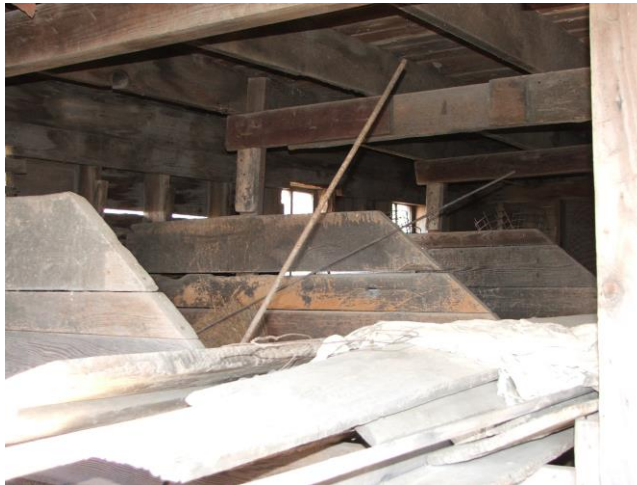
ROLL NUMBER: 5
PHOTO NUMBER: 5

INTERIOR NOTES: Has three rows of 4x6 posts with (2) 2x6's for beams and (2) 2X8's for center beam. All posts and beams removed from East 30'. May have only been a center beam in that area, as there is a 2x4 solid dividing wall between. Four single horse stalls on West wall still in place.

CAMERA DIRECTION: First floor, looking NW,
5' wide horse stalls on
West wall

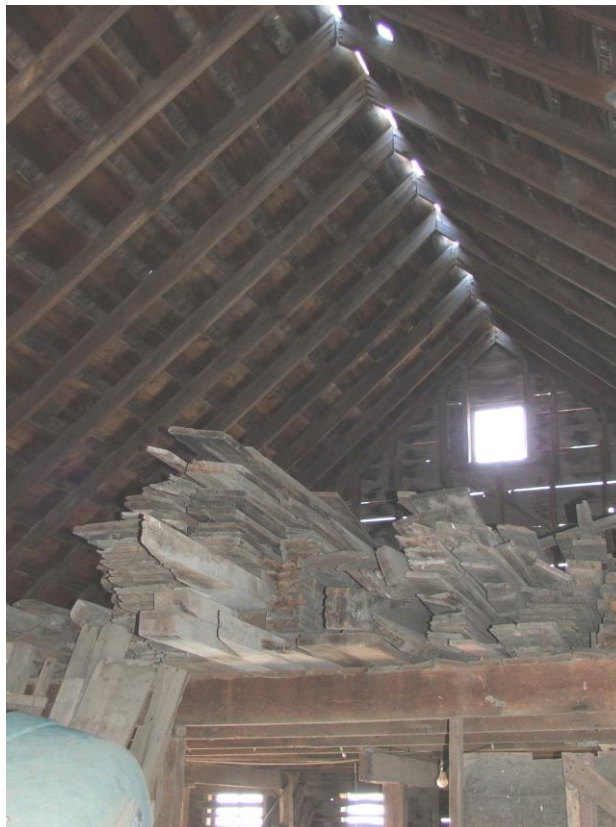
ROLL NUMBER: 6
PHOTO NUMBER: 6

CAMERA DIRECTION: First floor, East side,
looking up into hayloft
that is still in place

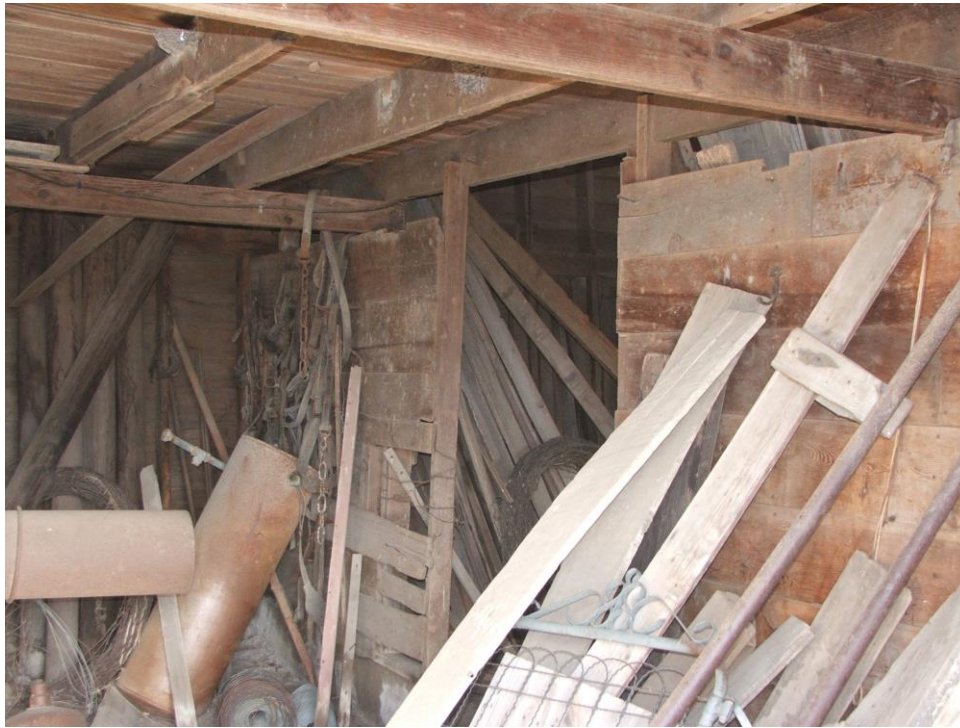
ROLL NUMBER: _____
PHOTO NUMBER: 7

CAMERA DIRECTION: First floor, looking NE,
solid wall dividing West
18' from East 30'
