SOUTH DAKOTA STATE HISTORIC PRESERVATION OFFICE
HISTORIC SITES SURVEY STRUCTURE FORM

*SURVEY DATE: October 30, 2012 *ADDRESS: 46952 306th Street
*SURVEYOR: Jim Stone *COUNTY: Clay
*CITY: Beresford

CURRENT SUBFUNCTION: Storage ROOF MATERIAL: _____
 HISTORIC FUNCTION: Livestock barn ROOF SHAPE: Gable
 HISTORIC SUBFUNCTION: Hay storage STRUCTURAL SYSTEM: Balloon framing

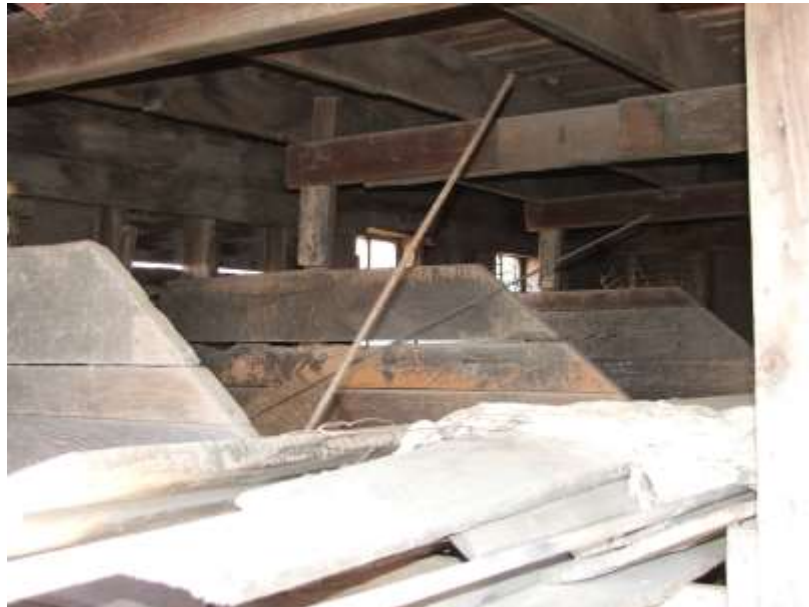
ROLL NUMBER: _____
PHOTO NUMBER: 5

INTERIOR NOTES: Has three rows of 4 x6 posts with (2) 2x6's for beams and (2) 2x8's for a center beam. All posts and beams removed from East 30'. May have only been a center beam in that area, as there is a 2x4 solid dividing wall between. Four single horse stalls on the West wall still in place.

CAMERA DIRECTION: First floor, looking NW,
5' wide horse stalls on
the West wall.

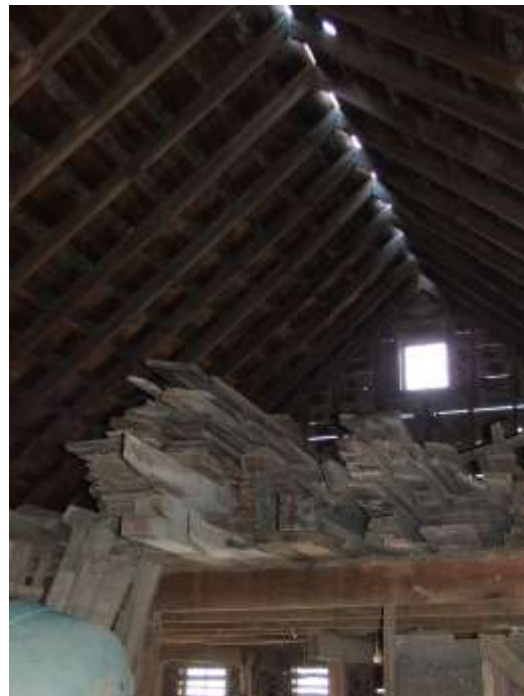
ROLL NUMBER: _____
PHOTO NUMBER: 6

CAMERA DIRECTION: First floor. looking West,
into hayloft that is still in
place

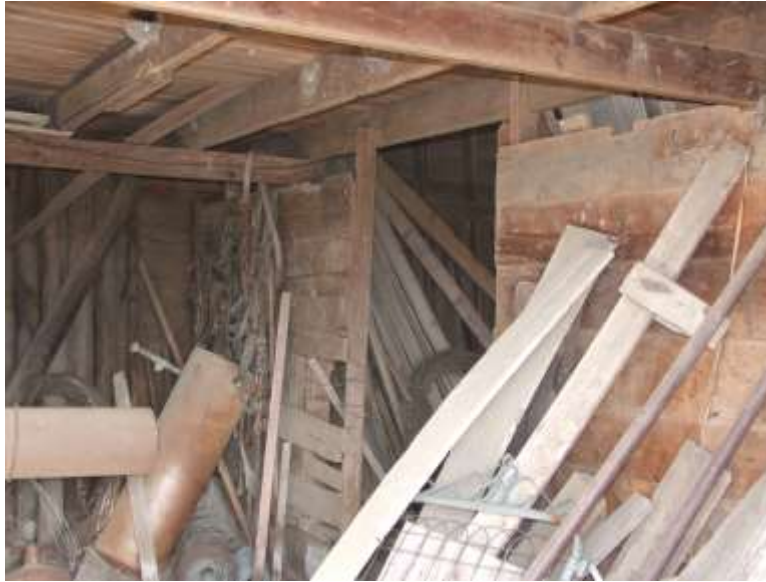
ROLL NUMBER: _____
PHOTO NUMBER: 7

CAMERA DIRECTION: First floor, looking NE,
solid wall dividing west
side from the East side.
