SITE INFORM	<u>ATION</u>					
*SURVEY DA	TE: September	er 3, 2013 *ADDRESS	: _31417 Bluff road Road			
*SURVEY	OR: Jim Stone	e *COUNTY	ː Clay			
		*CITY	: Vermillion			
LOCATION DESCR	IPTION: From Ver	million, intersection of South	Dakota Highway 50 bi-pass and			
South Dakota High	way 19, North about	1-1/4 miles to Bluff Road, tur	n left (West) and follow Bluff Road			
about 2-3/4 miles, o	on the left (West) sid	le.				
LEGAL DESCRIPTION: NE 1/4, NE ¼, 33 – 93 – 52 Spirit Mound Twp.						
*QUARTER 1:	NE 1/4	OWNER NAME:	Richard & Sally Abild			
*QUARTER 2:		OWNER ADDRESS:	31418 Bluff Road			
*TOWNSHIP:	Spirit Mound	OWNER CITY:	Vermillion			
*RANGE:	52	OWNER STATE:	So. Dak.			
*SECTION:	33	OWNER ZIP:	57069			
ACRES:	39.68	QUAD NAME:				
OWNER CODE 1:	Р					
OWNER CODE 2:						
OWNER CODE 3:						
HISTORIC SIGN	IEICANCE					
IIIOTORIO GIGIA	II IOANOL					
*D(OE:	REGISTER N	REGISTER NAME:			
*DOE DA	TE:	MULTIPLE P	ROPERTY NAME:

STRUCTURE DETAILS

SHPO ID:		_				
*PROPERTY NAME:						
OTHER NAME:						
CURRENT FUNCTION:	Storage	FOUNDATION	and the second s			
CURRENT SUBFUNCTION:	Storage	ROOF MATERIAL	Steel roofing over cedar shingles			
HISTORIC FUNCTION:	Livestock barn	ROOF SHAPE	: G

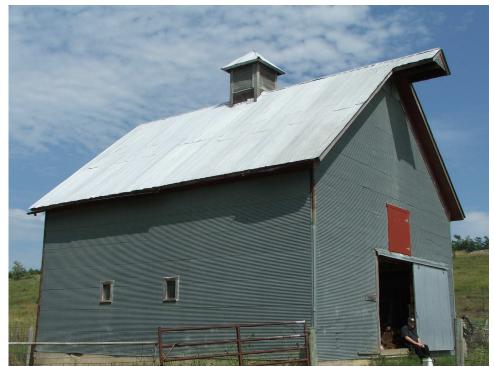
Looking NE, SW corner

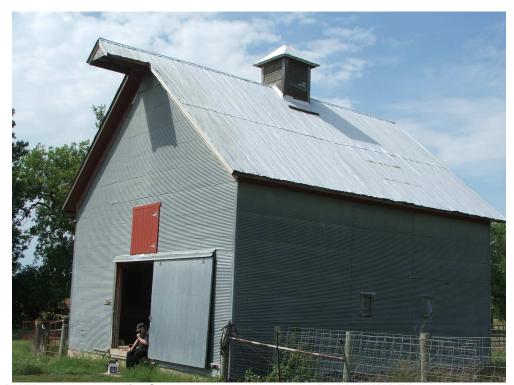
CAMERA DIRECTION: Looking NW, SE corner

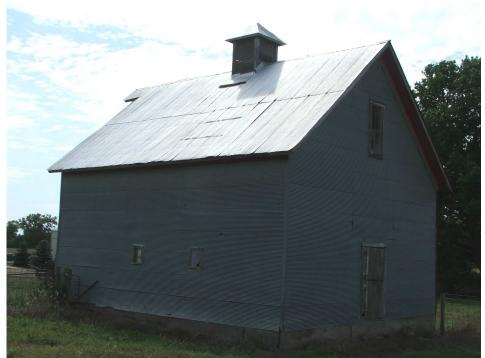
CAMERA DIRECTION: Looking SW, NE corner

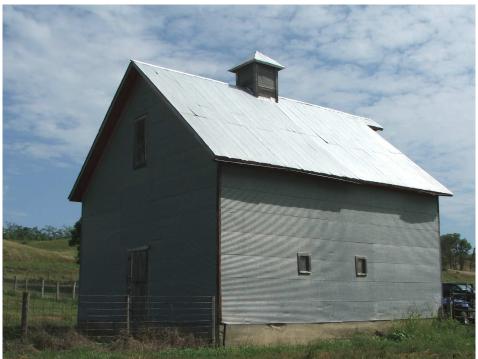
PHOTOGRAPHER: Jim Stone ROLL NUMBER: DATE OF PHOTO: September 3, 2013 PHOTO NUMBER: 4
CAMERA DIRECTION: Looking SE, NW corner

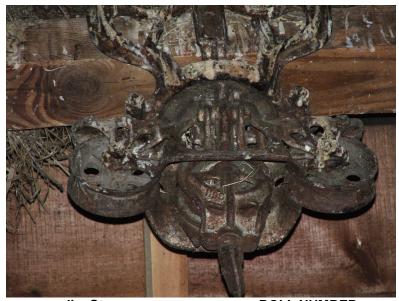
Hayloft, looking up and West, old trolley that uses a 4x4 for a hay

CAMERA DIRECTION: track.

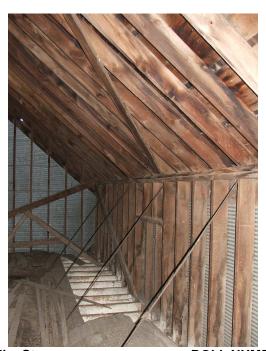
8

Hayloft, looking NE, 2x6 studs 16" O. C., 2x6 rafters and ½" steel rods bracing top of wall, 5' -

CAMERA DIRECTION: 4" O. C.
