**SOUTH DAKOTA STATE HISTORIC PRESERVATION OFFICE
HISTORIC SITES SURVEY STRUCTURE FORM**

*SURVEY DATE: July 17, 2012 *ADDRESS: 31489 455th Ave.
*SURVEYOR: Jim Stone *COUNTY: Clay
*CITY: Meckling

CURRENT FUNCTION: Shop and farm machinery storage

HISTORIC FUNCTION: Livestock barn

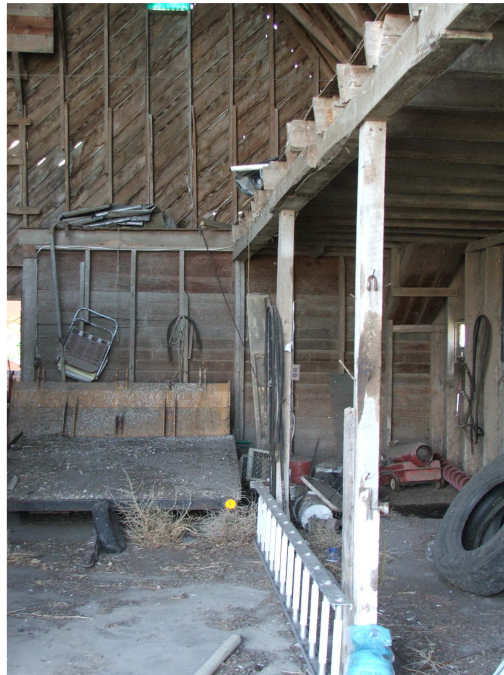
ROLL NUMBER: 5
PHOTO NUMBER: 5

ALTERED/MOVED NOTES: Original site. All (but 6' on the West end) of the hayloft floor has been removed. The floor joists only raised to 13' at 6' O. C. One 15'-4"x12' high sliding door has been added to the East wall. Asphalt shingles have been installed over the cedar shingles. A 20'x24' lean-to has been added to the West side. The lean-to is open on the North side. All evidence of stalls or stanchions has been removed.

CAMERA DIRECTION: Looking West, 6' of
hayloft floor remaining

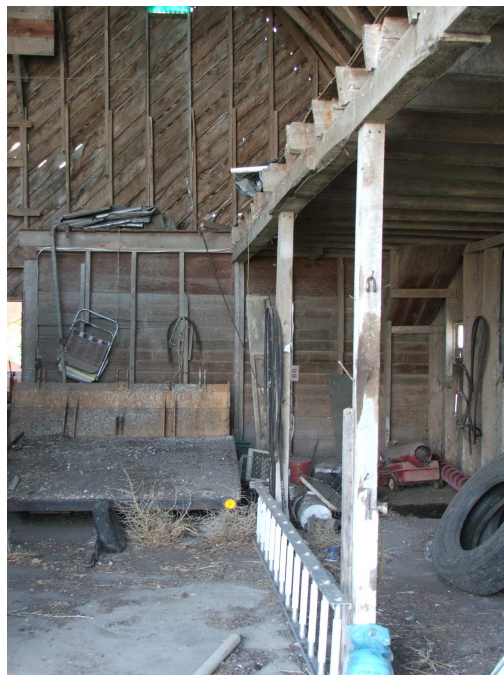
ROLL NUMBER: 6
PHOTO NUMBER: 6

CAMERA DIRECTION: First floor, looking West,
lower view of truss and
raised floor joists

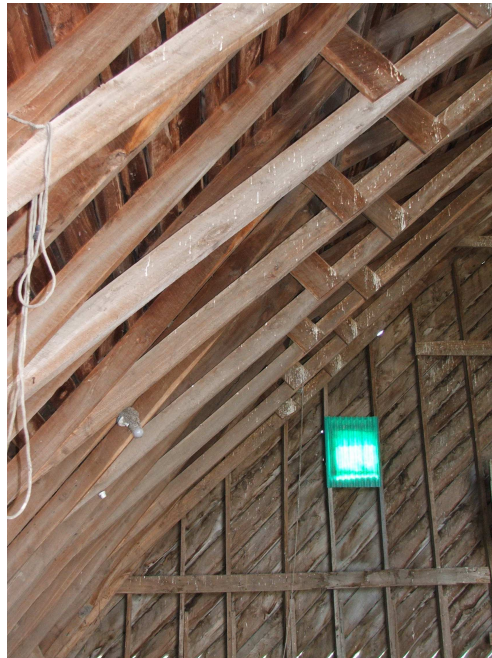
ROLL NUMBER: _____
PHOTO NUMBER: 7

CAMERA DIRECTION: Hayloft, looking West,
upper truss bracing and
raised floor joists 6' O.C.

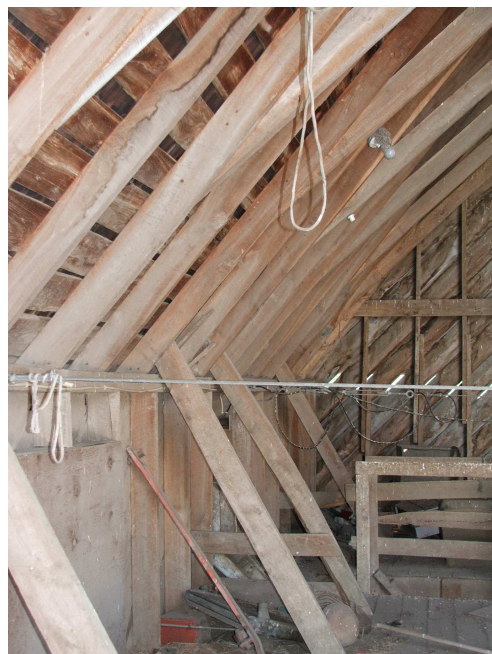
ROLL NUMBER: _____
PHOTO NUMBER: 7

CAMERA DIRECTION: Hayloft, looking
West, lower truss bracing
and raised floor joists 6'
O.C.
