**SOUTH DAKOTA STATE HISTORIC PRESERVATION OFFICE
HISTORIC SITES SURVEY STRUCTURE FORM**

*SURVEY DATE: December 16, 2013 *ADDRESS: 30715 460th Ave.
*SURVEYOR: Jim Stone *COUNTY: Clay
*CITY: Wakonda

CURRENT FUNCTION: Vacant FOUNDATION: Poured concrete
CURRENT SUBFUNCTION: Storage ROOF MATERIAL: Cedar shingles
HISTORIC FUNCTION: Dairy barn ROOF SHAPE: Gable roof
HISTORIC SUBFUNCTION: Hay storage STRUCTURAL SYSTEM: Balloon framing

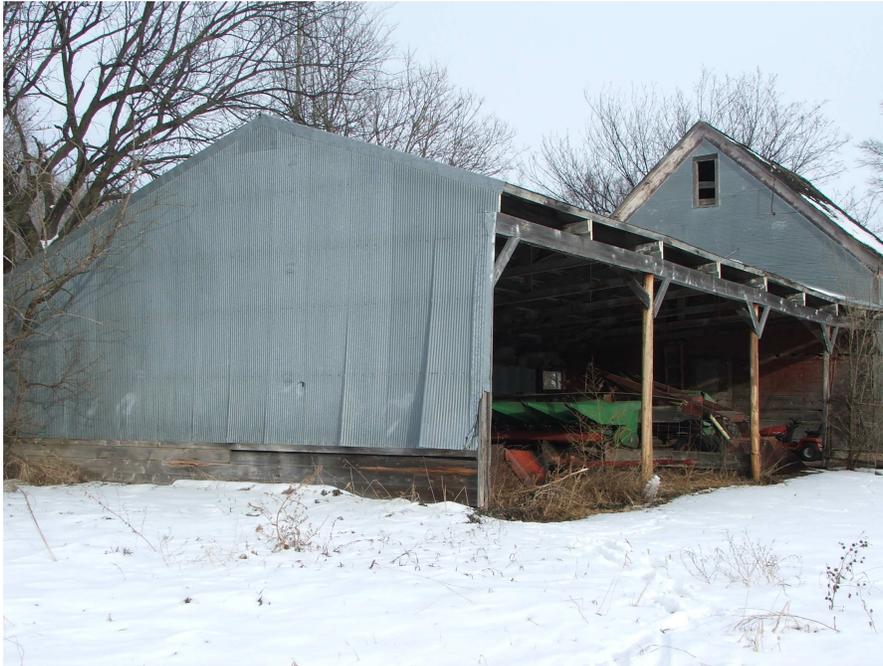
ROLL NUMBER: _____
PHOTO NUMBER: 5

CAMERA DIRECTION: Looking NE, 28' x 56'
pole barn lean-to added
on the West side.

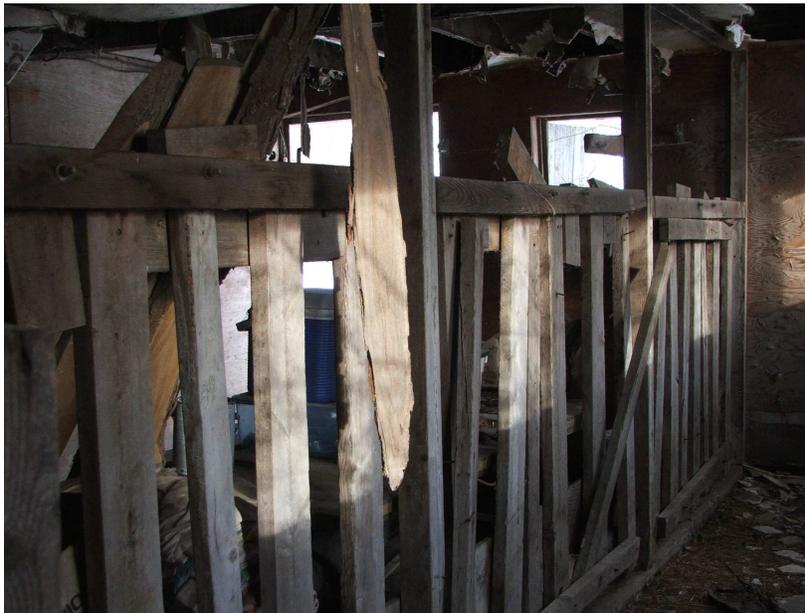
ROLL NUMBER: _____
PHOTO NUMBER: 6

CAMERA DIRECTION: First floor, looking NE,
six wooden milk cow
stanchions still in place.

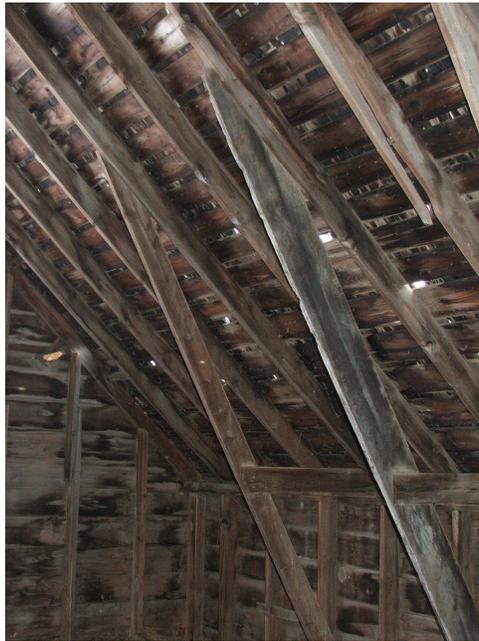
ROLL NUMBER: _____
PHOTO NUMBER: 7

**Hayloft, looking SE, 2x6
rafters, 2x6 bracing from
center of rafters down to
hayloft floor and exterior
wall.**

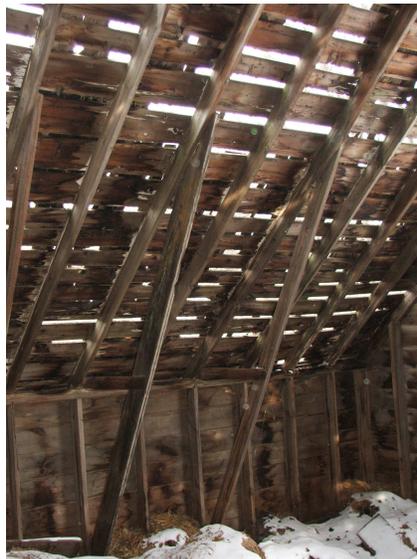
ROLL NUMBER: _____
PHOTO NUMBER: 8

**Hayloft, looking NE, 2x6
rafters and 2x6 bracing
from the center of rafter
down to floor and
exterior wall, 8', 4', 4', 8'**
