**SOUTH DAKOTA STATE HISTORIC PRESERVATION OFFICE
HISTORIC SITES SURVEY STRUCTURE FORM**

*SURVEY DATE: January 8, 2013 *ADDRESS: 46874 302rd Street
*SURVEYOR: Jim Stone *COUNTY: Clay
*CITY: Beresford

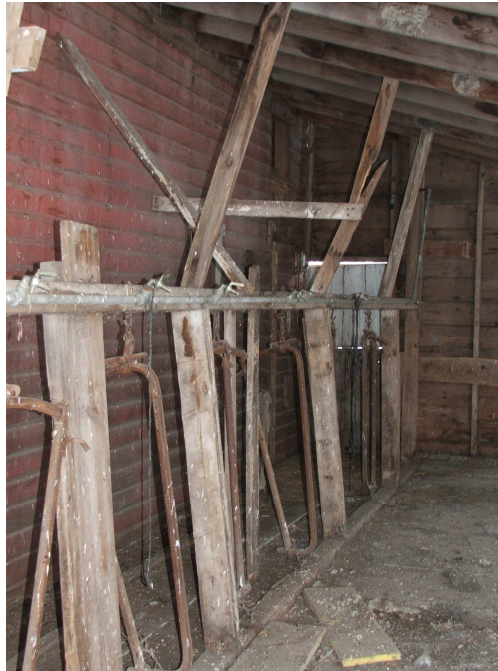
ROLL NUMBER: 5
PHOTO NUMBER: 5

**First floor, looking West
in the North lean-to, (9)
milk cow stanchions.**

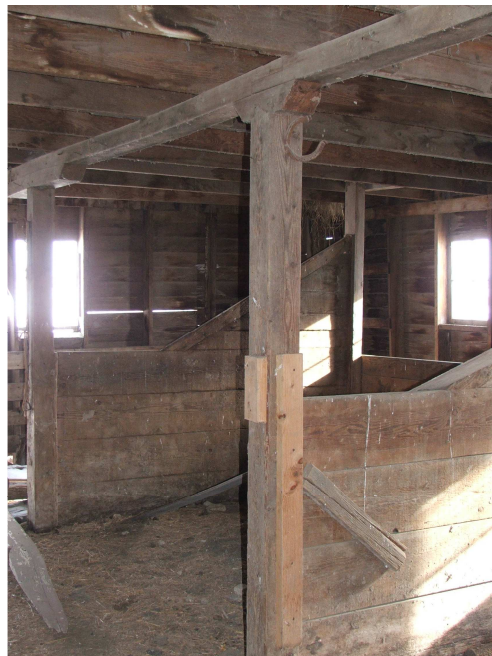
ROLL NUMBER: 6
PHOTO NUMBER: 6

**First floor, looking East,
horse stalls on the North
side**

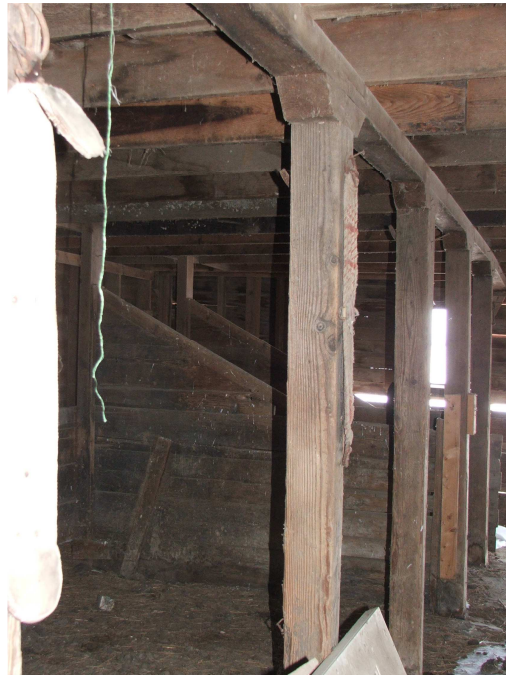
ROLL NUMBER: 7
PHOTO NUMBER: 7

**First floor, looking SE,
horse stalls on the South
side.**

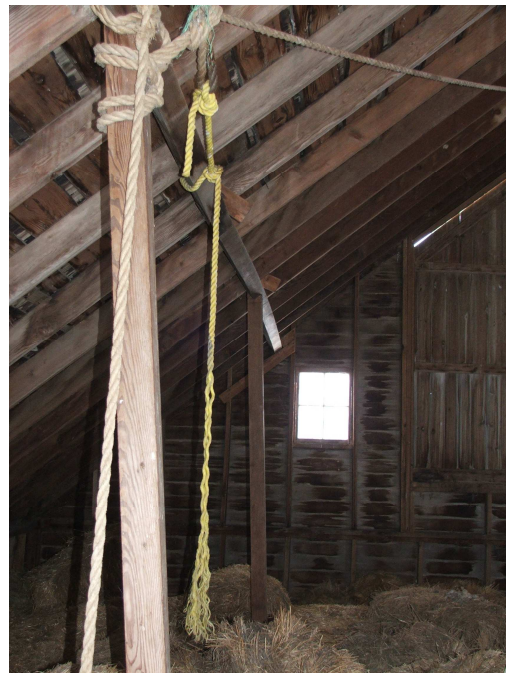
ROLL NUMBER: 8
PHOTO NUMBER: 8

**Hayloft, looking West.
4x4 posts and 4x4 beam
supporting the center of
the rafters.**
