**SOUTH DAKOTA STATE HISTORIC PRESERVATION OFFICE
HISTORIC SITES SURVEY STRUCTURE FORM**

*SURVEY DATE: January 13, 2012 *ADDRESS: 30867 S. D. Highway 19
*SURVEYOR: Jim Stone *COUNTY: Clay
*CITY: Vermillion

REGISTER NAME: Elmer Ellison barn
MULTIPLE PROPERTY NAME: _____

SHPO ID: 35 CL 0000579
*PROPERTY NAME: _____
OTHER NAME: _____

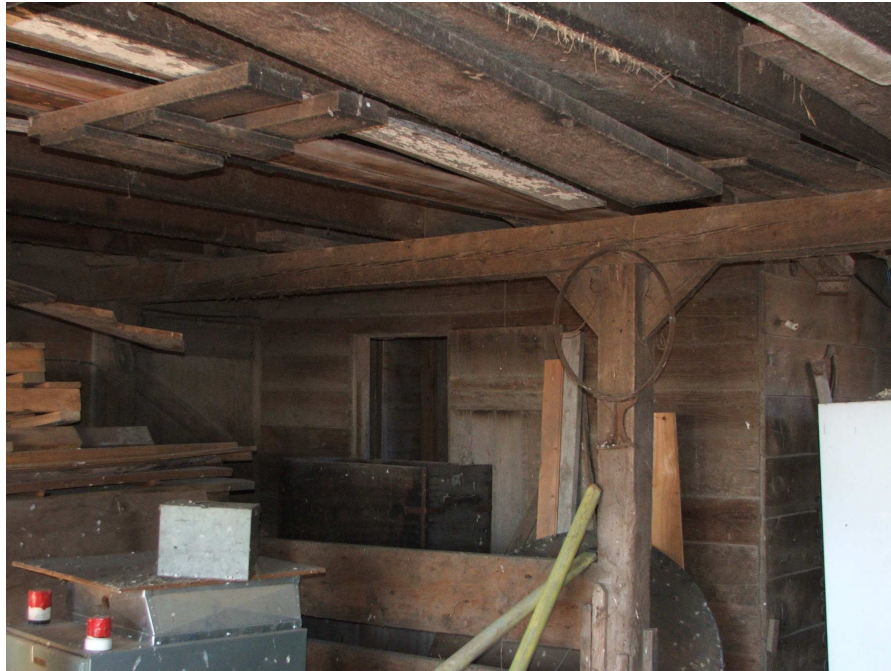
ROLL NUMBER: _____
PHOTO NUMBER: 5

CAMERA DIRECTION: First floor, looking NW.
Note granary in NW
corner
