SITE INFORMATION

*SURVEY DATE: _ Aug. 2, 2012				*ADDRESS: 29773 Greenfield Road							
*SURVEYOR: Jim Stone			*COUNTY	': Clay	Clay						
				*CITY	: Bere	sfor	t				
LOCATION DESCR				•			field	Roa	d, tu	rn let	it
(North), 19 miles to	298 th Street, a	bout 1	1/3 mile on N	orth, on the left ((West) si	de.					
LEGAL DESCRIPT	ION: SE 1/. 3	95 _	- 51 Glenwo	od Twp							
LEGAL DEGORII II	OL 74, 3	- 33 -	- 51 Olciiwo	od i wp.							
*QUARTER 1:	SE 1/4			OWNER NAME:	: Gary & Diane Lundberg						
*QUARTER 2:				NER ADDRESS:	29773 Greenfield Road						
*TOWNSHIP:	Greenwood			OWNER CITY:	Beresford						
*RANGE:	51			OWNER STATE:	South Dakota						
*SECTION:	3			OWNER ZIP:	57004						
ACRES:	256,62			QUAD NAME:							
OWNER CODE 1:	Р										
OWNER CODE 2:											
OWNER CODE 3:											
HISTORIC SIGN	IIFICANCE										
				DECISTED N	AME.						
*DOE: *DOE DATE:											
DE AGON INELIGIBLE				KOPEKI	1 11/	-CIVI C.	· —				
KLASON INCLIGIC)LL

STRUCTURE DETAILS

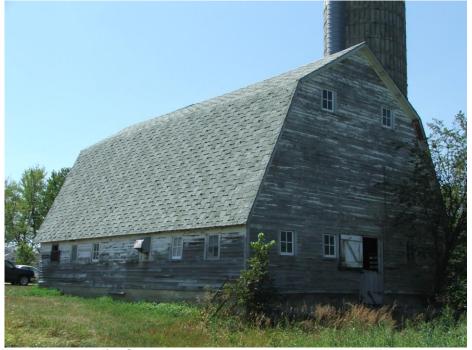
PHOTOGRAPHER: Jim Stone ROLL NUMBER: DATE OF PHOTO: Aug. 2, 2012 PHOTO NUMBER: 3

CAMERA DIRECTION: Looking SW, NE corner

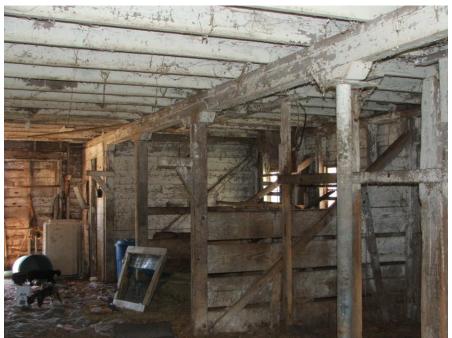
CAMERA DIRECTION: Feed room in SW corner

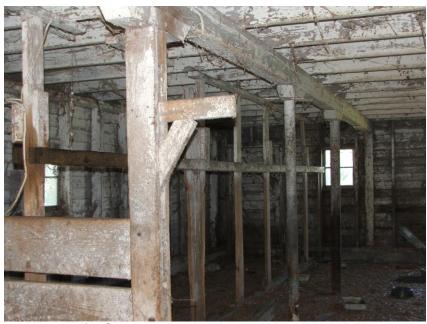
First floor, looking North, Milk cow stanchions on

CAMERA DIRECTION: West side

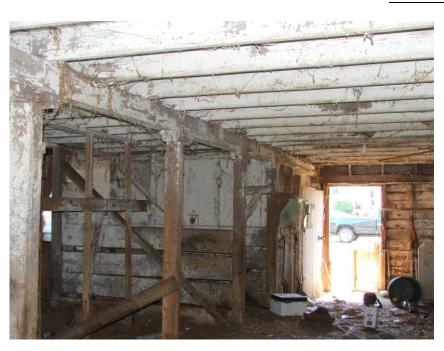
First floor, looking South, double horse stall and milk room in the SE

CAMERA DIRECTION: corner

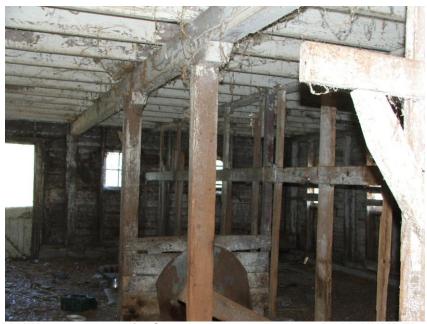
First floor, looking North, milk cow stanchions on

CAMERA DIRECTION: East side

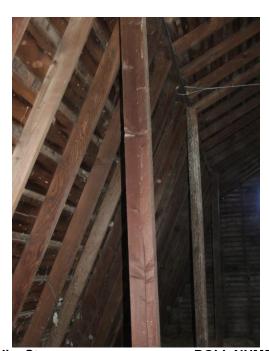
Hayloft, looking North, 4x6 posts to support the

CAMERA DIRECTION: hip

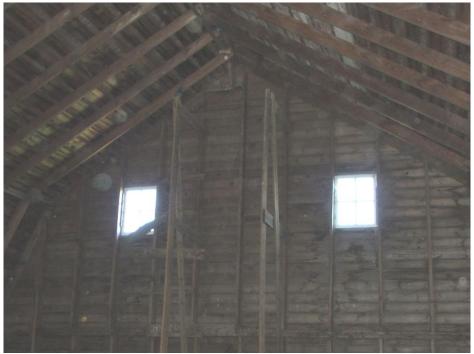
CAMERA DIRECTION: Hayloft, looking North, North gable end wall
