<b>""SITE INFORMATION</b>							
*SURVEY DATE: July 27, 2	2013 *ADDRESS:	45278 305 <sup>th</sup> Street					
*SURVEYOR: Jim Ston		Clay					
	*CITY:	Volin					
LOCATION DESCRIPTION: From Vermillion, intersection of South Dakota Highway 50 bi-pass and							
South Dakota Highway 19, North about 12 miles to 305th Street, turn left (West) 9-1/8 miles on the right							
(North) side.							
LEGAL DESCRIPTION: E½, SE 1/4, 7 – 94 – 53 Bethel Twp							
*QUARTER 1: SE 1/4	OWNER NAME:	OWNER NAME: Ronald Burnell & Jeanne M. Nelson					
*QUARTER 2:	OWNER ADDRESS:						
*TOWNSHIP: Bethel	OWNER CITY:						
*RANGE: 53	•	OWNER STATE: South Dakota					
*SECTION: 7	OWNER ZIP:						
ACRES: 79.16	QUAD NAME:						
OWNER CODE 1: P							
OWNER CODE 2:							
OWNER CODE 3:							
HISTORIC SIGNIFICANCE							
HISTORIC SIGNIFICANCE							
	REGISTER NA	REGISTER NAME:					
*DOE DATE:	MULTIPLE PR	MULTIPLE PROPERTY NAME:					
REASON INELIGIBLE:

#### STRUCTURE DETAILS

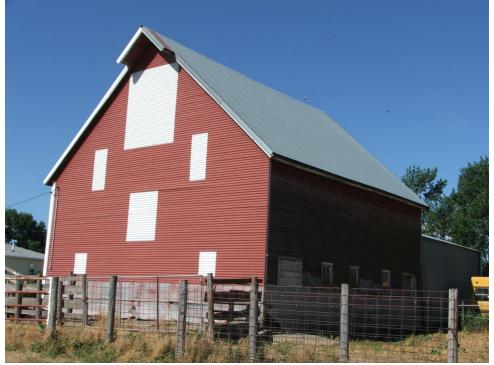
DATE OF PHOTO: July 26, 2013 PHOTO NUMBER: 3

CAMERA DIRECTION: Looking SW, NE corner

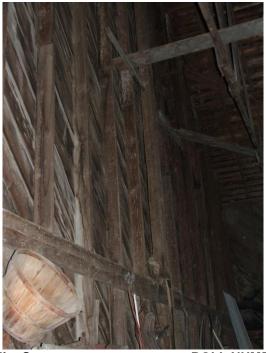
First floor, looking NW, 2x6 studs, diagonal sheathing on West of original barn.

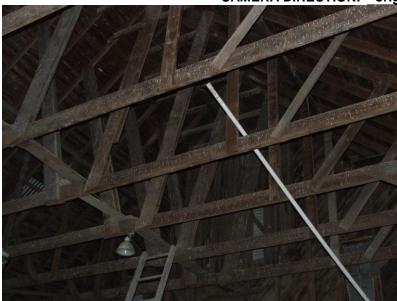
First floor, looking up and NE, raised 2x8 floor joists, 2x6 and double 1x8's bracing to create a

CAMERA DIRECTION: truss.

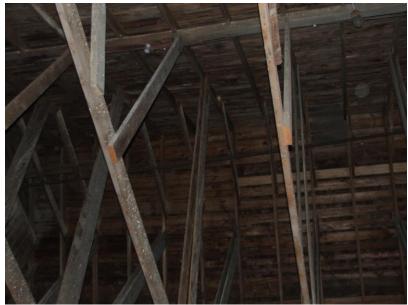
First floor, looking up and SE, very well engineered truss using

CAMERA DIRECTION: existing materials.

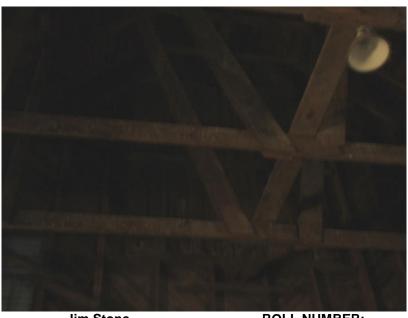
Hayloft, looking East, view of lowered hayloft door on East gable end, Hay track actually slopes about 2 feet to the West

CAMERA DIRECTION: gable end.

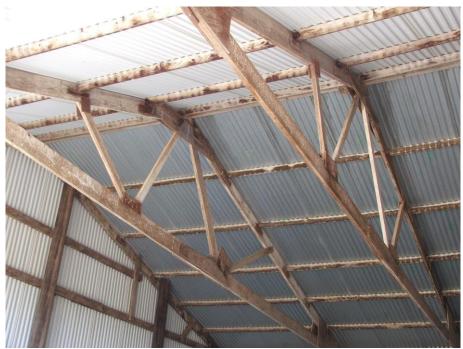
West addition, looking NW, typical pole barn

CAMERA DIRECTION: construction.
