SOUTH DAKOTA STATE HISTORIC PRESERVATION OFFICE
HISTORIC SITES SURVEY STRUCTURE FORM

*SURVEY DATE: March 8, 2012
*SURVEYOR: Jim Stone

*ADDRESS: 30221 Frog Creek Road
*COUNTY: Clay
*CITY: Wakonda

*PROPERTY NAME: Henry Dose barn

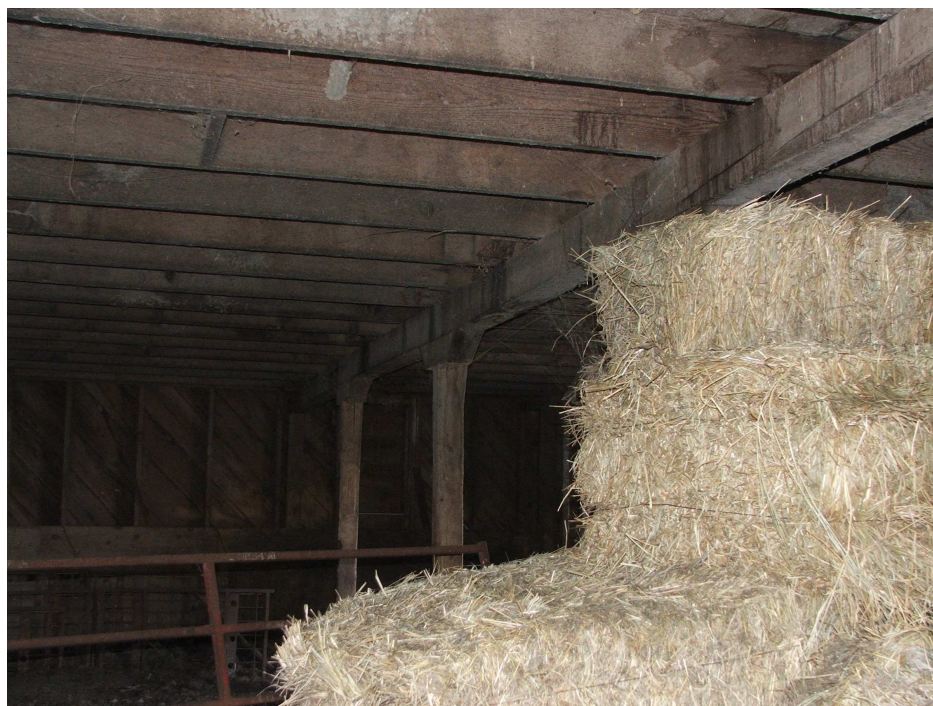
ROLL NUMBER: _____
PHOTO NUMBER: 4
CAMERA DIRECTION: First floor, looking North,
6x6 posts and 6x8 beam

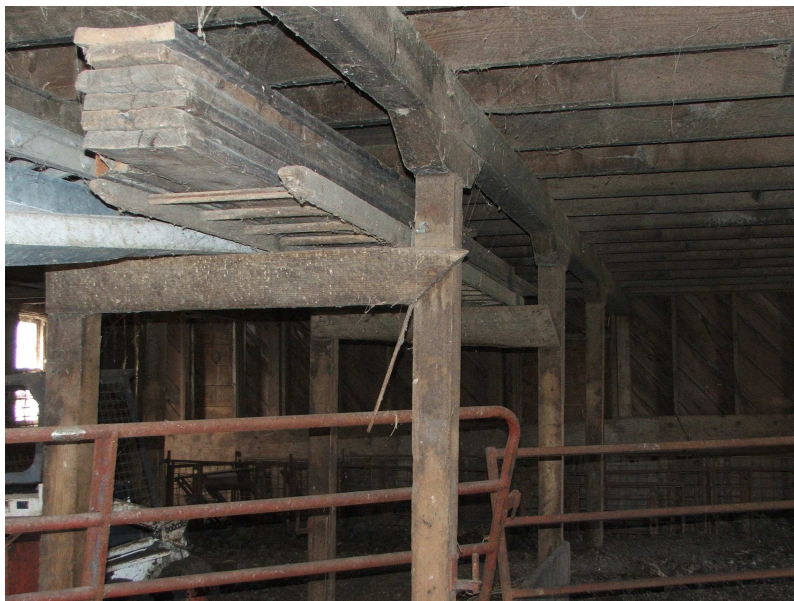
ROLL NUMBER: _____
PHOTO NUMBER: 5
CAMERA DIRECTION: First floor, looking North,
6x6 posts and 6x8 beam

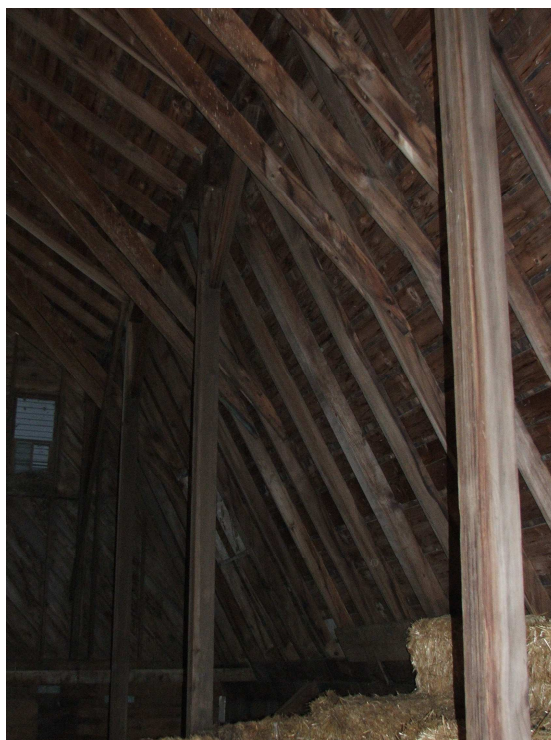
ROLL NUMBER: _____
PHOTO NUMBER: 6
CAMERA DIRECTION: Hayloft, looking North,
note 6x6 rafter behind
6x6 post

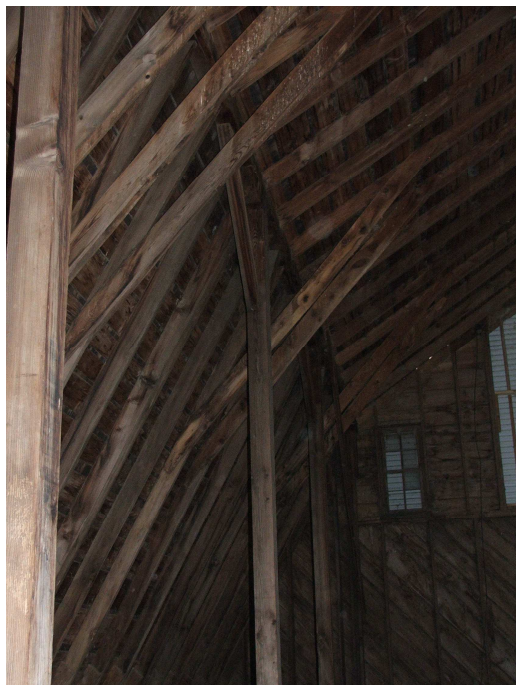
ROLL NUMBER: _____
PHOTO NUMBER: 7

CAMERA DIRECTION: Hayloft, looking North,
note 6x6 rafter behind
6x6 post

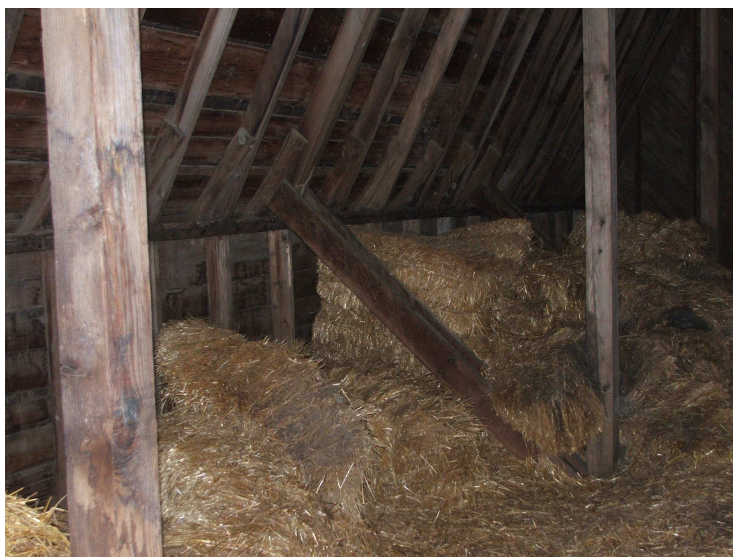
ROLL NUMBER: _____
PHOTO NUMBER: 8

CAMERA DIRECTION: Hayloft, looking NW,
note (2) 2x8 braces from
bottom of 6x6 rafter
down to bottom of 6x6
post
